Aviation Investigation Final Report

Location:	Moose Lake, Minnesota	Accident Number:	CEN19FA139
Date & Time:	May 8, 2019, 16:30 Local	Registration:	N111JP
Aircraft:	Mooney M20J	Aircraft Damage:	Substantial
Defining Event:	Loss of control in flight	Injuries:	1 Fatal
Flight Conducted Under:	Part 91: General aviation - Business

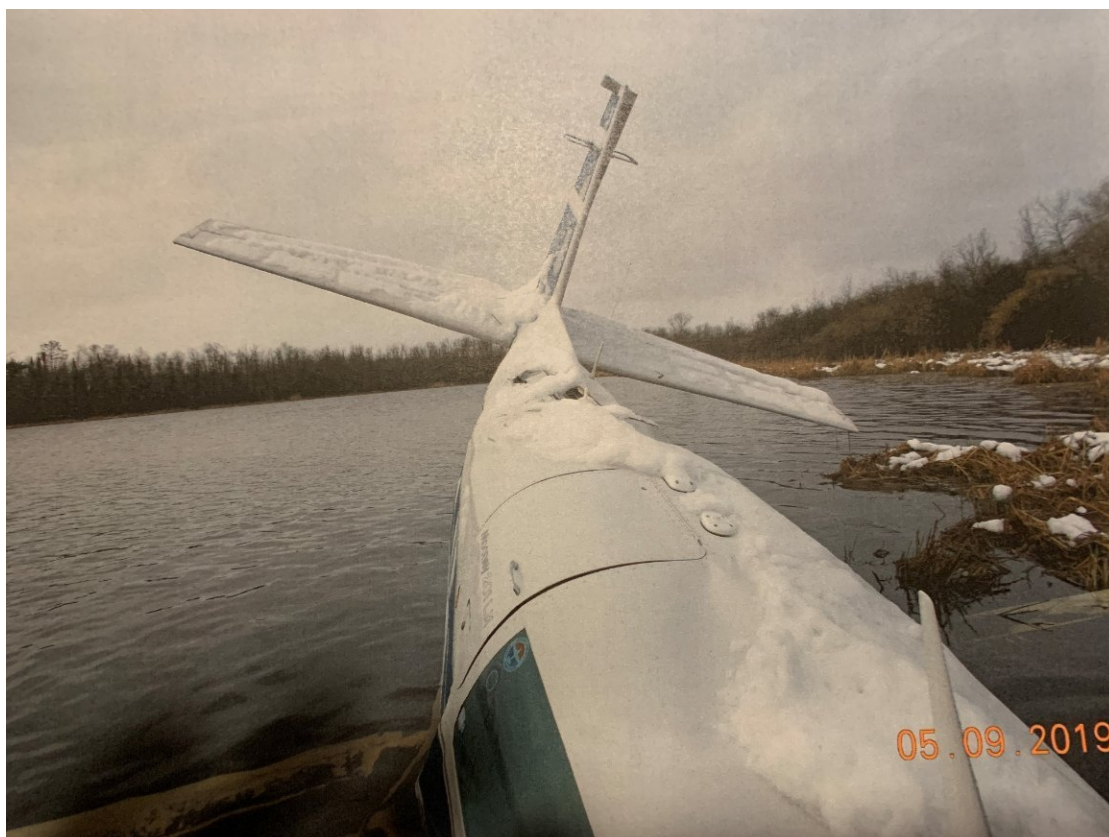
The airplane was parked outside on the day of the accident. A witness at the airport was unaware of any tools that the pilot had access to clear snow or ice from the airplane before the flight. Investigators were unable to determine how much snow may have accumulated on the airplane before the flight or if the pilot removed any wing contamination before he took off.

The airplane came to rest near the west bank of the river in about 2 to 4 ft of water. The engine and propeller were imbedded in the mud and silt on the bank of the river and the tail was extended into the air. When first responders arrived on scene the next morning, the visible portion of the empennage was covered in snow as illustrated in figure 1.

Figure 1. Empennage covered in snow (provided by LEO).
