Aviation Investigation Final Report

Location:	Fort Walton Beach, Florida	Accident Number:	CEN18FA358
Date & Time:	August 30, 2018, 10:30 Local	Registration:	N1876L
Aircraft:	Beech B60	Aircraft Damage:	Destroyed
Defining Event:	Controlled flight into terr/obj (CFIT)	Injuries:	4 Fatal
Flight Conducted Under:	Part 91: General aviation - Personal

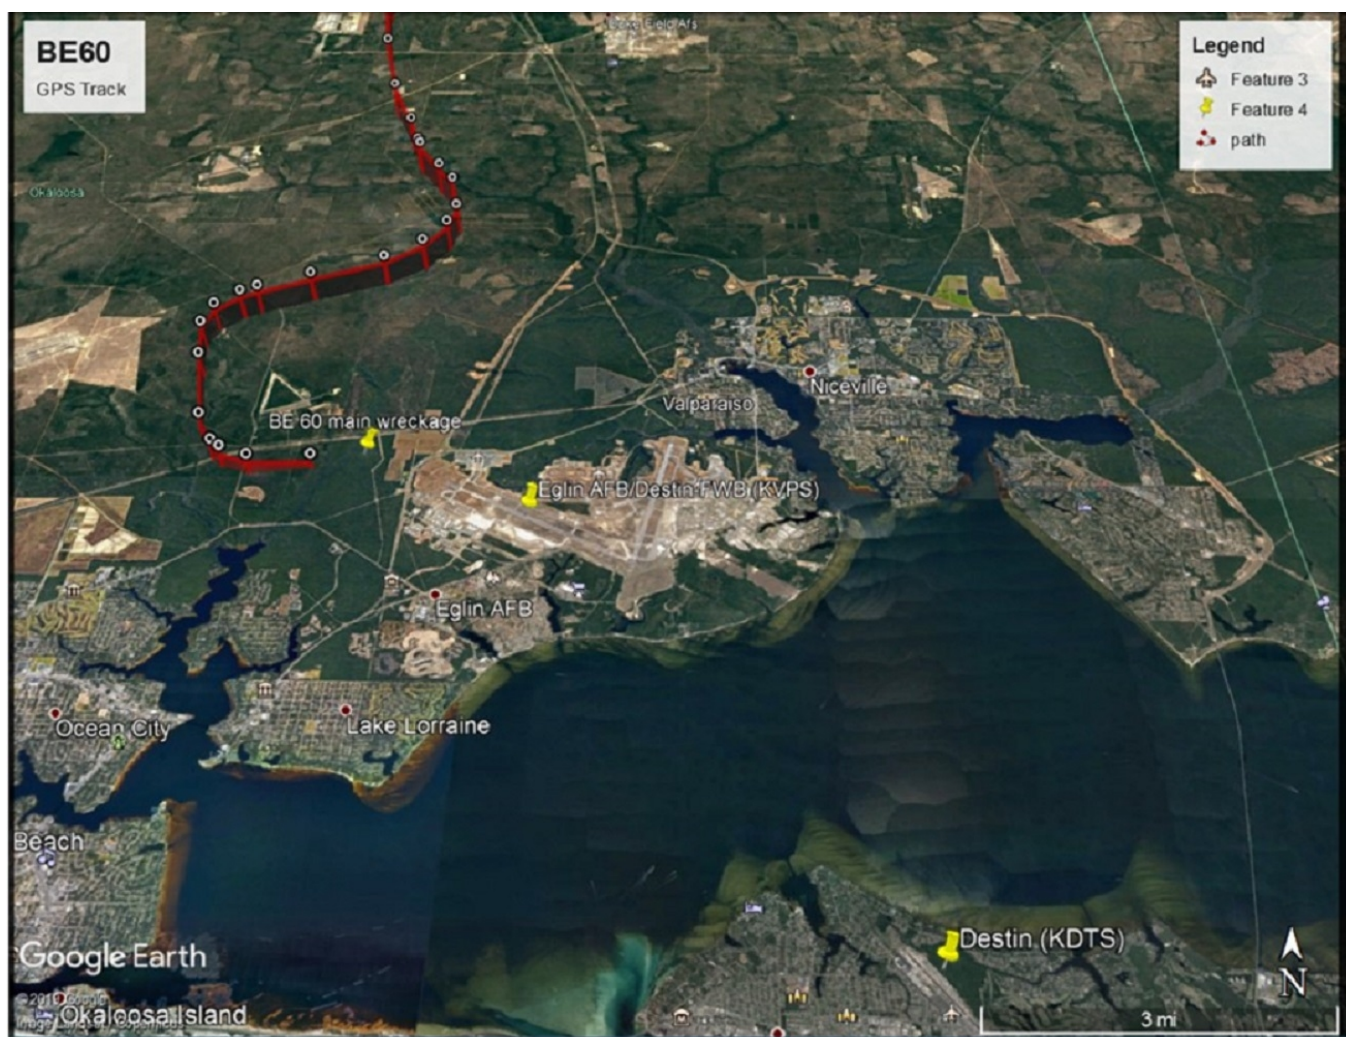
Figure 1: GPS Track

GPS data recovered from a portable onboard unit showed the airplane's track as it approached DTS. The last data point, at 1032, indicated that the airplane was at an altitude of 489 ft and a ground speed of 118 knots. At 1033, the approach controller asked the tower controller if the airplane had Eglin AFB and DTS in sight, and the tower controller responded that the pilot reported that the airplane was 2 miles out. The approach controller then stated that the airplane was 200 ft over Eglin AFB. The tower controller tried to contact the pilot, but the pilot did not respond to these transmissions. The airplane wreckage was located in a remote wooded area about 8 miles northwest of DTS and 2.5 miles northwest of Destin-Fort Walton Beach Airport (VPS), Eglin AFB, Florida.
