Aviation Investigation Final Report

Location:	Marion, Indiana	Accident Number:	CEN19FA035
Date & Time:	November 29, 2018, 14:21 Local	Registration:	N7751Y
Aircraft:	Piper PA 30	Aircraft Damage:	Destroyed
Defining Event:	Aerodynamic stall/spin	Injuries:	1 Fatal
Flight Conducted Under:	Part 91: General aviation - Personal

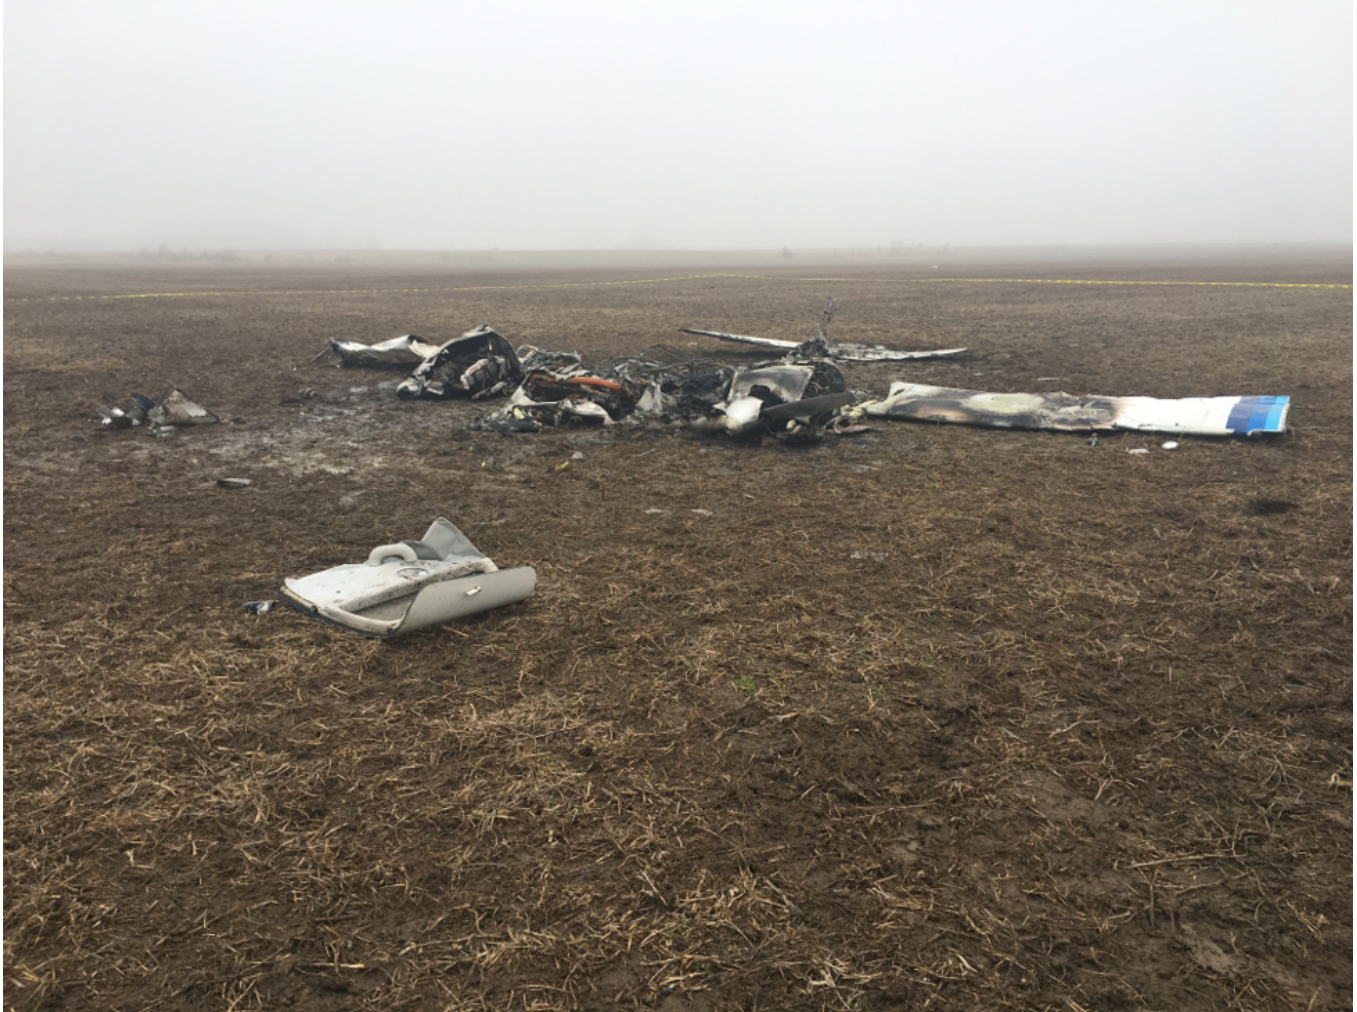
Figure. Accident Site

The airplane came to rest upright in a soft, wet field about 1/4 mile south of the departure runway. The accident site and the airplane wreckage are shown in the figure. Postaccident examination of the airplane showed that the fuselage, empennage, and inboard sections of both wings were consumed by post-impact fire. The instrument panel, instruments, and engine controls were destroyed by fire and impact. The front left seat remained attached to the cabin floor. (The right front seat was not installed and was found in the pilot's hangar.) The main cabin door was separated and came to rest about 15 ft forward of the main wreckage. The upper latch and side pin were found engaged, consistent with a closed or locked door position.

The left and right wings remained partially attached to the fuselage and displayed thermal, buckling, and leading edge damage. The left and right ailerons remained attached to the wing attach brackets and control pushrod. The left and right flaps remained attached to the wing structure and displayed thermal damage. The right outboard wing and wing tip were deformed aft. A ground scar, consistent with the right wing, was noted about 3 ft in front of the damaged right wing. The right flap control mechanism displayed thermal damage and the control arm was found between the flaps 0° and slightly extended position. The landing gear retraction push-pull rod was found in the landing gear extended position.

The empennage was consumed by fire. The horizontal and vertical stabilizers and rudder were attached and displayed thermal damage. The rudder trim mechanism shaft position correlated to a neutral rudder trim setting.

The left engine and propeller assembly remained partially attached to the airframe. One propeller blade showed no damage, and one propeller blade was not twisted and bent aft. The right engine remained partially attached to the airframe, and the right propeller assembly was separated from the engine, aft of the crankshaft flange. The crankshaft fracture surface exhibited 45° shear lips. One propeller blade was twisted and bent forward, and one propeller blade was twisted and bent aft. Both the left and right propeller blades appeared to be in a low-pitch position.
