# Aviation Investigation Final Report

<b>Location:</b>	Lincolnton, North Carolina	<b>Accident Number:</b>	ERA18FA197
<b>Date &amp; Time:</b>	July 24, 2018, 05:21 Local	<b>Registration:</b>	N38523
<b>Aircraft:</b>	Piper PA32R	<b>Aircraft Damage:</b>	Substantial
<b>Defining Event:</b>	VFR encounter with IMC	<b>Injuries:</b>	2 Fatal
<b>Flight Conducted Under:</b>	Part 91: General aviation - Personal

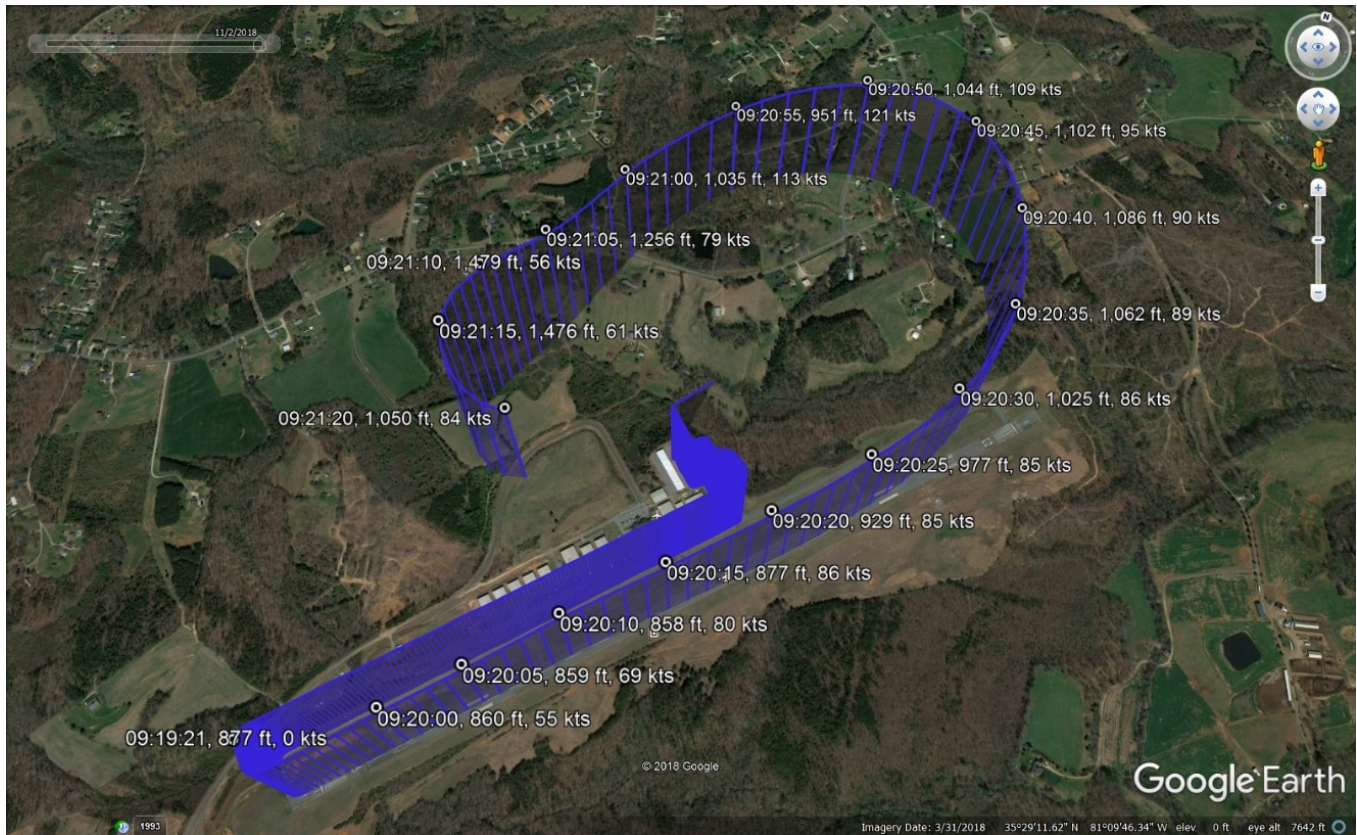
Data from the onboard Appareo Stratus 2S unit indicated that the airplane departed runway 05 about 0520; about 0520:25, the pilot initiated a left turn as it climbed from the runway. The airplane continued the climbing left turn to about 1,100 ft GPS altitude and a groundspeed about 95 knots, then descended to about 950 ft GPS altitude and accelerated to a groundspeed about 121 knots on an approximate left downwind leg for runway 05. About 0521:10, the airplane was about 1,480 ft GPS altitude and a groundspeed about 56 knots. The airplane subsequently entered a descending left turn; the final recorded data point captured a GPS altitude of 1,050 ft and a rate of descent greater than 4,000 ft per minute. (see Figure 1.) A witness near the accident site reported that he was sleeping when he heard a low-flying airplane followed by a "thud." He drove to the airport and located the airplane in an open field about 1/2-mile northwest of midfield.

Google Earth overlay showing accident flight track data
