Aviation Investigation Final Report

Location:	Fancy Gap, Virginia	Accident Number:	ERA19FA003
Date & Time:	October 6, 2018, 12:15 Local	Registration:	N38811
Aircraft:	Piper J3C	Aircraft Damage:	Substantial
Defining Event:	Controlled flight into terr/obj (CFIT)	Injuries:	1 Fatal
Flight Conducted Under:	Part 91: General aviation - Personal

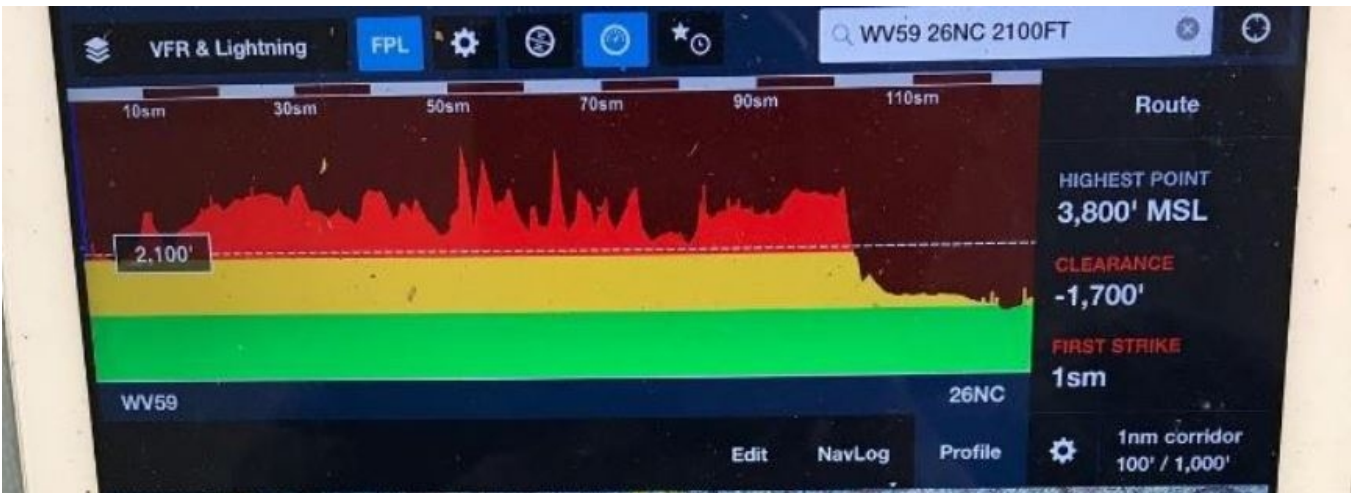
According to information retrieved from one of the pilot's personal electronic devices, when the device was turned on and the ForeFlight application was started it showed that the pilot had entered a flight plan that noted "WV59 26NC 2100 FT." This indicated that the flight would depart from WV59 and fly to Booneville Airport (26NC), Booneville, North Carolina, which was about 22 nautical miles from the destination airport. The 2,100 ft indicated the planned altitude on the route of flight. Further, the ForeFlight application was displaying the map screen with a terrain cross-section overview, a "first strike" distance indicating 1 statute mile, and the highest point along the route indicating 3,800 ft mean sea level (msl), as shown in figure 1. According to ForeFlight, "first strike" was the distance "...from your origin or current position to where your first impact with terrain or an obstacle would be based on your planned altitude."

Figure 1. ForeFlight information displayed on pilot's personal electronic device.
