Aviation Investigation Final Report

Location:	Walton, New York	Accident Number:	ERA19FA039
Date & Time:	November 9, 2018, 15:00 Local	Registration:	N5044J
Aircraft:	Cessna 310	Aircraft Damage:	Destroyed
Defining Event:	Fire/smoke (non-impact)	Injuries:	1 Fatal
Flight Conducted Under:	Part 91: General aviation - Personal

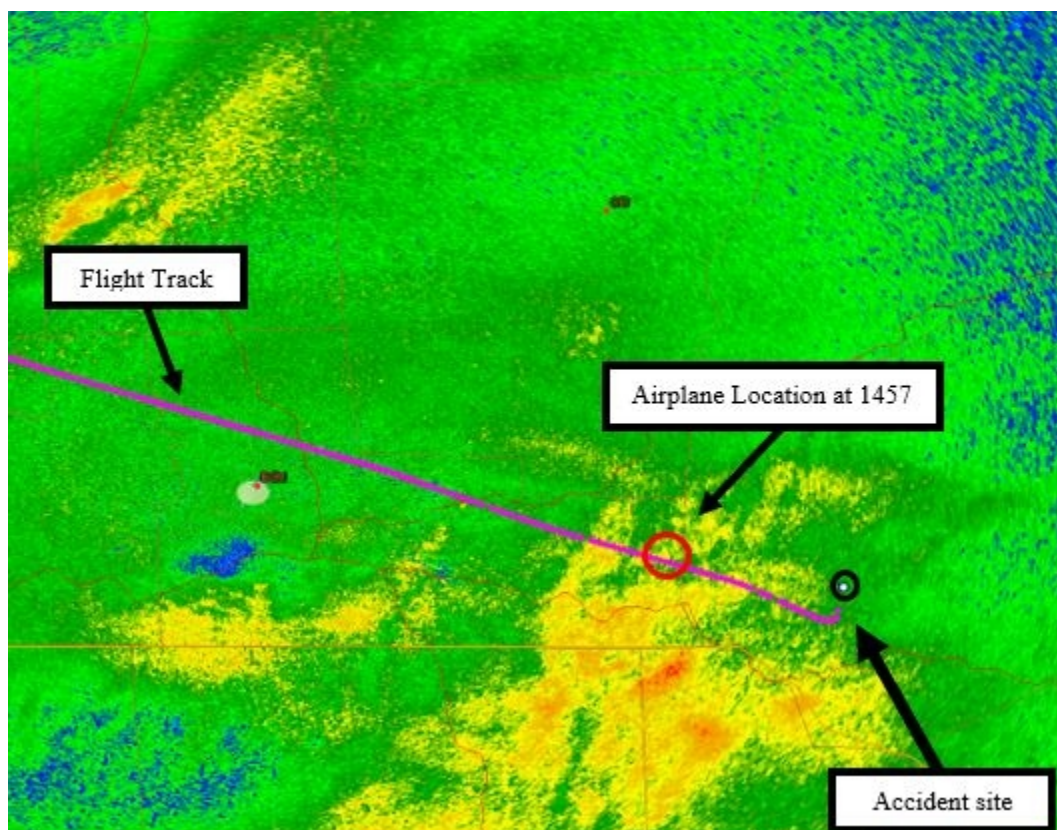
The GOES-16 Icing index imagery for 1445 and 1515 for the accident area suggested likely moderate to heavy icing. Additional review of the BGM Weather Surveillance Radar (WSR-88D) revealed reflectivity values that indicated light to heavy precipitation was falling at 1457 along the route of flight and near the accident site. (refer to Figure 1.)

Figure 1. Weather Radar Imagery at 1457, with the airplane's flight track noted by the magenta line, the airplane's position at 1457 circled in red, and the accident site circled in black.

Review of the WSR-88D Dual-Polarization Product revealed signatures consistent with Supercooled Large Droplet (SLD) icing conditions.

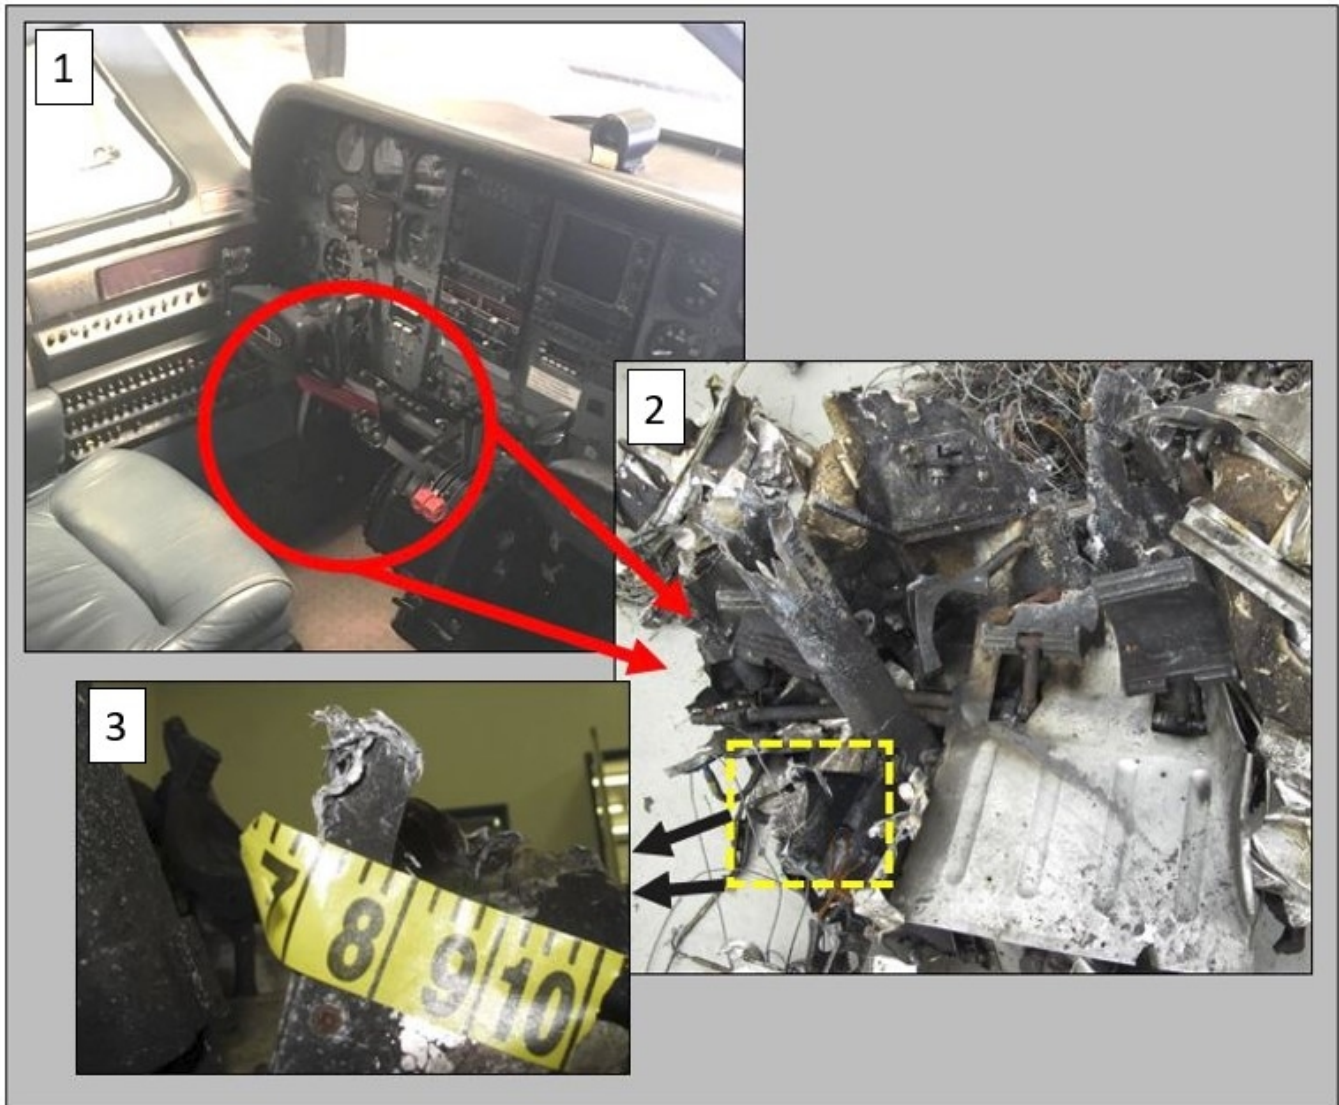
The airplane was examined for evidence of an in-flight fire. Small areas of broomstrawing and localized thermal damage were found on a pedestal structure located in the left side of the cockpit area, where the pilot was likely seated (broomstrawing is an effect that occurs when aluminum components become semi-molten due to exposure to heat and are then subjected to a shock loading, such as an impact.) Figure 2 shows three numerically labeled photographs; the first shows the accident airplane's cockpit about 1 year before the accident, with the red circle highlighting the area where broomstrawing was located. The second photograph shows the wreckage postaccident, and the third photograph is a closer image of the area highlighted by the yellow box, showing an area of broomstrawing.

Figure 2: Photographs of the cockpit area preaccident (image 1) and postaccident showing the area where broomstrawing was found (images 2 and 3).

Sections of the cockpit floor area also exhibited heavy sooting and varying levels of thermal damage. The exterior skin directly beneath the cockpit exhibited a localized area of thermal damage. In this area, the exterior paint was missing, and the primer was discolored white and exhibited a powdery appearance. There were other, smaller areas of localized paint damage on the exterior surface. In these areas, the paint was discolored black with some localized bubbling. The left section exhibited general mechanical damage and was heavily sooted with varying levels of soot tailing (an airflow-driven pattern) along the rivet lines. There were no other exterior areas that exhibited thermal damage.
