Aviation Investigation Final Report

Location:	Deadwood, California	Accident Number:	WPR18LA233
Date & Time:	August 20, 2018, 16:30 Local	Registration:	N14CK
Aircraft:	Blue Oak LLC. CCK-1865	Aircraft Damage:	Substantial
Defining Event:	Loss of engine power (total)	Injuries:	1 None
Flight Conducted Under:	Part 91: General aviation - Personal

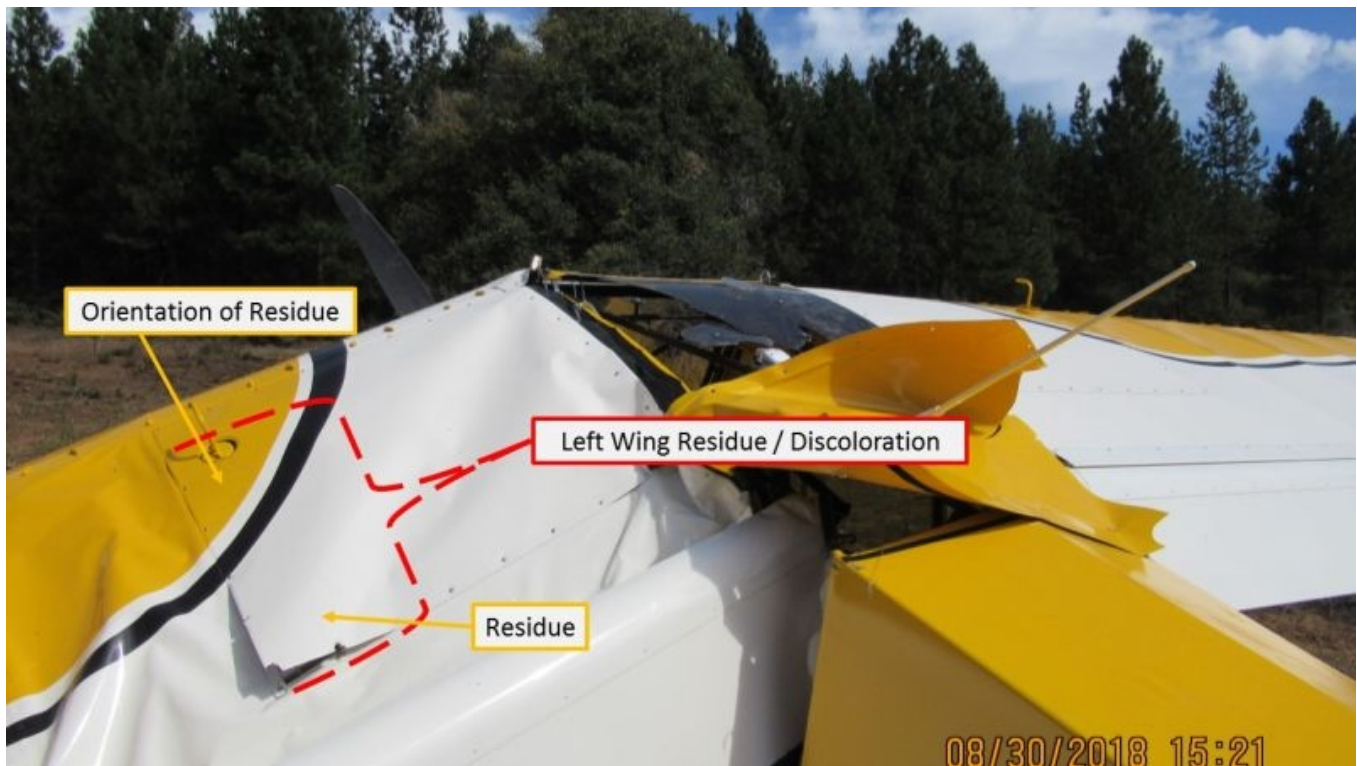
A loss of engine power due to fuel exhaustion and the pilot's failure to ensure that the left-wing fuel cap was secure before flight. Contributing to the accident was the pilot's failure to monitor fuel levels while in flight.

During the uneventful flight, he was about 500 ft above ground level over mountain ridge tops when the engine lost partial power. The pilot said that he was able to maintain level flight and maneuver toward more favorable terrain before the engine lost total power. Subsequently, the pilot initiated a forced landing in a small clearing within heavily wooded mountainous terrain. During the landing roll, the airplane struck a tree and came to rest upright. The pilot added that following the accident, he noticed that the left wing fuel tank cap was not secured.

The airplane was recovered to a secure location for further examination. Recovery company personnel reported that prior to disassembly of the airplane to facilitate removal of the wreckage, the right wing fuel tank contained no fuel, and the left wing fuel tank had about one-half gallon of fuel in it. Review of a photo furnished by the wreckage recovery company revealed that 10 days following the accident, a slight amount of residue / discoloration in trail of the left wing fuel tank filler neck, and extended to the trailing edge of the fuel tank cover.

Photo 1: View of the left wing fuel tank, noting the slight discoloration in trail of the left fuel tank filler neck. Courtesy of Plain Parts.
