Aviation Investigation Final Report

Location:	Aberdeen, Mississippi	Accident Number:	CEN19TA112
Date & Time:	March 29, 2019, 17:45 Local	Registration:	N8397W
Aircraft:	Piper PA28	Aircraft Damage:	Substantial
Defining Event:	Collision during takeoff/land	Injuries:	2 Minor
Flight Conducted Under:	Part 91: General aviation - Personal

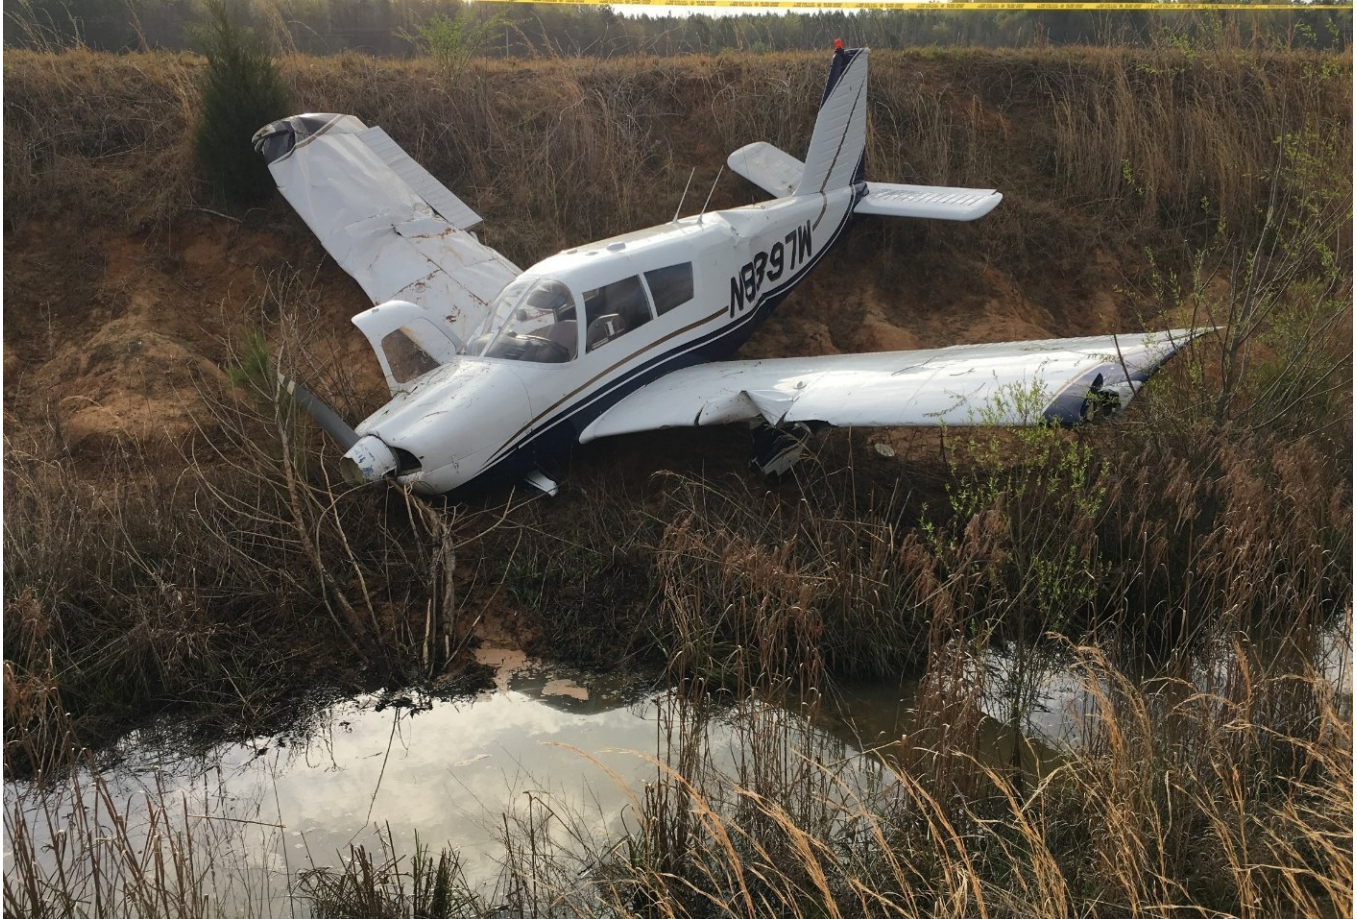
The passenger, who held a student pilot certificate with about 40 hours of flight time, stated that he had recently purchased the airplane and planned to take lessons from a flight instructor at M40 on April 1, 2019. He and the private pilot intended to reposition the airplane to M40 where it was to be refueled for the upcoming flight instruction. He stated the private pilot was acting as the pilot in command and was manipulating the flight controls. He added that the flight was uneventful until the landing at M40. During the landing flare, the airplane was slightly left of the runway centerline when it suddenly veered left. As the airplane continued off the left side of the runway, the private pilot applied full power and attempted to abort the landing. During the aborted landing the airplane collided with the north-south airport perimeter fence then continued into a ditch (figure 1).

Figure 1 – Accident airplane in a ditch

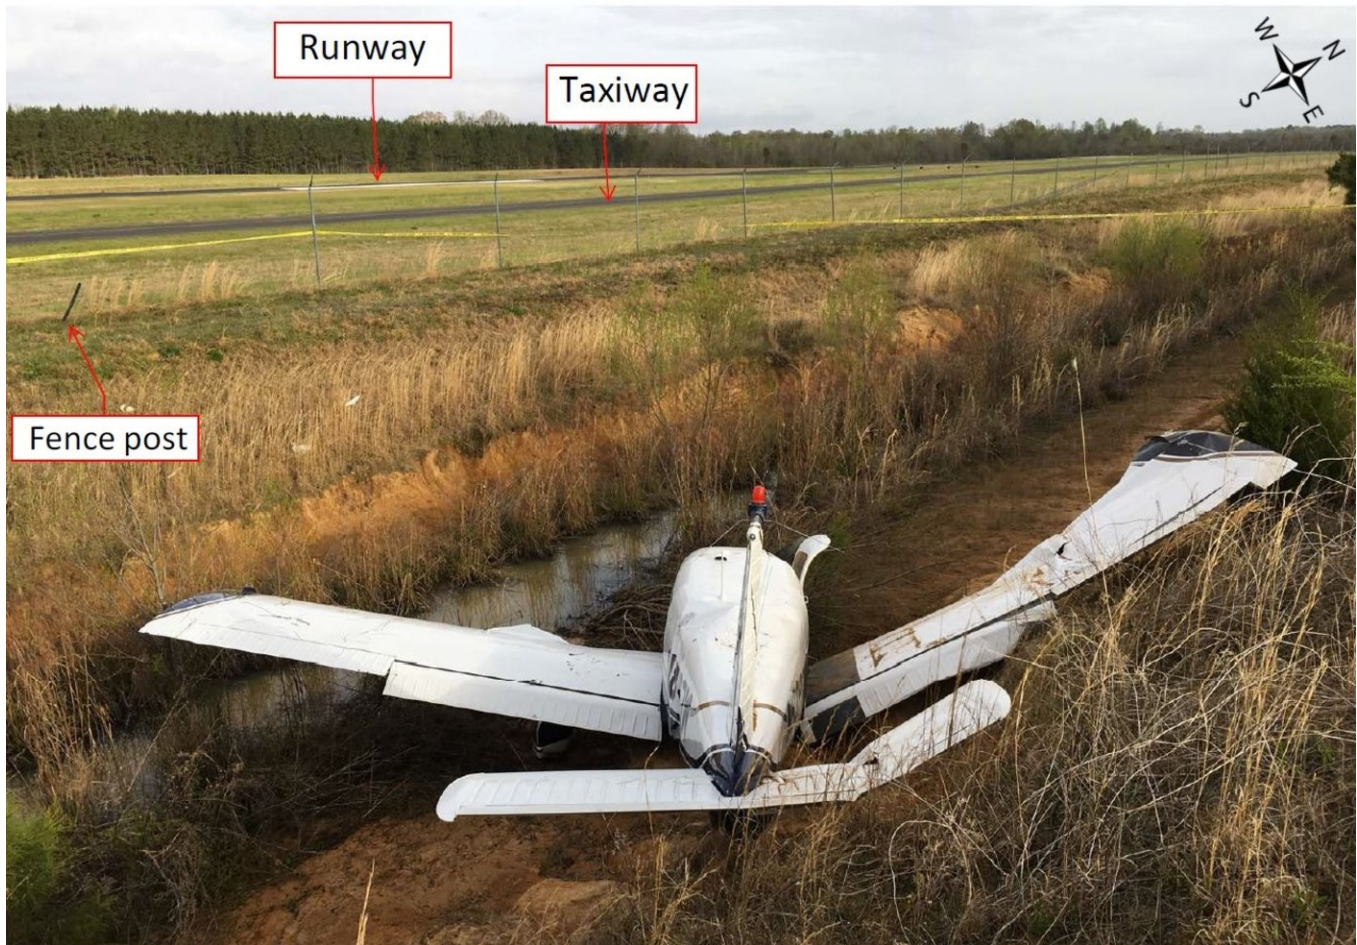
The responding Federal Aviation Administration (FAA) inspector completed a postaccident examination of the airplane on April 1, 2019. The flaps were found fully extended and the flight control cables were continuous. The nose landing gear was impact damaged; the corresponding rudder cable was off of the pulley and the cable's attachment point to the rudder pedal was broken. The examination did not reveal any preimpact anomalies that would have precluded normal operation. The FAA inspector's photos revealed tire tracks in the grass where the airplane exited the runway. The tire tracks continued left across the taxiway and led to a knocked over fence post and metal fence laid on the ground toward the airplane. The airplane came to rest facing northwest toward the runway 18 threshold (figure 2).

Figure 2 – Airplane in a ditch facing toward the runway 18 threshold
