Aviation Investigation Final Report

Location:	Plain City, Ohio	Accident Number:	CEN19FA100
Date & Time:	March 17, 2019, 17:45 Local	Registration:	N424TW
Aircraft:	Cessna 421	Aircraft Damage:	Destroyed
Defining Event:	Loss of control in flight	Injuries:	1 Fatal
Flight Conducted Under:	Part 91: General aviation

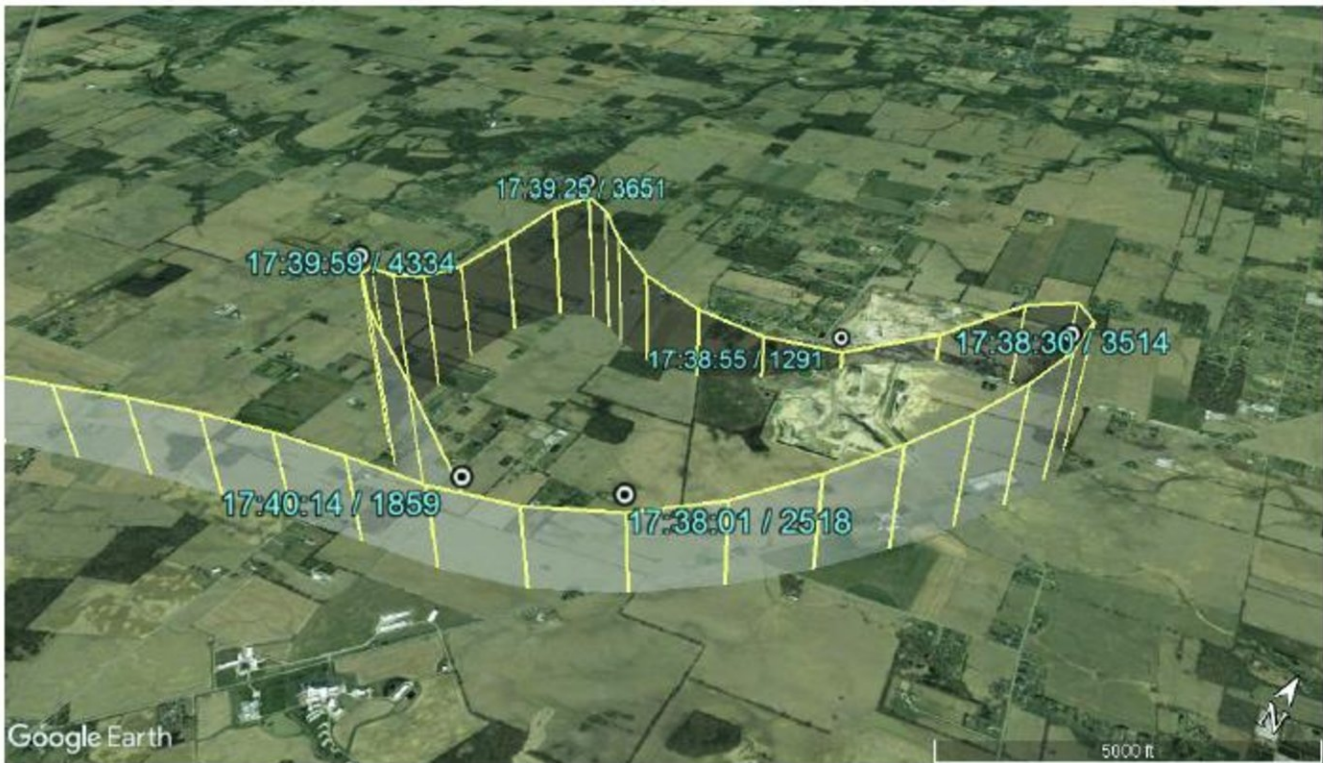
Figure 1: Airplane's Final Flight Track

A review of recovered data from onboard avionics indicated that, about 17 minutes after takeoff, the airplane's indicated airspeed began to decay while its groundspeed, as calculated from position information, remained steady. About 1 minute later, fuel flow increased from 38 gallons per hour (gph) to 60 gph, consistent with an increase in engine power. At this time, the indicated airspeed had decayed to about 100 knots (kts), while the groundspeed remained about 150 kts. For the final approximate 2.5 minutes of the flight, the airplane was in a left turn. The airplane entered a climb to about 3,500 ft msl, then began descending around 5,000 ft per minute. The data recorded "SINK RATE" and "PULL UP PULL UP" annunciations, and the airplane's rate of descent was arrested about 300 ft above ground level (agl). The airplane subsequently entered two additional sets of climbs and descents, receiving the same annunciations; however, the pilot did not recover from the third descent. During this time, the airplane's groundspeed, and likely airspeed, exceeded the airplane's maneuvering speed (Va) of 150 kts, and during both the first and final "SINK RATE" annunciations, the airplane's groundspeed exceeded its maximum structural cruising speed (Vno) of 200 kts.
