Aviation Investigation Final Report

| Location: | Niceville, Florida | Accident Number: | ERA19FA048 |
| Date & Time: | November 17, 2018, 12:37 Local | Registration: | N232VA |
| Aircraft: | Vans RV-12 | Aircraft Damage: | Substantial |

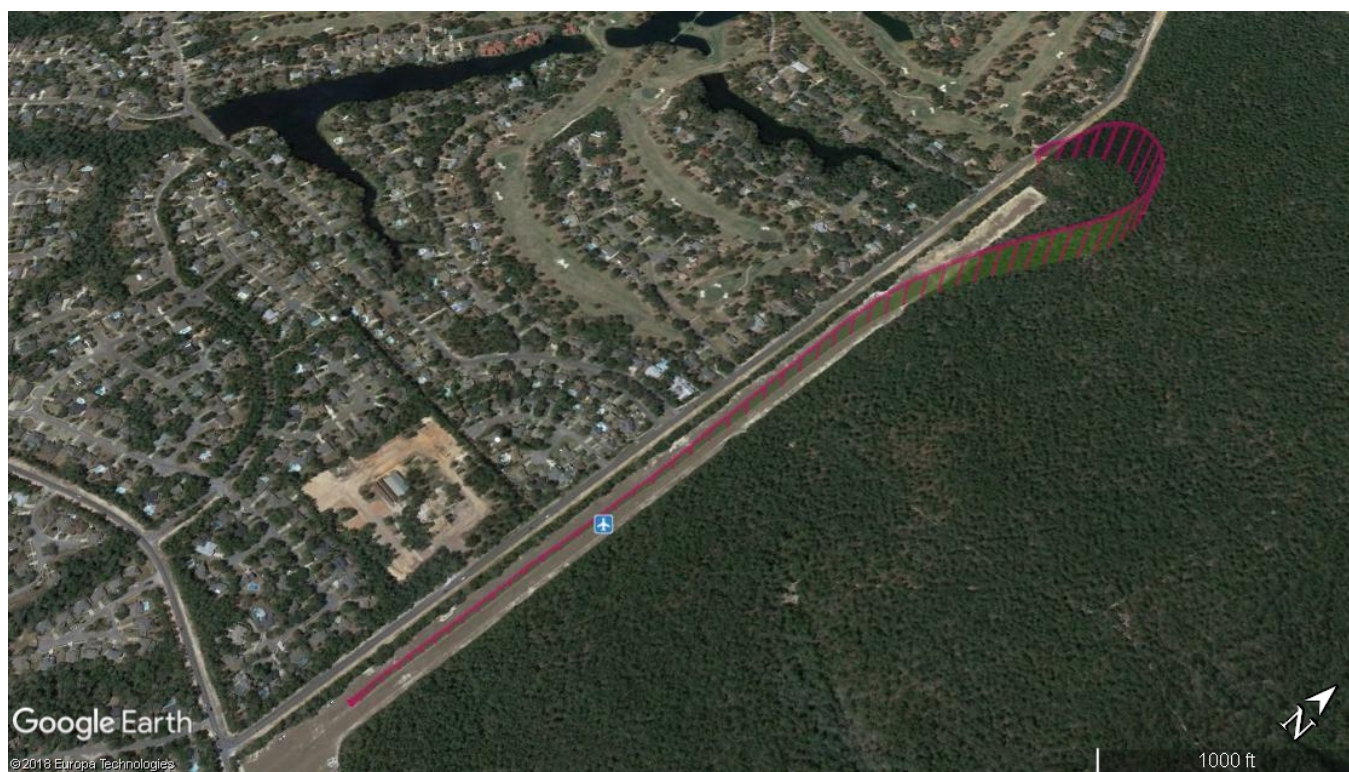
rpm. At 1236:45, the airplane was about 55 ft above the ground when the engine experienced a sudden reduction in speed to less than 4,000 rpm without a corresponding change in manifold pressure; consistent with the throttle staying at WOT. At 1237:07, manifold pressure reduced consistent with the throttle being pulled back to idle and remained at idle for 3 seconds. During this time, the airplane reached a maximum altitude of about 250 ft at an airspeed of 44 knots. Vertical acceleration began to oscillate, the airplane was banking to the left and reached a 68° left wing down bank angle. It then began to descend rapidly, and the manifold pressure increased consistent with the throttle being advanced. The engine speed increased along with the increase in manifold pressure and reached 4,700 rpm. Shortly thereafter, at 1237:17, excursions consistent with impact were recorded (Figure 1 depicts a map overlay of the accident flight track).

Figure 1. Map overlay of the accident flight (The end of the track is consistent with the approximate location of the accident site).
