# Aviation Investigation Final Report

<b>Location:</b>	La Verne, California	<b>Accident Number:</b>	WPR18FA279
<b>Date &amp; Time:</b>	September 29, 2018, 18:00 Local	<b>Registration:</b>	N46321
<b>Aircraft:</b>	Cessna 177RG	<b>Aircraft Damage:</b>	Substantial
<b>Defining Event:</b>	Loss of control in flight	<b>Injuries:</b>	1 Fatal, 1 Serious
<b>Flight Conducted Under:</b>	Part 91: General aviation - Personal

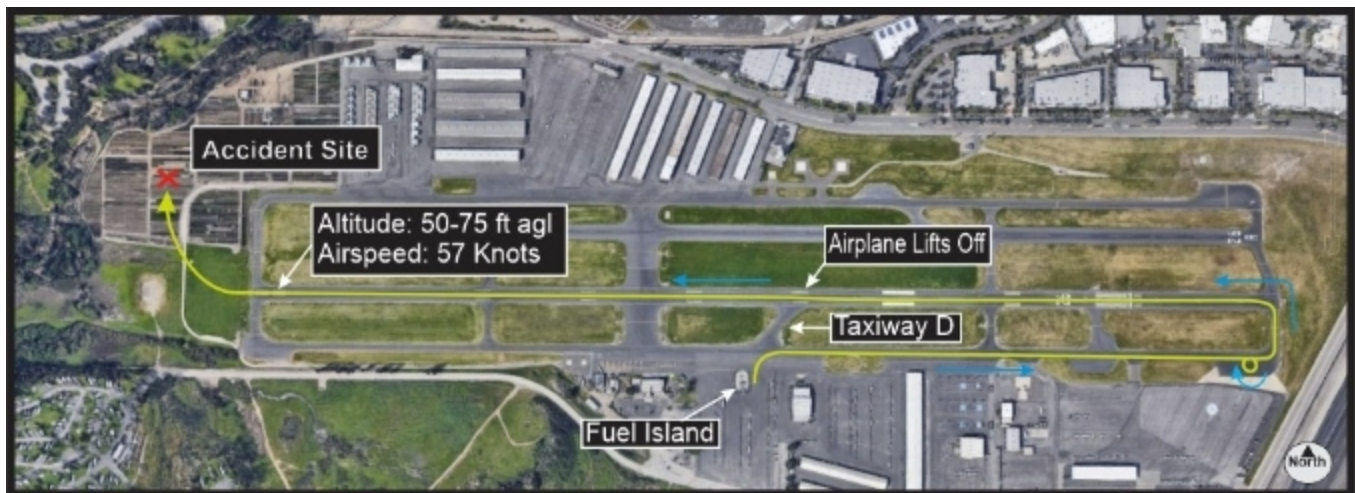
Figure 1.- Flight Data

A review of air traffic control audio and radar recordings provided by the Federal Aviation Administration (FAA) showed that the airplane taxied from the self-service fuel station, turned right onto taxiway S, then proceeded to the runup area near the approach end for runway 26L. The airplane made a 360° turn at the runup area and parked facing the runway. The pilot then contacted the tower controller and requested clearance for takeoff and left closed traffic. The tower controller granted takeoff clearance and left closed traffic. The airplane then taxied onto runway 26L and started its departure. A witness at the airport said that, as the airplane was on the takeoff roll, he heard backfiring coming from the airplane and that it was "real loud, like firecrackers." He reported that the airplane continued the takeoff and the landing gear was retracted. About 1 minute 30 seconds after the takeoff clearance was granted, the pilot requested a return to the airport due to an engine problem. After crossing the departure end of runway 26L, the airplane turned right towards runway 8L. The last radar return showed the airplane at a ground speed of 57 knots, and a heading 353°. The witness reported that the airplane descended in a steep nose-down attitude until it went out of sight. Radar data showed that the airplane climbed to a maximum altitude of about 50 to 75 ft agl. (see Figure 1).

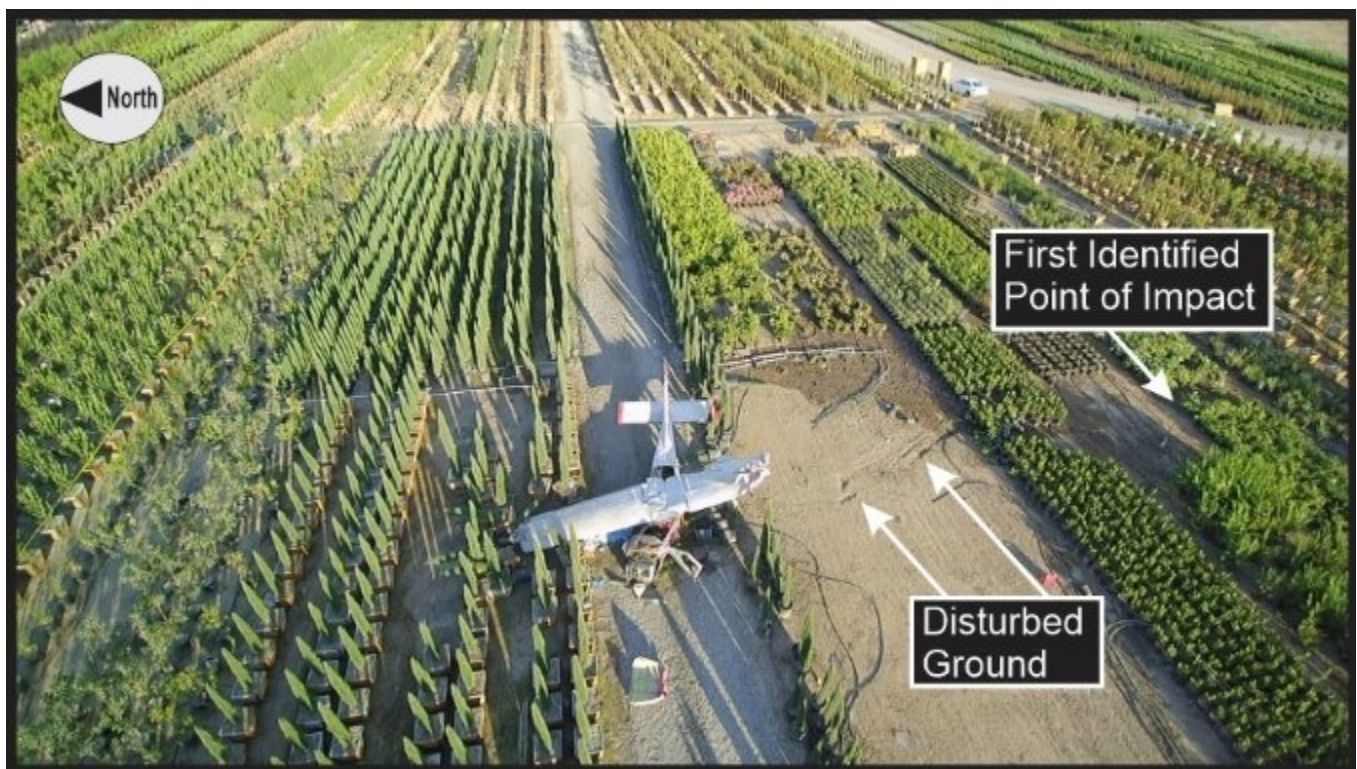
## *Figure 2. Accident Site*

The accident site was located about a tenth of a mile from the departure end of runway 26L. Examination of the accident site revealed that the airplane impacted level terrain on the airport property at an elevation of 955 ft mean sea level (msl) that was used as a plant nursery. The debris field was about 40 ft wide and about 70 ft long and was oriented on a heading of about 353° magnetic. The airplane was oriented on a magnetic heading of about 265° magnetic. The first identified point of impact was a small area of disturbed ground of about 24 inches by 12 inches. A portion of the left wing-tip cap was found nearby. About 40 ft from the first identified point of impact and heading towards the airplane was a series of disturbed ground and cut water irrigation lines. All the control surfaces were found at the accident site. Ground scars were observed extending back from the wreckage about 85 ft on a bearing of about 173°. Numerous small components consisting of composite wing-tip fragments, red navigation light glass, and aluminum fragments were found strewn along the disturbed ground. (See figure 2.)
