# Aviation Investigation Final Report

<b>Location:</b>	Addison, Texas	<b>Accident Number:</b>	CEN18LA119
<b>Date &amp; Time:</b>	March 10, 2018, 16:46 Local	<b>Registration:</b>	N422PS
<b>Aircraft:</b>	CZECH SPORT AIRCRAFT AS PIPER SPORT	<b>Aircraft Damage:</b>	Substantial
<b>Defining Event:</b>	Fuel related	<b>Injuries:</b>	2 Serious
<b>Flight Conducted Under:</b>	Part 91: General aviation - Instructional

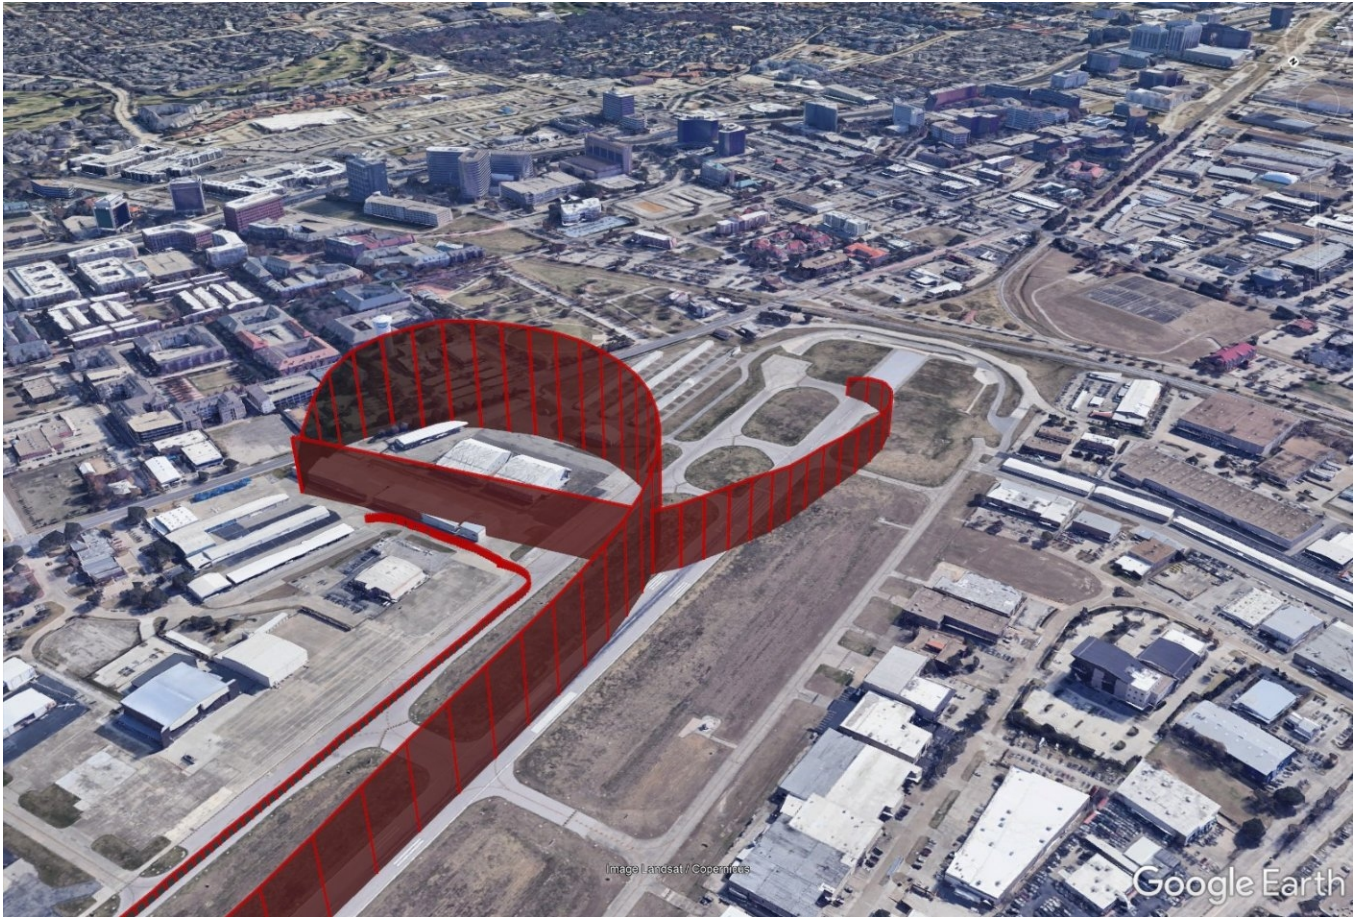
Recorded flight track data indicated that the airplane departed runway 15 and made a climbing right turn to the southeast, then continued circling left toward the runway before the data ended near the accident site. Figure 1 depicts the final flight track in red overlaid on Google Earth.

Figure 1 – Final flight track in red overlaid on Google Earth.
