# Aviation Investigation Final Report

<b>Location:</b>	Cottonwood, Arizona	<b>Accident Number:</b>	WPR18FA266
<b>Date &amp; Time:</b>	September 17, 2018, 09:45 Local	<b>Registration:</b>	N2031D
<b>Aircraft:</b>	Beech 33	<b>Aircraft Damage:</b>	Substantial
<b>Defining Event:</b>	Loss of engine power (total)	<b>Injuries:</b>	1 Fatal
<b>Flight Conducted Under:</b>	Part 91: General aviation - Personal

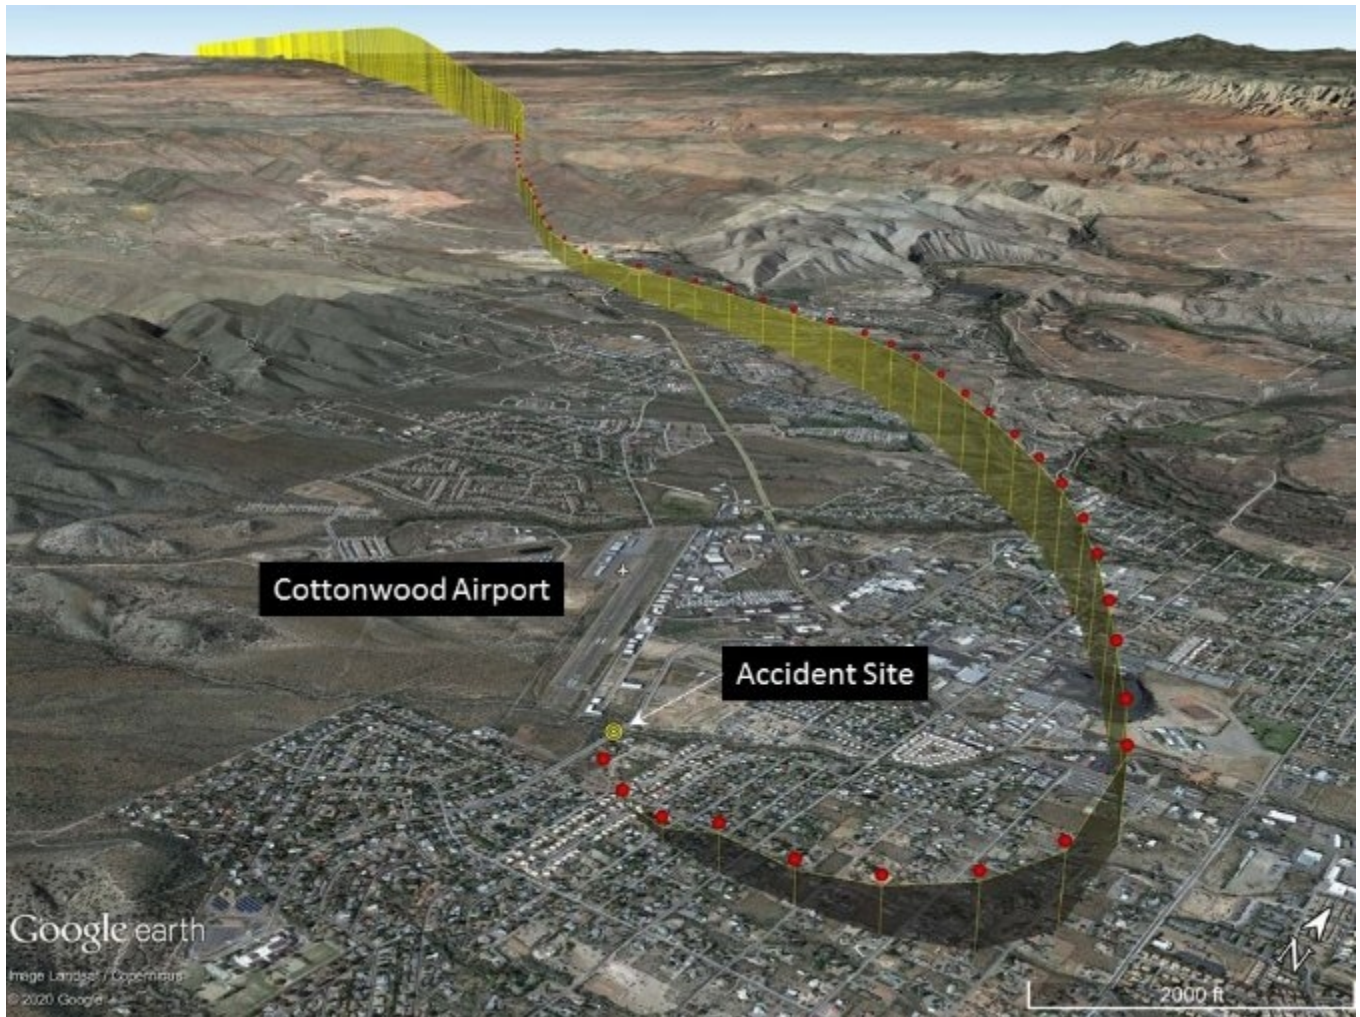
Radar data showed that, as the airplane approached P52, it entered a right downwind leg for runway 32. The airplane made a right turn for the base leg for runway 32 and began to descend, then continued its descent as it turned toward the runway; the last radar returns were low to the ground and near the accident site. (See Figure 1.) The airplane impacted a house and cartwheeled into the backyard.

Figure 1-Radar flight track data and the accident site location.
