# Aviation Investigation Final Report

<b>Location:</b>	Goodyear, Arizona	<b>Accident Number:</b>	WPR17LA121
<b>Date &amp; Time:</b>	June 4, 2017, 09:17 Local	<b>Registration:</b>	N51FB
<b>Aircraft:</b>	Bob Frederick Titan T-51	<b>Aircraft Damage:</b>	Substantial
<b>Defining Event:</b>	Powerplant sys/comp malf/fail	<b>Injuries:</b>	1 None
<b>Flight Conducted Under:</b>	Part 91: General aviation - Personal

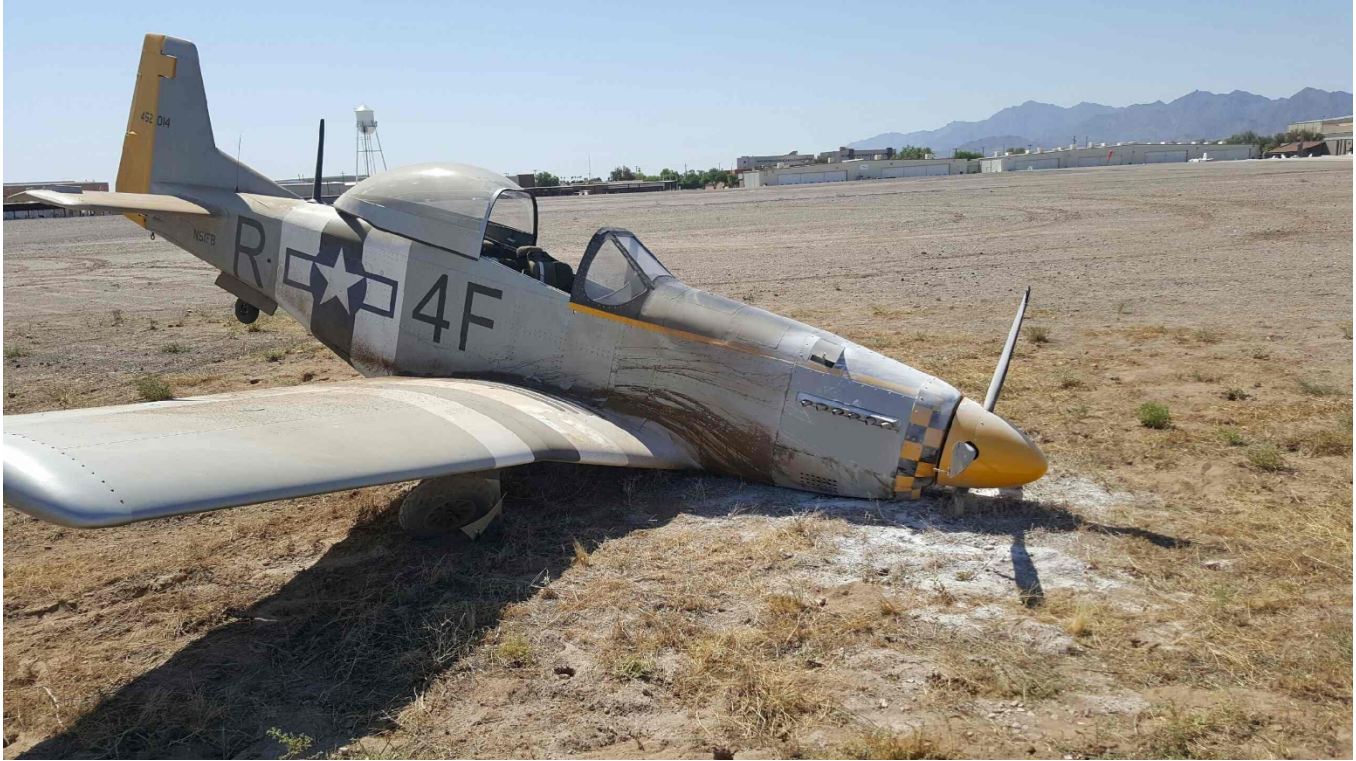
The pilot reported that immediately after takeoff, the airplane began to vibrate. He stated that it felt like one of the wheels was still spinning, so he applied the brakes, but the vibration continued. As he transitioned the airplane to the downwind leg, the vibration increased, and the engine then experienced an overspeed and lost all power. As the pilot initiated a return to runway 21, the cockpit filled with smoke, and unable to reach the runway, the airplane landed short in a dirt area, where the landing gear collapsed (See Figure 1).

Figure 1 – Airplane at the Accident Site

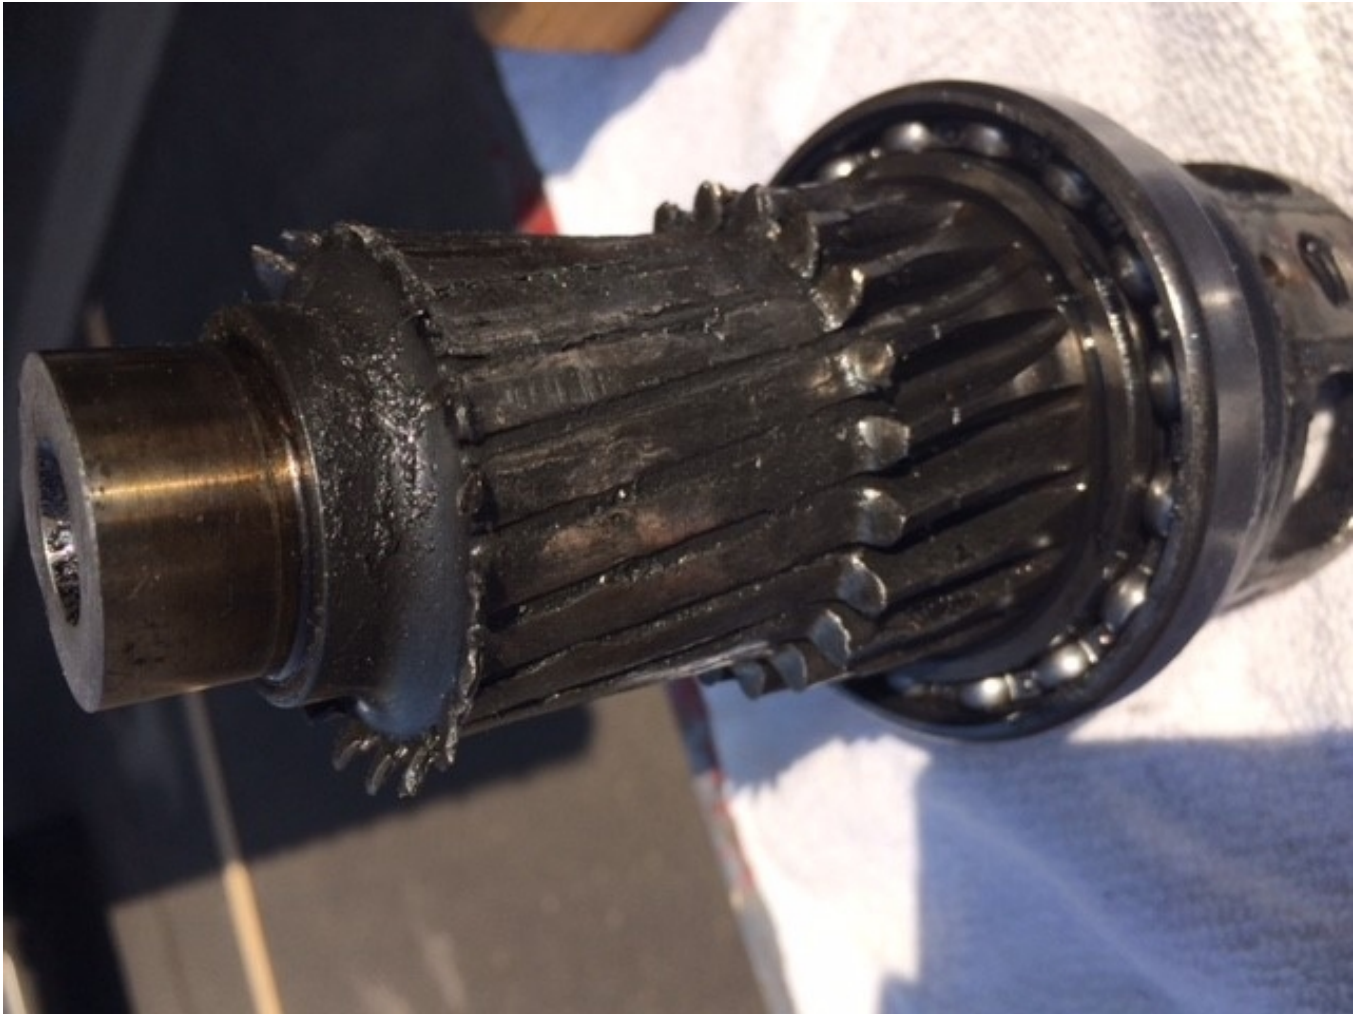
Examination of the propeller speed reduction gearbox revealed that the teeth of the input drive gear had separated, which caused a loss of drive continuity to the propeller. The drive and idler gears did not appear to meet the manufacturer's case hardness requirements; however, evidence suggests that the gearbox had undergone severe heat buildup during the failure sequence, which may have subsequently altered the hardness. Oil starvation or exhaustion likely did not occur, as the gearbox bearings were intact and largely undamaged. Due to damage sustained to the gears, an accurate assessment of the initial failure mode could not be determined. Thus, the investigation could not determine the reason for the failure of the propeller speed reduction gearbox input drive gear.

Figure 2 – Input Drive Gear

Follow-up NTSB examination of the gearbox components revealed that the input drive gear had shed all of its teeth at its contact area with the idler gear (See Figure 2). The idler gear teeth were all deformed and rounded, with numerous sections of their tips and faces missing (See Figure 3). Both damaged gears exhibited a dark surface tint. The inner and outer rings of the input drive gear bearing on the forward side were intact, but its polymer cage had disintegrated and/or melted. The balls were round and intact, and remained within the bearing, and the ring-to-ball contact faces were free of damage. All remaining drive gear bearings were intact and were free of damage.

The bottom of the gearbox case contained crushed slivers of gear teeth coated in oil. The failure surfaces of the input drive gear teeth were obliterated and smeared, preventing a detailed examination of their fracture surfaces.

The results for the drive gear indicated maximum hardness values of between 49.3, and 49.7 Rockwell C (HRC), with case depths of between 0.029in and 0.034in.

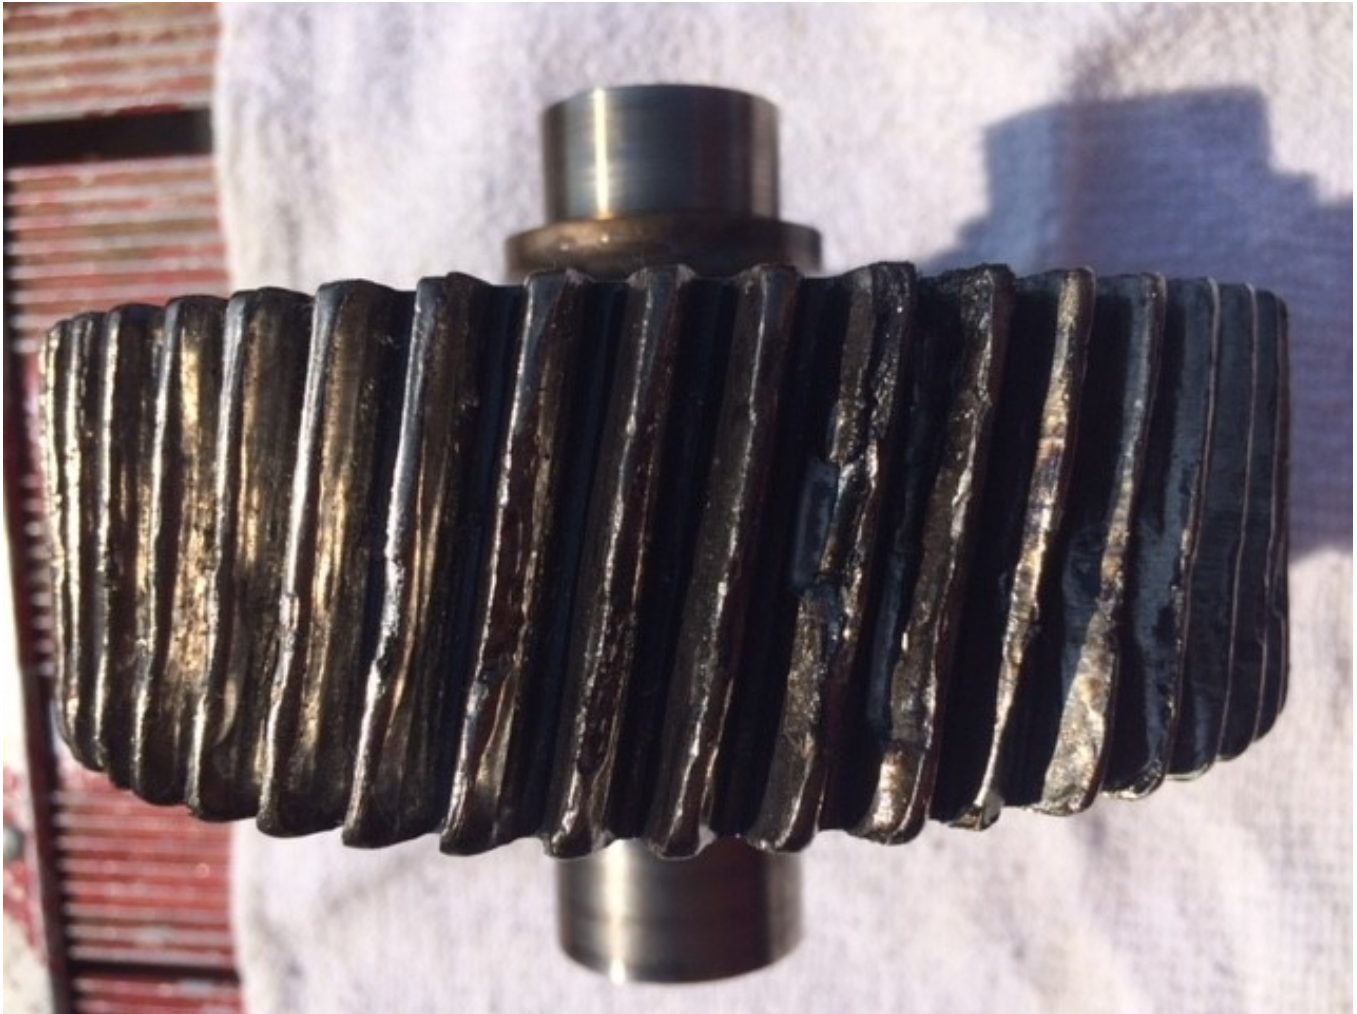
Figure 3 – Idler Gear

The results for the idler gear indicated maximum hardness values of between 42.5 and 54.6 HRC, with a case depth of 0.025in for the inside diameter edge (case depth is typically defined as the depth of hardness where the hardened layer reaches the same hardness and properties as the base or core material). Damage prevented an accurate assessment of the case depth at the other locations.
