Aviation Investigation Final Report

Location:	Fullerton, California	Accident Number:	WPR19FA115
Date & Time:	April 18, 2019, 19:51 Local	Registration:	N65MY
Aircraft:	Beech 60	Aircraft Damage:	Destroyed
Defining Event:	Ground handling event	Injuries:	1 Fatal
Flight Conducted Under:	Part 91: General aviation - Personal

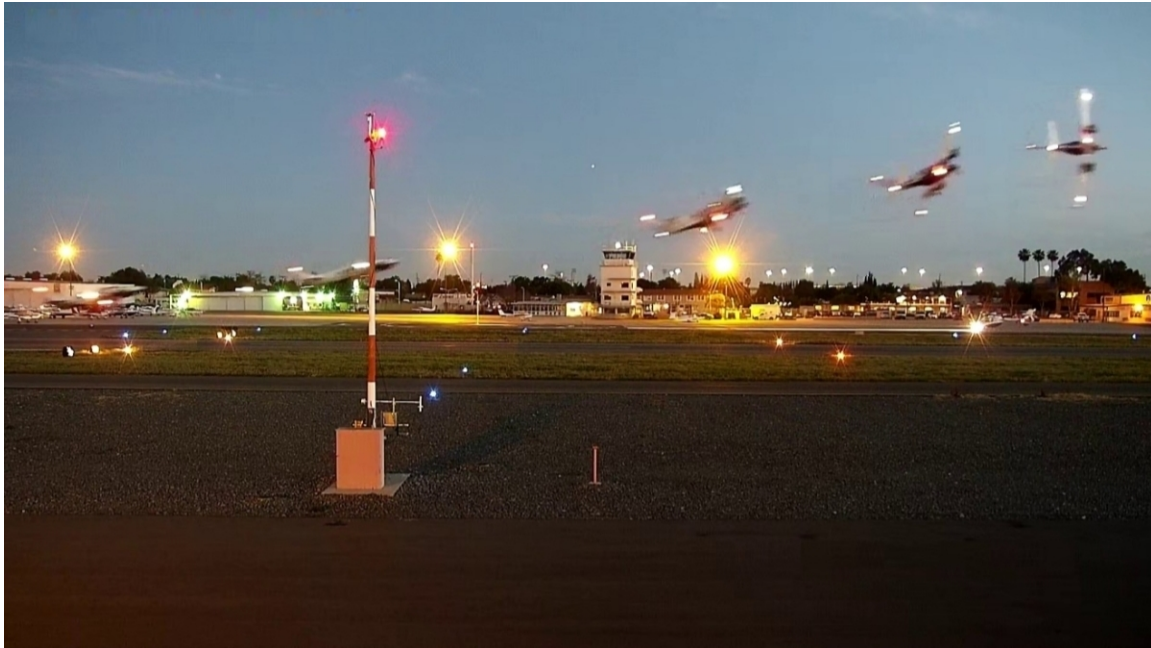
After the pilot was given the takeoff clearance, the airplane began the takeoff roll. The airplane was airborne after traveling about 1,300 ft down the runway, and about 2 seconds after rotation, it began to roll to the left. Three seconds later, the airplane had reached an altitude of about 80 ft above ground level and was in a 90° left bank (figure 1). The nose then dropped as the airplane rolled inverted and struck the southern side of taxiway E in a right-wing-low, nose-down attitude.

Figure 1. Composite video surveillance image of takeoff as viewed from the north.

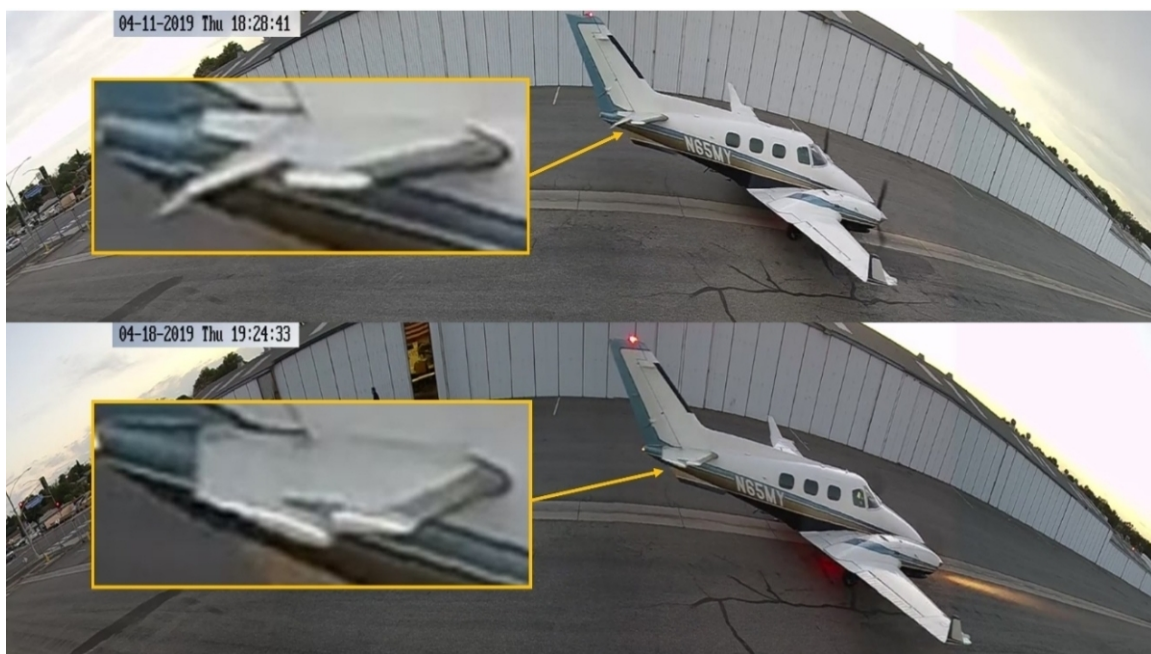
One of the surveillance cameras was positioned above the pilot's hangar and captured the airplane as it was being moved inside that night. Review of the footage revealed that, as the airplane was first being maneuvered, the elevator was hanging at about the 15° trailing edge down position, consistent with the pilot's friend's observation. The following evening, as the pilot pulled the airplane back out of the hangar for the accident flight, the elevator was at about the 15° trailing edge up position such that the elevator balance weight hung below the lower skin of the horizontal stabilizer trailing edge.

The video footage on the day of the accident was compared with video footage of the last time the pilot flew the airplane on April 11, 2019. On that day, the elevator was in the trailing edge down position as the airplane was maneuvered out of the hangar and remained in that position while it taxied to the runup area (figures 2 and 3). While in the runup area on April 11, the elevator moved up and down, consistent with the pilot performing a flight control check.

Figure 2 - Composite image of the elevator position outside of the hangar on April 11, 2019 (top) and April 18, 2019 (bottom). (Video timestamp, 07:07 slow)

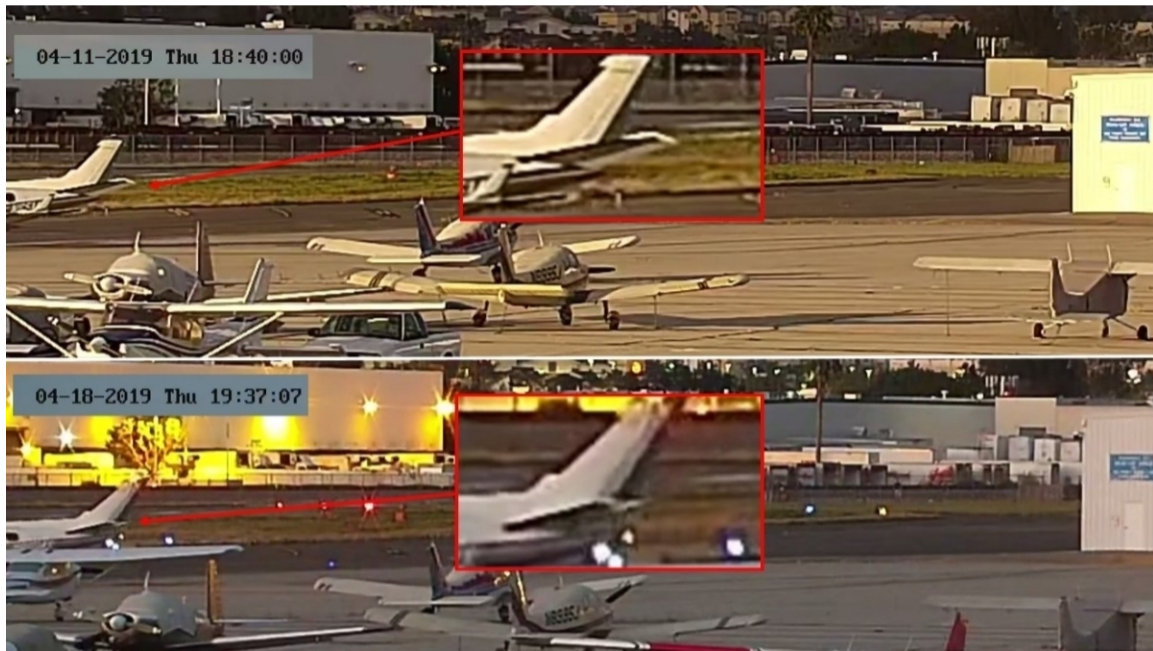
The loss of control during takeoff was likely due to the pilot’s use of an unapproved elevator control lock device. Despite video evidence of the elevator locked in the trailing edge up position before the accident, an examination revealed no evidence of an installed control lock in the cabin. Therefore, during the night before the accident, the pilot likely placed an unapproved object between the elevator balance weight and the trailing edge of the horizontal stabilizer to lock the elevator in the trailing edge up position.

Review of video footage throughout the airport revealed that the elevator remained in the same trailing edge up position throughout taxi, in the runup area, and at the runway hold short line.

Figure 3 – Composite image of the elevator position after the airplane departed the runup area on April 11 (top) and April 18 (bottom). (Video timestamp, 07:07 slow)
