# Aviation Investigation Final Report

<b>Location:</b>	Rhome, Texas	<b>Accident Number:</b>	CEN18FA336
<b>Date &amp; Time:</b>	August 16, 2018, 19:35 Local	<b>Registration:</b>	N2893Q
<b>Aircraft:</b>	Cessna 172	<b>Aircraft Damage:</b>	Substantial
<b>Defining Event:</b>	Loss of engine power (total)	<b>Injuries:</b>	1 Fatal, 3 Serious
<b>Flight Conducted Under:</b>	Part 91: General aviation - Personal

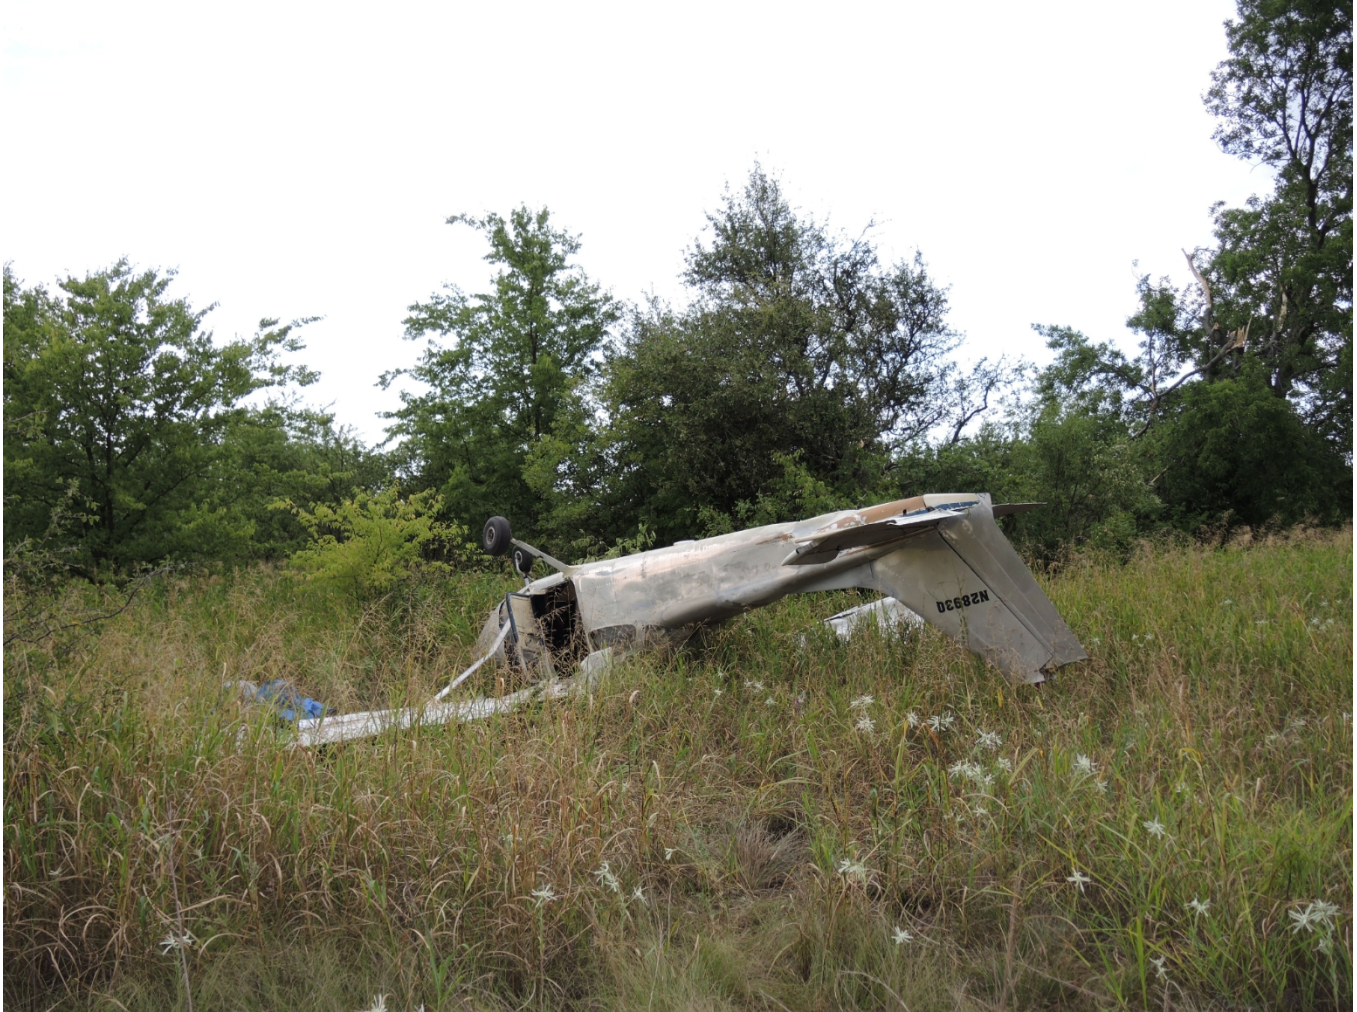
The airplane came to rest inverted on a southeast heading about 350 yards north of the departure end of runway 13 (see figure 2).

**Figure 2.** Airplane inverted in a field

A postaccident examination of the accident site and wreckage revealed that the left wing leading edge was crushed aft and sustained impact damage, including evidence of tree strikes; the wing was partially separated from the fuselage and distorted aft. The right wing leading edge was crushed aft. All flight control cables were traced from their respective control surfaces to the cockpit controls with no separations or anomalies noted. The elevator trim tab was slightly nose-down but near neutral. The flaps were retracted. The right control yoke was separated at the control column, consistent with impact damage. The left control yoke was damaged consistent with impact.

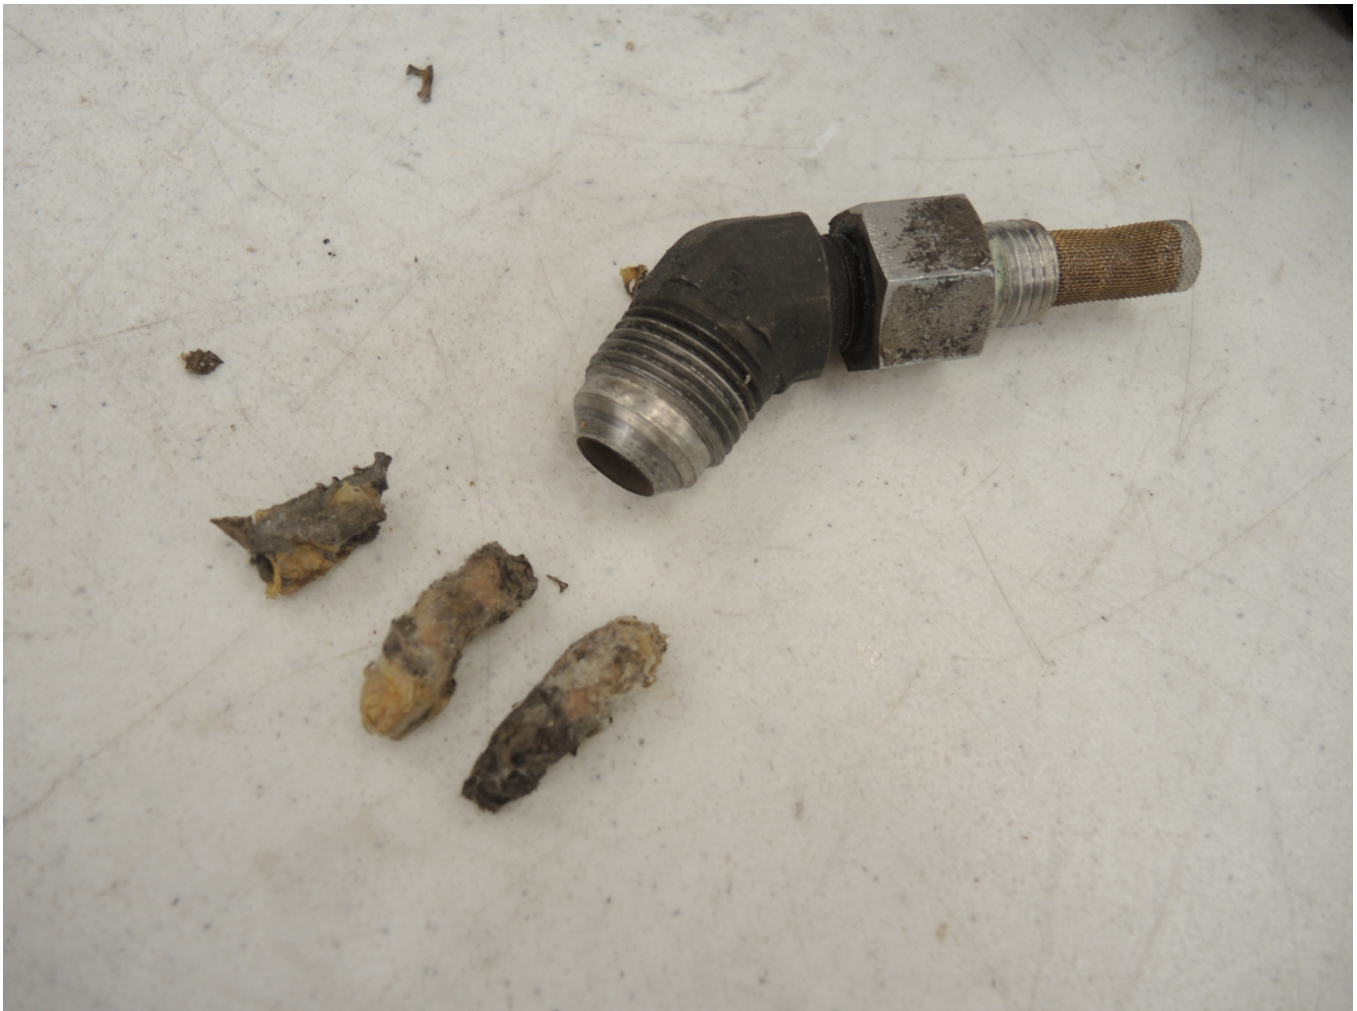
Examination of the airplane revealed evidence of a longstanding pattern of inadequate maintenance, including a rodent's nest in the leading edge of the left wing, a large mud dauber nest on the oil cooler, and cobwebs in the engine compartment. An automotive hydraulic hose was used in place of the main fuel line from the gascolator to the carburetor. The gascolator fuel strainer contained 3 large pieces of organic debris similar to insect cocoons, which were the same size as the hydraulic hose and associated fuel fitting. It is likely that the fuel line was removed for an extended period of time and eventually replaced with the automotive hydraulic hose, during which time the fuel system was exposed, which allowed insects to nest inside; because there were no maintenance records associated with the airplane, it could not be determined when the hose was replaced. During the accident flight, it is likely that the organic material became dislodged and restricted fuel to the carburetor, which subsequently starved the engine of available fuel and resulted in a total loss of engine power.

The National Transportation Safety Board determines the probable cause(s) of this accident to be: The pilot's inadequate maintenance of the airplane, which resulted in a total loss of engine power due to fuel starvation when organic debris restricted available fuel to the carburetor, and the pilot's impairment due to the ingestion of alcohol, which affected his ability to safely operate the airplane following the loss of engine power.

The gascolator fuel strainer was disassembled and organic debris similar to insect cocoons was found inside the strainer screen (see figure 3). The strainer bowl was mostly full of blue-colored fuel consistent with 100LL aviation gasoline.

### **Figure 3. Fuel fitting with organic contaminants**
