# Aviation Investigation Final Report

<b>Location:</b>	Shreveport, Louisiana	<b>Accident Number:</b>	CEN19FA088
<b>Date &amp; Time:</b>	February 28, 2019, 10:40 Local	<b>Registration:</b>	N428CD
<b>Aircraft:</b>	Piper PA46	<b>Aircraft Damage:</b>	Substantial
<b>Defining Event:</b>	Loss of control in flight	<b>Injuries:</b>	2 Fatal
<b>Flight Conducted Under:</b>	Part 91: General aviation - Personal

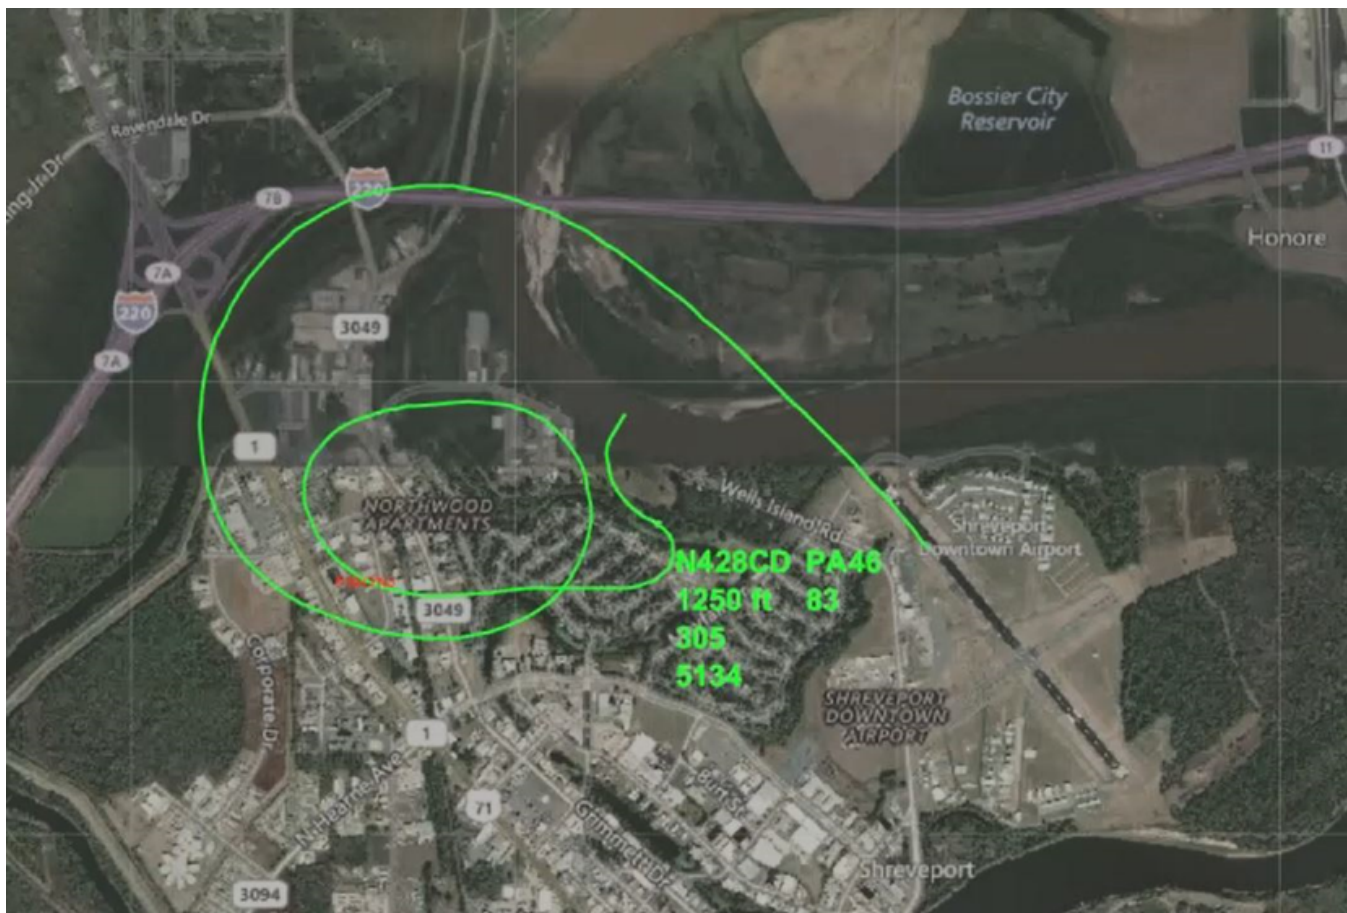
Figure 1 - Air Traffic Control Flight Track of N428CD

After climbing to 1,400 ft msl, the airplane's altitude and airspeed began to fluctuate as it continued in a tightening left spiral (see figure 1). About 35 seconds after transmitting "standby," the pilot stated, "we're in trouble up here." The airplane subsequently made a decelerating right turn then rapidly descended. The last ATC data recorded for the flight indicated a groundspeed of 31 knots at 575 ft msl.

Onboard data showed the airplane's altitude, vertical velocity, and speed oscillated several times and the turn rate increased during the last minute of the flight. From 10:39:25 to 10:39:58, the airplane's altitude varied from 1,987 to 822 to 1,980 ft msl and the vertical velocity fluctuated from -6,001 to +5,834 ft per minute (fpm). The last data captured at 10:40:07 was 1217 ft msl and -6818 fpm.
