Aviation Investigation Final Report

Location:	McCormick, South Carolina	Accident Number:	ERA19LA074
Date & Time:	December 19, 2018, 14:20 Local	Registration:	N346MA
Aircraft:	Diamond DA20	Aircraft Damage:	Substantial
Defining Event:	Fuel related	Injuries:	2 Minor
Flight Conducted Under:	Part 91: General aviation - Flight test

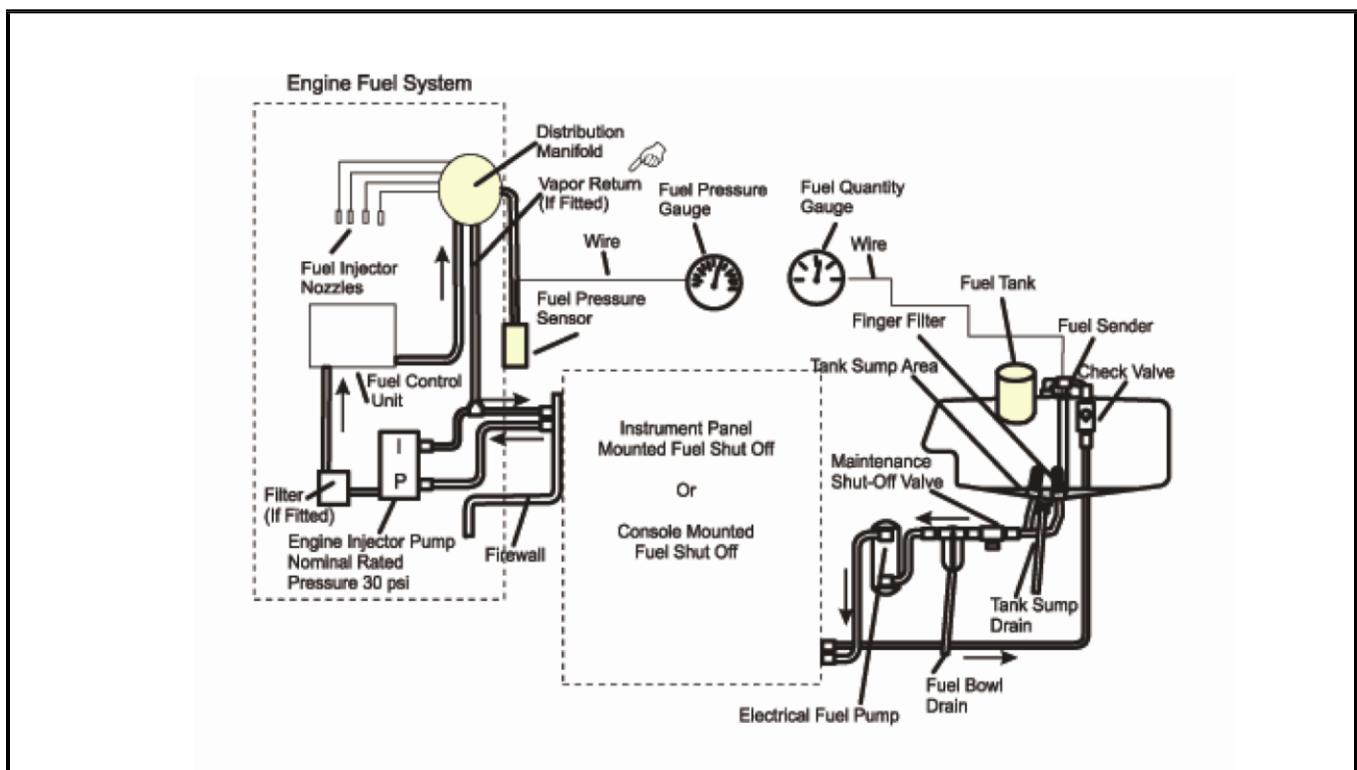
Fuel flows from a single fuel tank, through one of two outlet finger screens, to a filter bowl and then the electrical fuel pump. It then passes through a shutoff valve before entering the engine driven fuel pump, which is fitted with an inlet finger screen. Fuel then flows to the throttle and metering unit (labeled “Fuel Control Unit” in the figure below) before entering the manifold valve (labeled “Distribution Manifold”) which is fitted with an internal filter screen. Four lines deliver fuel from the manifold valve to the four engine cylinders through the fuel injector nozzles.

Figure. – Fuel system diagram with annotations
