# Aviation Investigation Final Report

<b>Location:</b>	Prescott, Arizona	<b>Accident Number:</b>	WPR18FA245
<b>Date &amp; Time:</b>	August 29, 2018, 20:35 Local	<b>Registration:</b>	N6500W
<b>Aircraft:</b>	Cessna P210	<b>Aircraft Damage:</b>	Destroyed
<b>Defining Event:</b>	Controlled flight into terr/obj (CFIT)	<b>Injuries:</b>	1 Fatal
<b>Flight Conducted Under:</b>	Part 91: General aviation - Personal

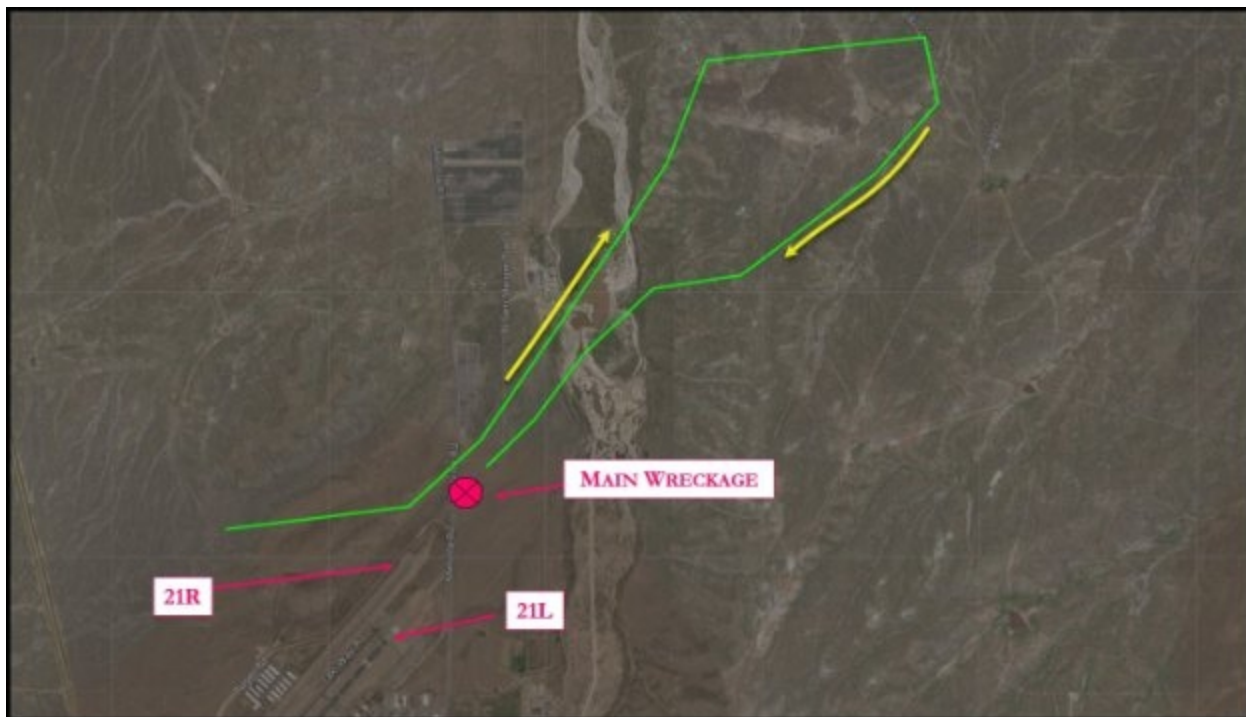
Figure 1: Radar Track

A review of the radar track data indicated that after departure, the airplane joined a right traffic pattern for runway 21R (see figure 1). On the downwind leg, the track was not parallel to the runway and neared the approach end. The track then progressed into a long teardrop-shaped 180° turn; about 2.8 nautical miles (nm) from the approach end of runway 21R, the airplane's heading turned right toward the runway. At 2032:59 the tower controller stated to the pilot, "just verifying you're lining up for runway 21R." Four seconds later the pilot replied, "roger that, 21R, 6500W." At 2033:19 the controller told the pilot to go around.

The last recorded data point was at 2034:17 and about 740 ft northeast of the accident site. At that time, the airplane was about 5,050 ft mean sea level (msl), which was about 145 ft above ground level (agl), at a ground speed of 99 kts. At 2034:24, the controller again told the pilot to go around, to which another pilot in the pattern responded that the airplane was on fire.

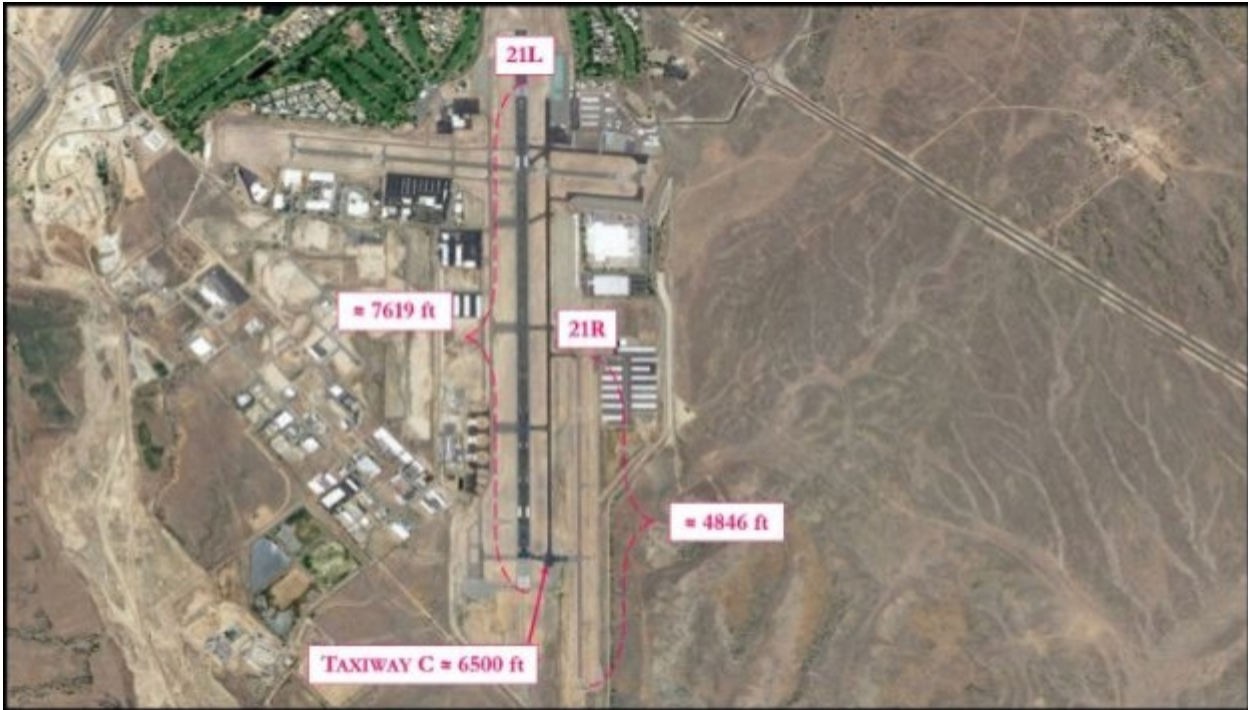
Figure 2: Airport

Runway 21R was 4,846 ft long by 60 ft wide, and runway 21L was 7,619 ft long by 150 ft wide. The threshold for runway 21L was 1,500 ft beyond the threshold for runway 21R (see figure 2). Further, a lighted taxiway was between the two runways.

Runway 21R was equipped with a 2-light precision approach path indicator (PAPI) system with an approach angle of 3.00° located to the left of the runway that provided a threshold crossing height of 48 ft. The runway was equipped with medium intensity edge lights. The runway 21R threshold was at an elevation of 4,938 ft and it sloped up at 0.8% to 4,975 ft at the runway end.

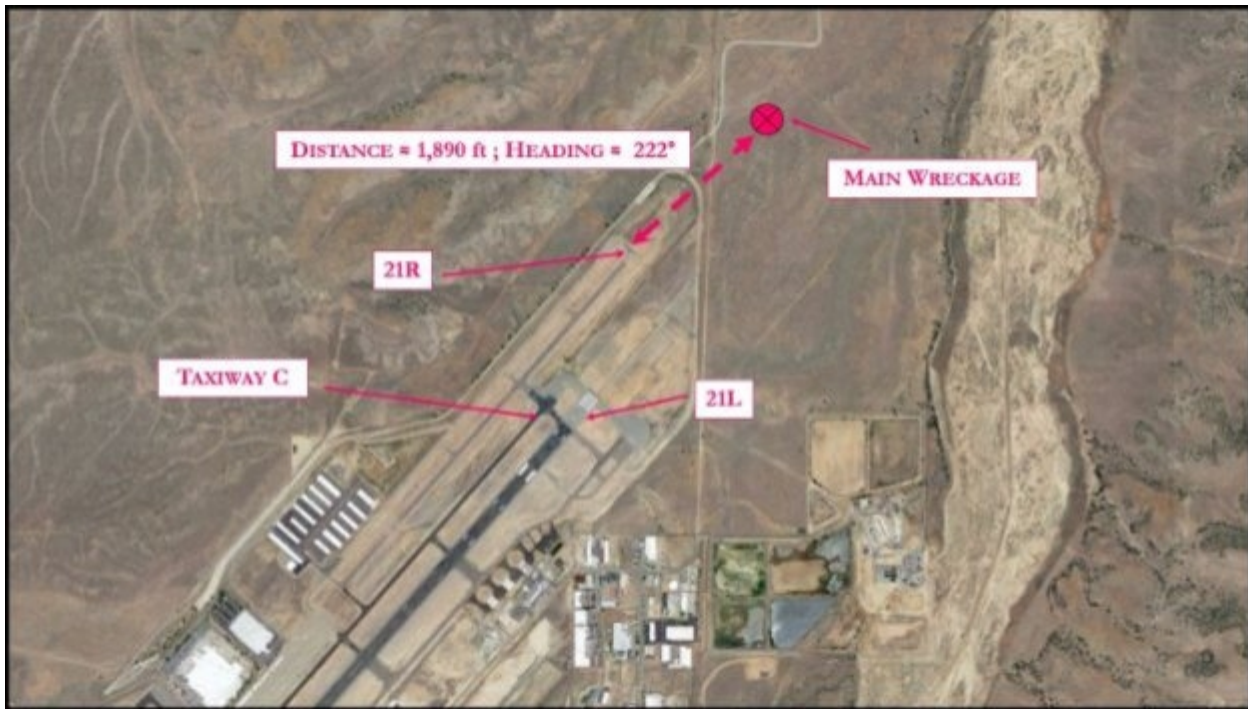
*Figure 3: Accident Site in Reference to the Airport*

The accident site was located in desert terrain about 1,890 ft from the runway 21R threshold (see figure 3). The wreckage was found distributed over a 240-ft distance on a median magnetic track of about 222°.
