Aviation Investigation Final Report

Location:	Reno, Nevada	Accident Number:	WPR19LA098
Date & Time:	March 17, 2019, 08:10 Local	Registration:	N5028P
Aircraft:	Piper PA 24	Aircraft Damage:	Substantial
Defining Event:	Loss of control on ground	Injuries:	3 None
Flight Conducted Under:	Part 91: General aviation - Personal

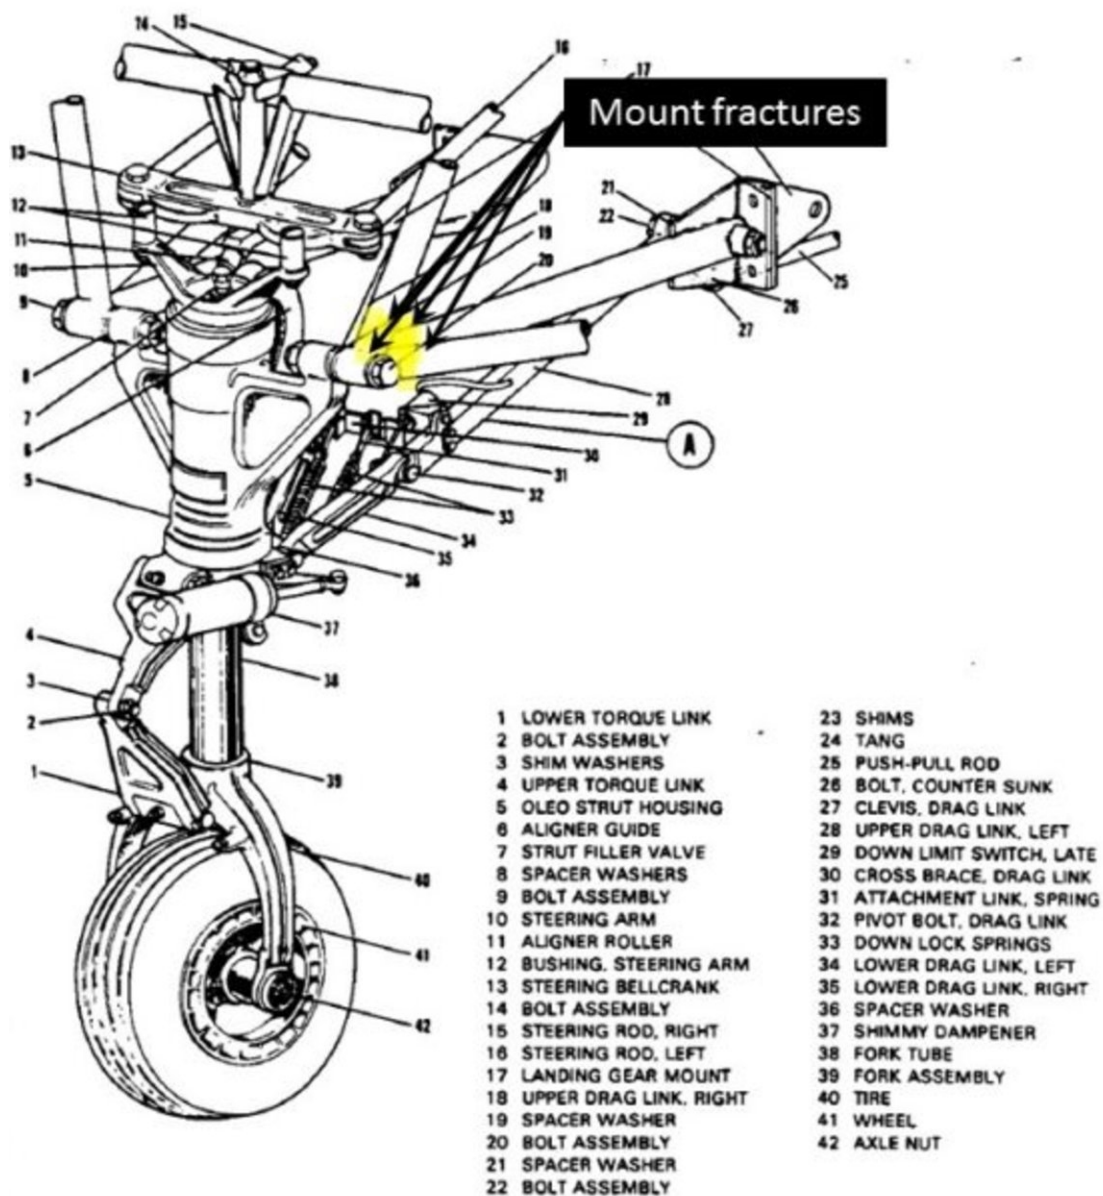
Figure 2: Location of Mount Fractures on NLG Assembly

Failure of the engine mount due to internal corrosion and wall thinning, which resulted in a loss of directional control and nose gear collapse during landing.

Portions of the engine mount were submitted to the NTSB Materials Laboratory for analysis. Each engine mount fracture surface was non-planar and rough, consistent with overstress. Moderate to heavy corrosion products were observed on the inner surfaces of each tube and several tubes displayed evidence of wall thinning from the internal corrosion. The exact order that the tubes failed could not be determined.
