Aviation Investigation Final Report

Location:	Lake, Mississippi	Accident Number:	CEN19FA120
Date & Time:	April 13, 2019, 00:15 Local	Registration:	N4890L
Aircraft:	Piper PA28	Aircraft Damage:	Destroyed
Defining Event:	Loss of control in flight	Injuries:	1 Fatal
Flight Conducted Under:	Part 91: General aviation - Personal

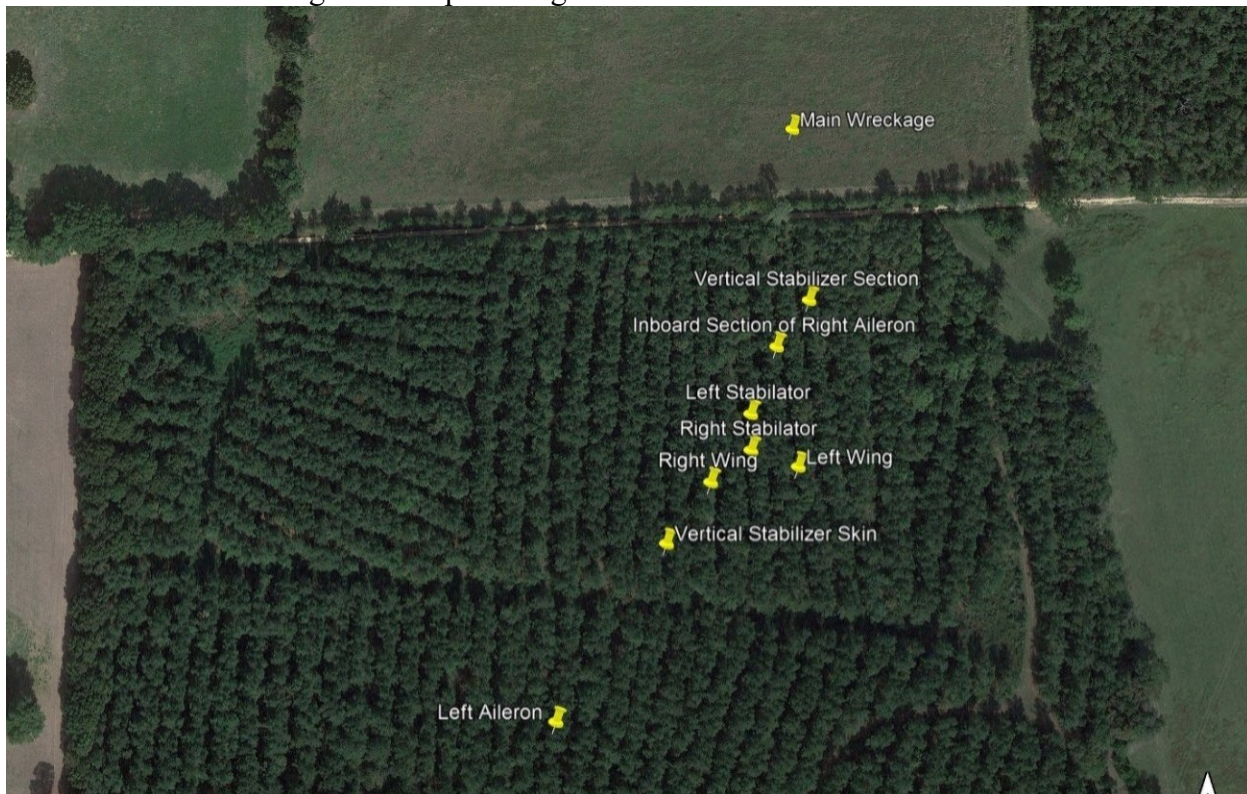
wings were attached to the fuselage at their respective roots and exhibited aft and upward deformations. Outboard sections of the left and right wings, and portions of the empennage, were not found with the main wreckage. A search of the wooded area adjacent to the main wreckage was conducted. The farthest part from the main wreckage (the left aileron) was located about 1,500 ft from the main wreckage, outboard sections of the left and right wings were located about 1,000 ft from the main wreckage, and the left and right horizontal stabilizers were located about 900 ft from the main wreckage. The debris path and separated sections of the wings and empennage were consistent with an in-flight breakup. See figure.

Figure. Wreckage distribution.
