Aviation Investigation Final Report

Location:	Kingsville, Texas	Accident Number:	CEN18FA147
Date & Time:	April 25, 2018, 12:25 Local	Registration:	N12377
Aircraft:	North American SNJ 5	Aircraft Damage:	Destroyed
Defining Event:	Aerodynamic stall/spin	Injuries:	2 Fatal
Flight Conducted Under:	Part 91: General aviation - Personal

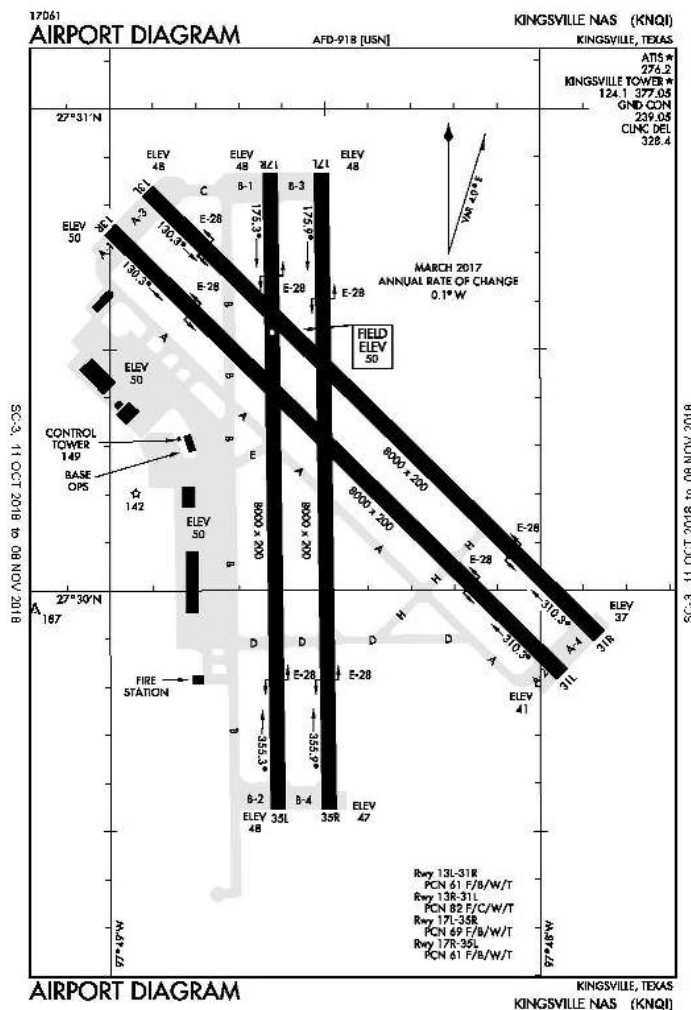
Figure 1. Airport diagram showing the layout of Kingsville NAS

Air traffic control tower personnel reported that the airplane took off on runway 13R and had requested a right teardrop turn for a departure toward the north. Several witnesses reported seeing the airplane in a steep right bank; some witnesses reporting that the bank angle exceeded 90° and the maximum altitude achieved was 200-300 ft above ground level. The airplane descended nose low and the right bank angle decreased before the airplane impacted the ground between runway 17R/35L and taxiway B just south of the intersection of taxiways B and E (Figure 1.).

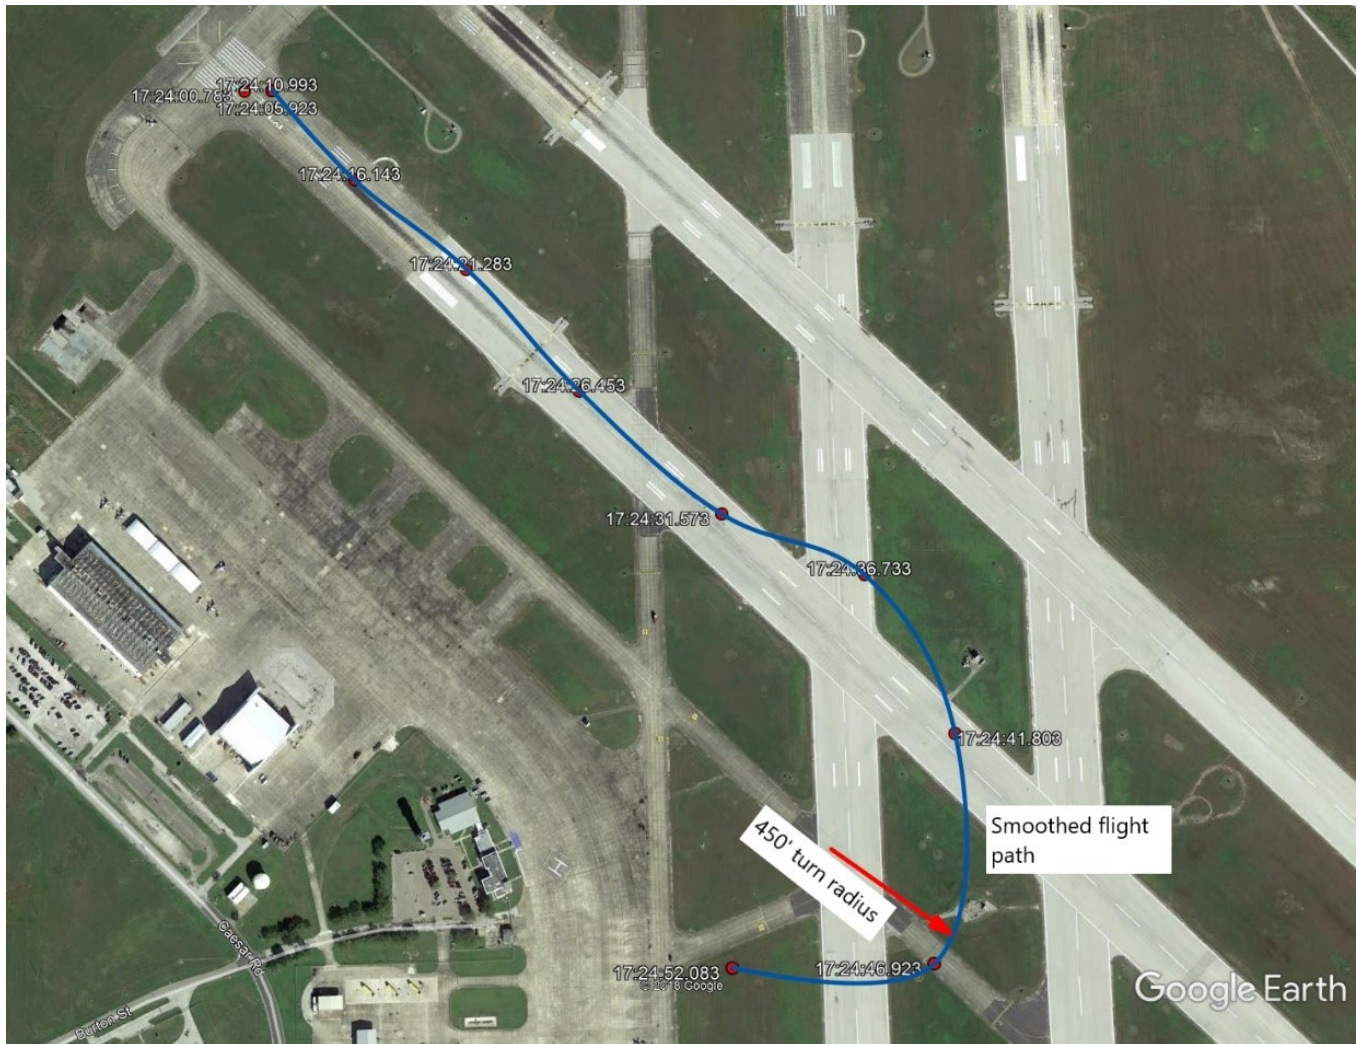
Figure 2. Overhead view of the airplane's ground track

Review of radar data showed that the airplane began its takeoff roll from runway 13R at 1224:01. The accident flight was captured in 11 radar returns, with the final return at 1224:52. No altitude data was recorded. The airplane's ground track continued along the runway centerline from the takeoff position for about 2,000 ft before making a slight left turn followed by a right turn. The right turn continued to the end of the data and the final recorded position was about 100 ft east of the initial impact point. Based on the final 3 recorded radar returns, the turn radius was estimated to be about 450 ft and the calculated average groundspeed was 87 mph. Based on this information, the calculated bank angle was about 56° during the final portion of the flight. For a level, 56°-banking turn, the calculated flight load factor was 1.8g. Based on the velocity versus load factor (V-N) diagram for the accident airplane, a load factor of 1.8g equated to an accelerated stall speed about 95 mph. The airplane's ground track is depicted in Figure2.
