# Aviation Investigation Final Report

| <b>Location:</b> | Copalis, Washington | <b>Accident Number:</b> | WPR19LA105 |
| <b>Date &amp; Time:</b> | March 30, 2019, 12:56 Local | <b>Registration:</b> | N215T |
| <b>Aircraft:</b> | Piper PA18 | <b>Aircraft Damage:</b> | Destroyed |

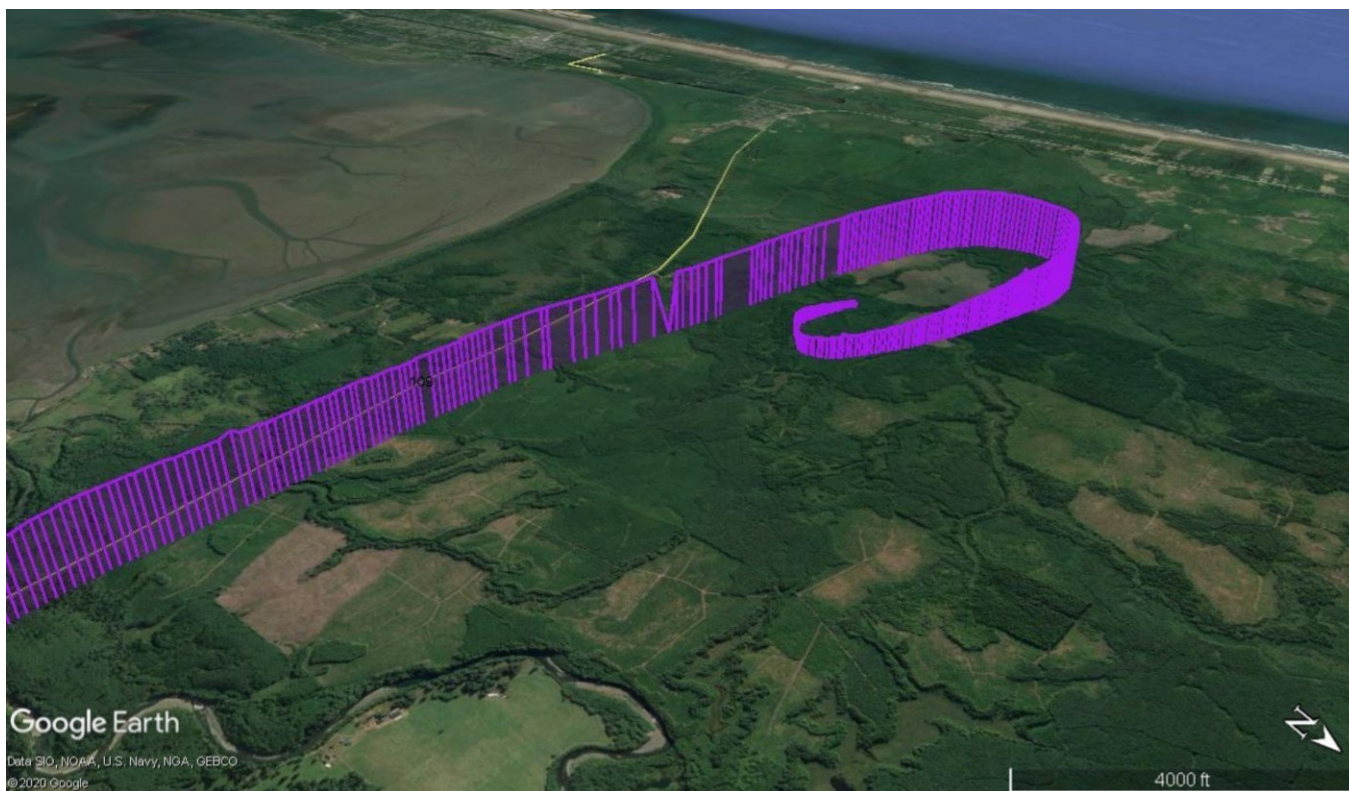
The altitude, speed, and ground track traces of the approach to the logging road, which included level-offs and speed increases, were consistent with a normal traffic pattern flown with an engine developing sufficient power for the entirety of the approach. The fact that both propeller blades were damaged, as well as their damage patterns, also indicated that the engine was developing power.

The flight track was south of the clearing, and at the point where it was abeam the eastern edge of the clearing, was about the same distance north of a straight 12,000 ft segment of a two-lane paved road that was oriented on a true heading of about 270°. The center of the forest clearing was about 13,000 ft from the linear shoreline that was oriented approximately perpendicular to the flight track. The shoreline consisted of a sandy beach that was about 600 ft wide and extended at least 5 miles each way to the north and south. The pilot's destination airport, S16, was situated on that same linear stretch of shoreline/beach, about 4 miles north of where the flight track would have intersected the shoreline if the pilot did not turn towards the forest clearing and logging road that became the accident site.

In its landing circuit for the forest clearing, the airplane traveled a total distance of about 16,000 ft from the point where it began the descent and turn from cruise flight to the last recorded data point (See Figure 1). From that same top of descent point and before the turn, the airplane was about 12,000 ft from, and headed almost directly toward, the shoreline/beach.

Figure 1. Landing/Accident Site Approach Flight Path (Note proximity to road and beach)
