# Aviation Investigation Final Report

<b>Location:</b>	Yuma, Arizona	<b>Accident Number:</b>	WPR18LA250
<b>Date &amp; Time:</b>	August 27, 2018, 10:36 Local	<b>Registration:</b>	N8162H
<b>Aircraft:</b>	Stoddard Hamilton GLASAIR SUPER IIS	<b>Aircraft Damage:</b>	Substantial
<b>Defining Event:</b>	Loss of engine power (partial)	<b>Injuries:</b>	1 None
<b>Flight Conducted Under:</b>	Part 91: General aviation - Personal

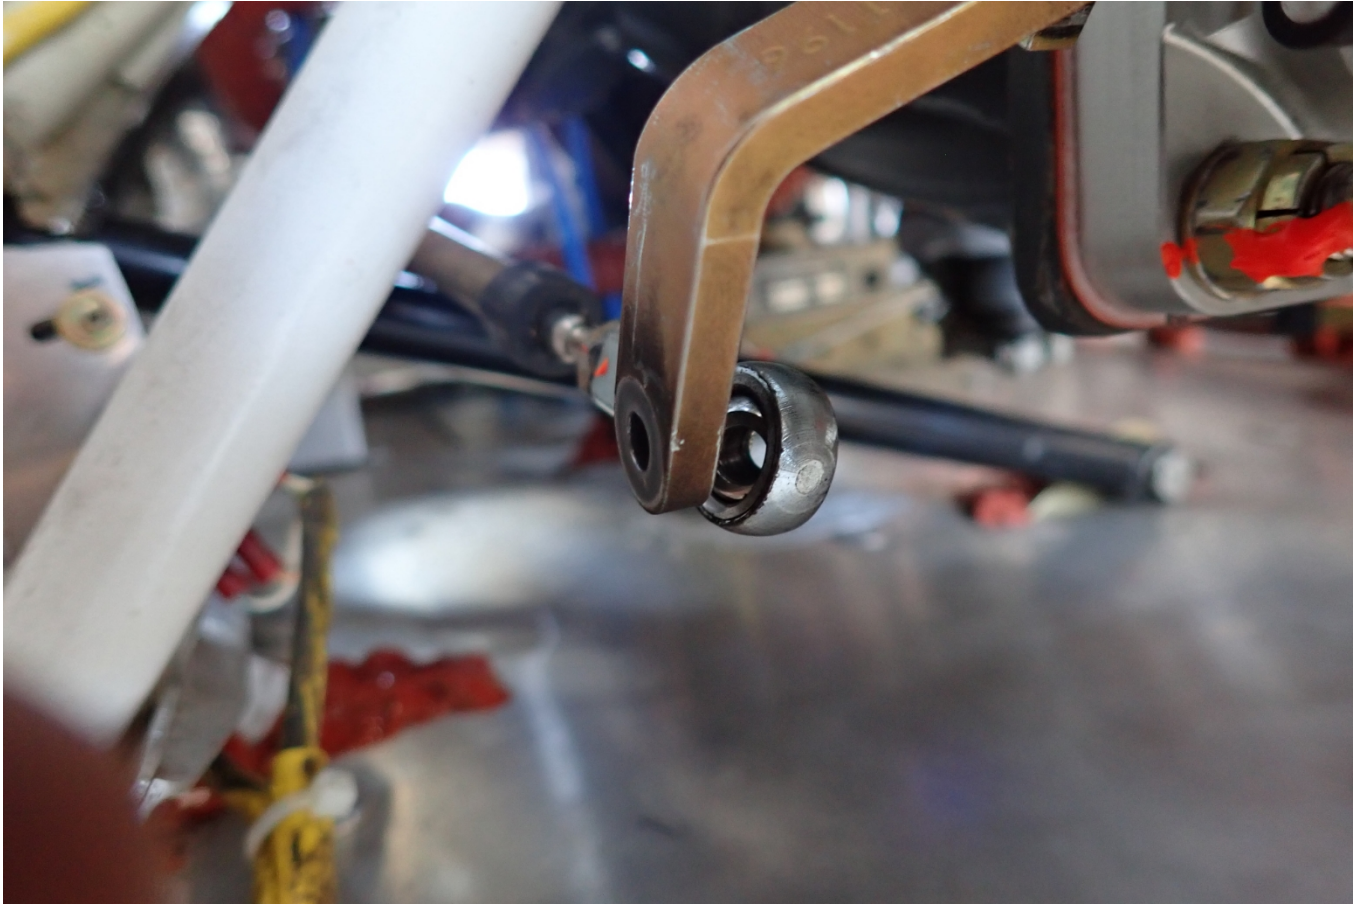
Postaccident examination of the engine revealed that the throttle linkage had detached from the throttle arm of the fuel injection servo. The rod end bearing for the linkage and the throttle arm were intact and undamaged, but the connecting bolt and its associated washers, castellated nut, and cotter pin were missing. The butterfly valve within the throttle body was in the closed position, and the throttle lever in the cabin was in the full forward (open) position. It is likely that the bolt securing the linkage had not been sufficiently tightened and secured with a cotter pin during the installation and that the error was not detected during the subsequent condition inspection.

A total loss of engine power as a result of the detachment of the throttle linkage from the throttle arm of the fuel injector servo due to an insufficiently tightened and secured bolt and the subsequent inadequate maintenance inspection.

Postaccident examination of the engine revealed that the throttle linkage had detached from the throttle arm of the fuel injection servo. The rod end bearing (Heim joint) for the linkage, and the throttle arm were intact and undamaged, but the connecting bolt and its associated washers, castellated nut and cotter pin were not present (Photo 1). The butterfly valve within the throttle body was in the closed position, and the throttle lever in the cabin was in the full forward, "open" position.

Photo 1 – Throttle Linkage
