Aviation Investigation Final Report

Location:	Glendale, California	Accident Number:	WPR17LA212
Date & Time:	September 22, 2017, 21:57 Local	Registration:	N34BE
Aircraft:	Mooney M20E	Aircraft Damage:	Substantial
Defining Event:	Fuel exhaustion	Injuries:	2 Minor
Flight Conducted Under:	Part 91: General aviation - Personal

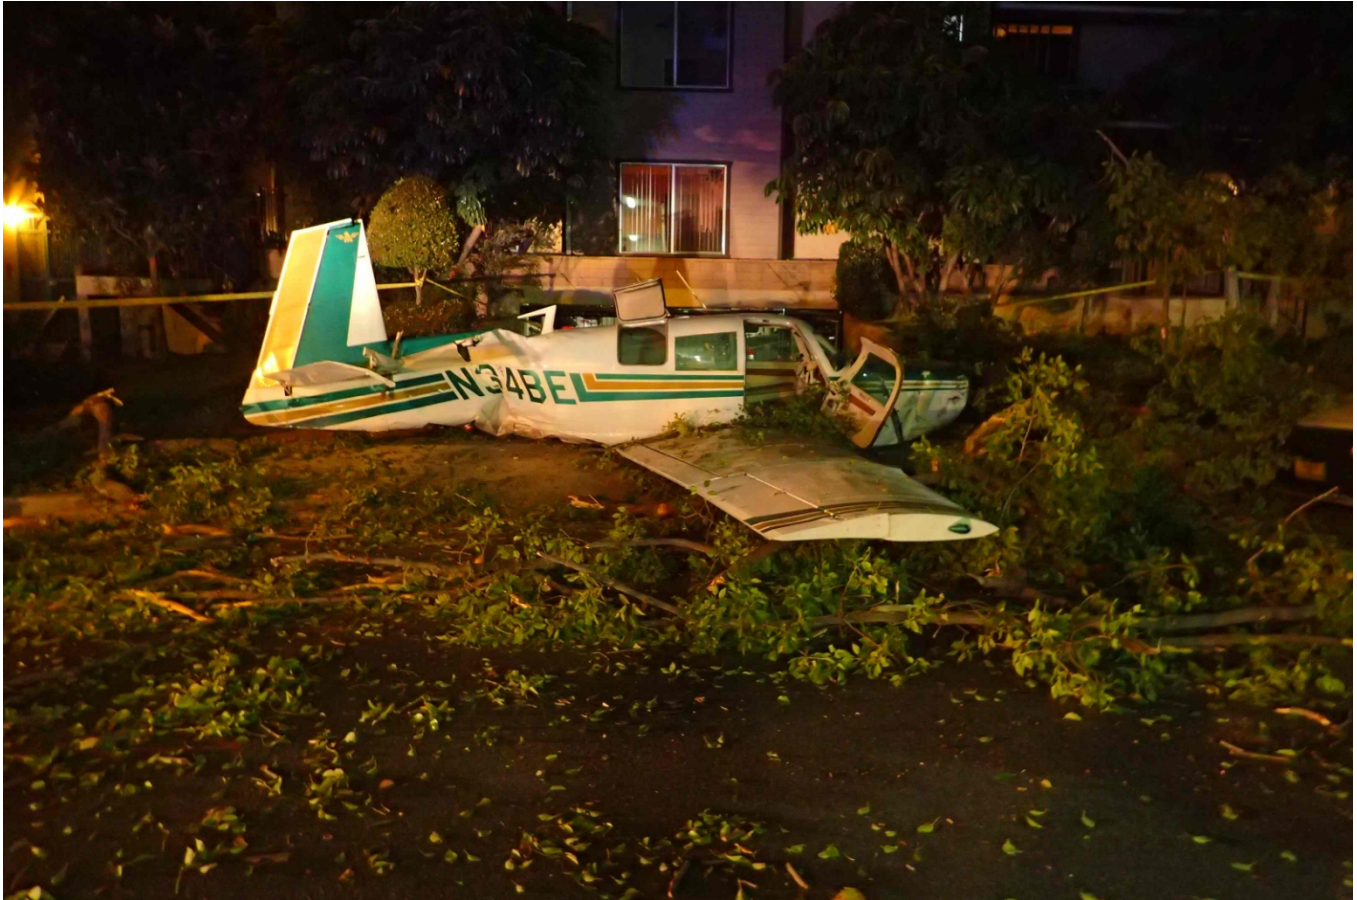
About 90 seconds later, at an altitude of about 2,500 ft msl (1,800 ft above ground level) the engine began to lose power. The pilot declared an emergency, and unable to maintain altitude, he pitched the airplane for best glide speed and began to perform trouble shooting procedures, which included turning on the auxiliary fuel pump and switching to the opposing fuel tank. The engine did not respond, and after referring to the display of his handheld electronic navigation device (which provided a glide distance radius) he concluded that he would not be able to make the runway. He then began to look for a suitable landing site, and because all highways and major streets were congested, he elected to land on the darkest street he could see. As he approached the street, the left wing struck a tree, and the airplane spun around, coming to rest upright on the pavement at the entrance to an apartment complex parking lot (Photo 1).

Photo 1 – Airplane at Accident Site

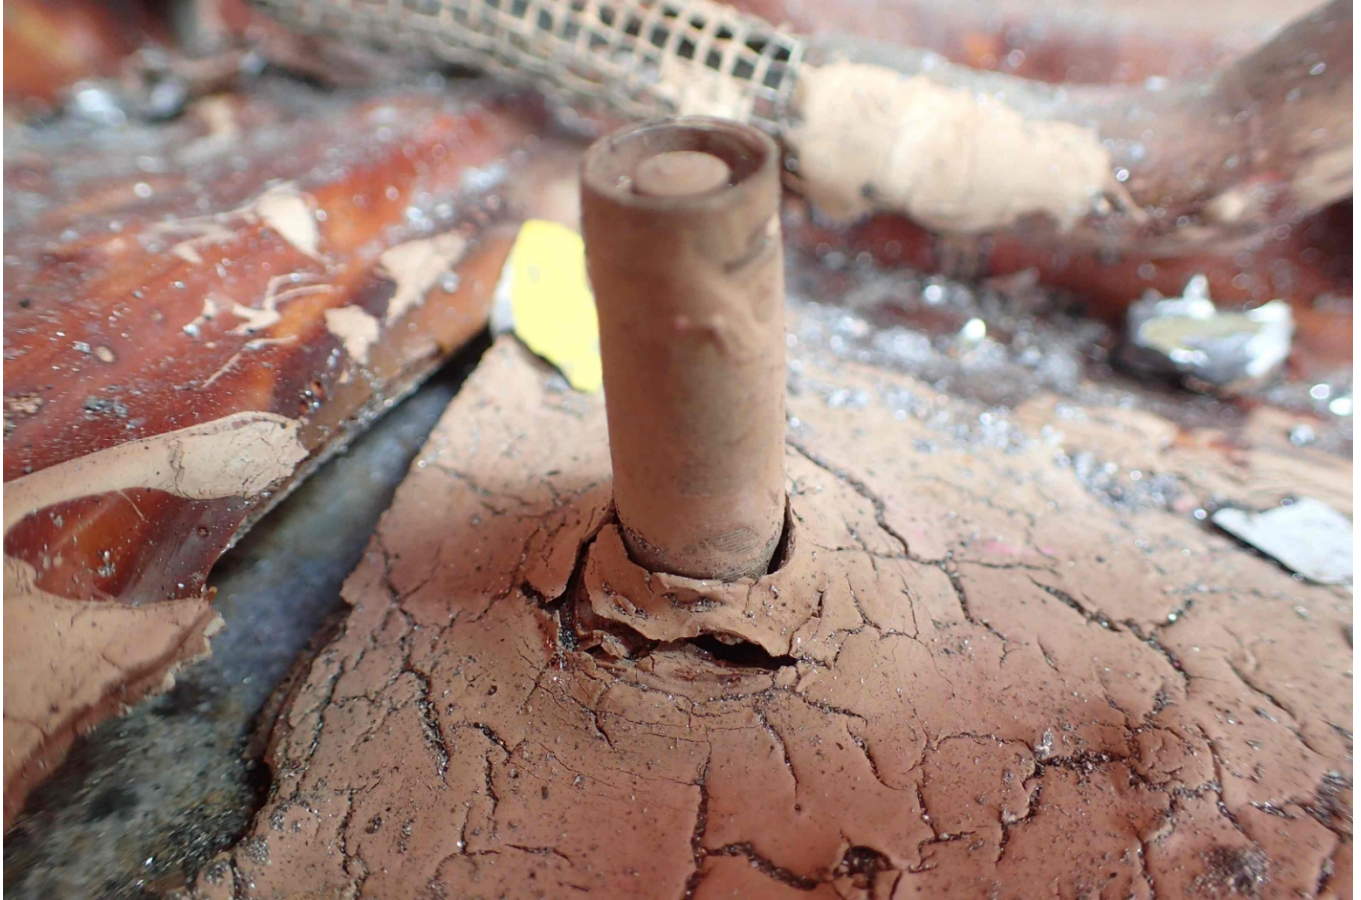
The airplane was examined at the accident site about 90 minutes later by the NTSB investigator-in-charge. There was no fuel odor, and no fuel was observed in either tank when viewed through their respective filler necks. The fuel selector valve had been switched to the "OFF" position by first response personnel, and its pre-accident position could not be verified. Following recovery of the airplane, damage was observed to the underside of the right tank, which had caused a breach (Photo 2) at the inboard rib and lower spar cap adjacent to the drain valve. The left fuel tank was undamaged.

SB M20-188A had not been complied to the right tank, and the valve appeared to be original. The valve was found in the closed position, and it opened and closed freely when tested. The valve did not leak when low-pressure air was applied to the valve inlet. The interior tank sealant around the valve was light brown in color, cracked and degraded, and had a dry chalky appearance (Photo 2). A series of brown streaks were observed on the external underside skins of the tank emanating aft from the area of the inboard wing doubler and adjacent to the drain valve (Photo 3). Due to the impact damage, the pre-accident integrity of the tank, particularly around the sump drain valve, could not be confirmed.

Photo 2 – Right Fuel Tank Drain Valve and Tank Breach

Mooney Service Bulletin (SB) M20-188A, issued in January 1980, documents the replacement of the wing tank drain valves. The bulletin recommends replacing the factory-installed drain valve with a "screw in" type valve. The reason given for the bulletin is to allow for faster complete draining of the fuel tank during future repairs. The SB-specified compliance timing was at the owner's option and should be accomplished any time the tank needs to be resealed or the valve replaced.

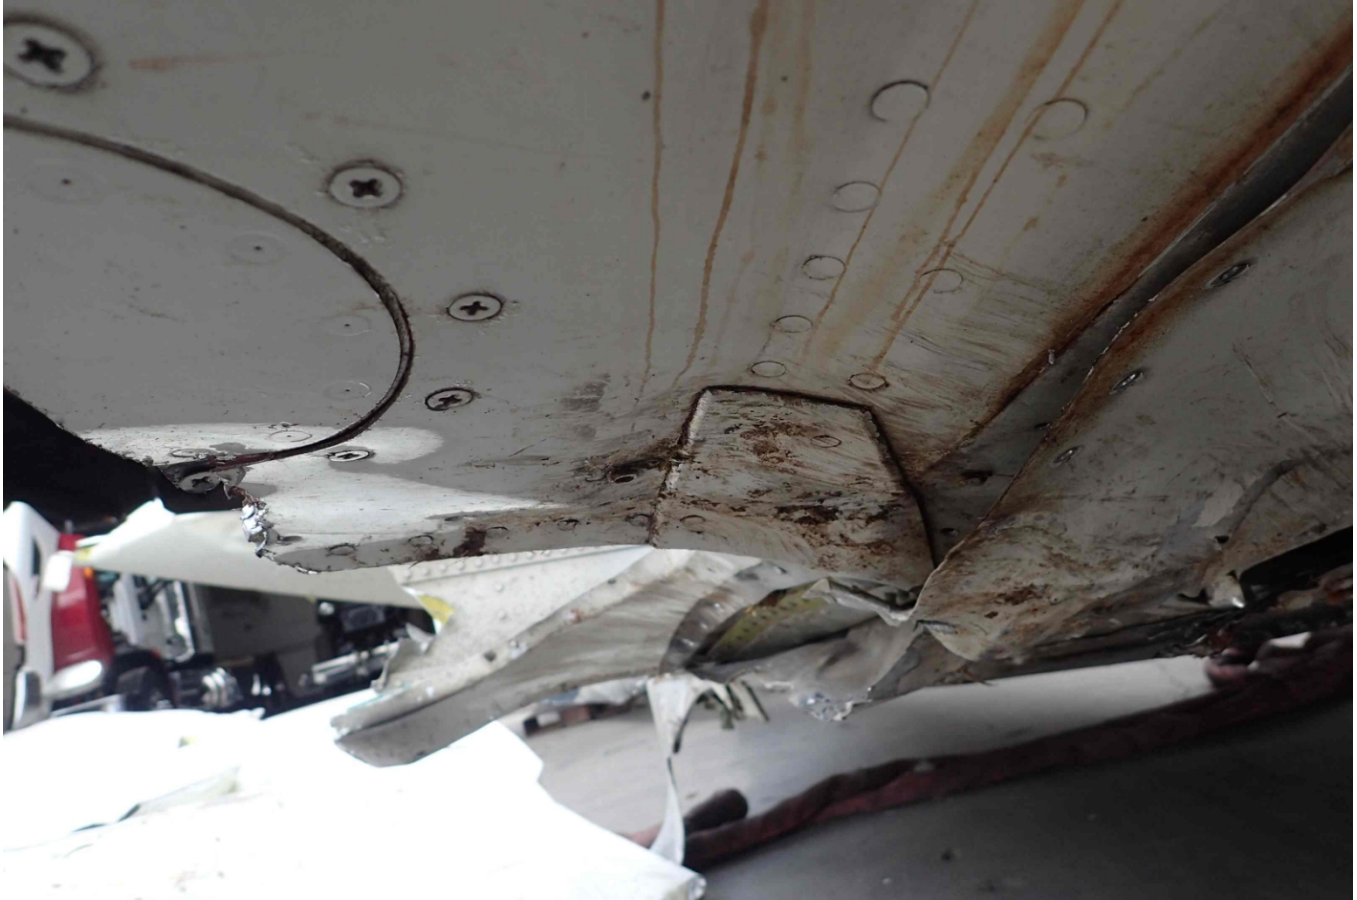
Postaccident wreckage examination revealed that both fuel tanks were empty, and although the right fuel tank sustained a small breach during impact, there was no fuel odor at the accident site. A series of brown streaks were observed trailing from an area adjacent to the right-wing fuel sump drain. The sump valve sealant was badly degraded, and it is possible that a small fuel leak had developed at an undetermined time; however, blue streaking would have been more likely if a significant and recent fuel loss had occurred. Further examination revealed no leaks in the fuel supply system or engine. The engine tachometer was tested for accuracy, and no anomalies were noted. During an engine test run, the engine started normally and operated through its full speed range with no evidence of a mechanical anomaly.

Photo 3 – Streaks Under the Right Fuel Tank
