# Aviation Investigation Final Report

<b>Location:</b>	Loma, Colorado	<b>Accident Number:</b>	CEN18LA303
<b>Date &amp; Time:</b>	July 31, 2018, 11:30 Local	<b>Registration:</b>	N125TY
<b>Aircraft:</b>	Buchanan Kitfox IV	<b>Aircraft Damage:</b>	Substantial
<b>Defining Event:</b>	Loss of control in flight	<b>Injuries:</b>	1 Minor
<b>Flight Conducted Under:</b>	Part 91: General aviation - Personal

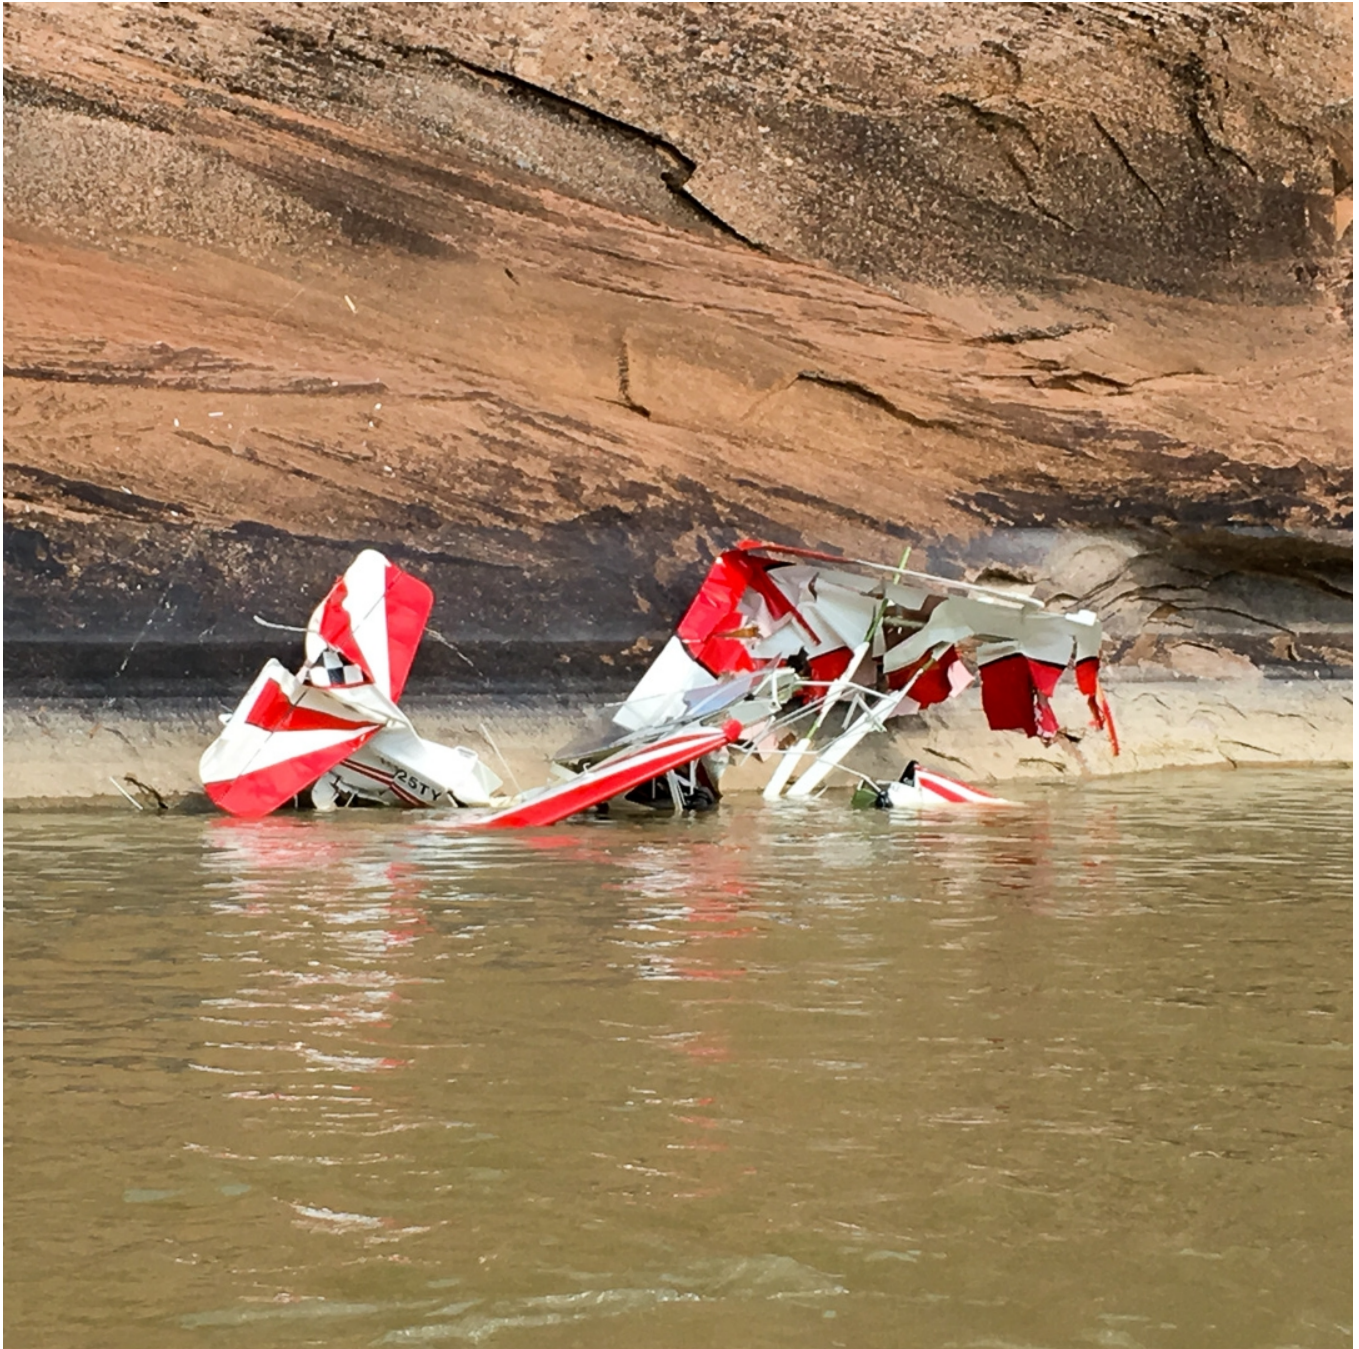
According to the pilot, he departed GJT and elected to fly at low altitude over the Colorado River. After over passing a group of river rafters about 500 ft above ground level, the pilot "dropped [the airplane] low to the river." Shortly after descending, the airplane's vertical stabilizer struck a cableway (owned and maintained by the US Geological Survey (USGS)) that crossed over the river. The pilot lost control of the airplane, and the airplane impacted the side of the river canyon. The airplane came to rest partially submerged in the river, and the pilot was rescued by passing river rafters (Figure 1).

Figure 1 - Accident Site (photo provided by Mesa County Sheriff's Office)

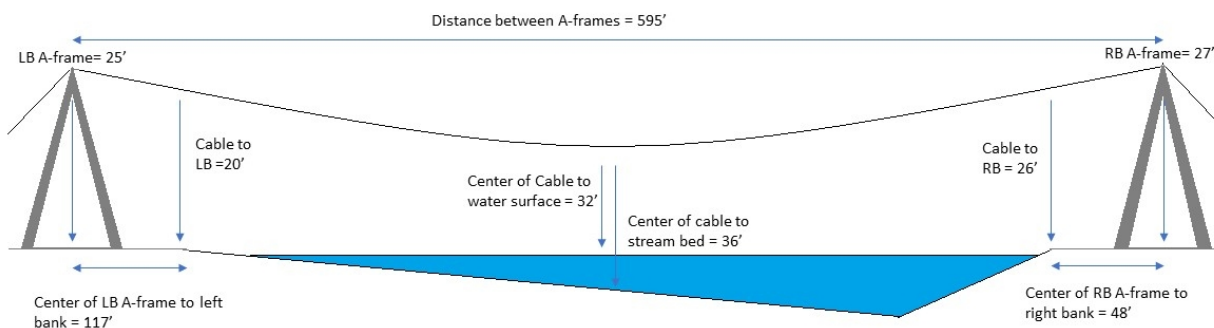
09163500 Colorado River Near Colorado Utah Stateline  
(As of 08/27/2018)

According to the USGS, the cableway is supported by two fixed A-frame structures located on the sides of the riverbank. The center of the cable to the water surface is 32 ft (Figure 2).

Figure 2 - Cableway dimensions (USGS)
