Aviation Investigation Final Report

Location:	Heber, Utah	Accident Number:	WPR18LA272
Date & Time:	September 25, 2018, 11:00 Local	Registration:	N90339
Aircraft:	Smith Aerostar601	Aircraft Damage:	Substantial
Defining Event:	Landing gear collapse	Injuries:	1 None
Flight Conducted Under:	Part 91: General aviation - Personal

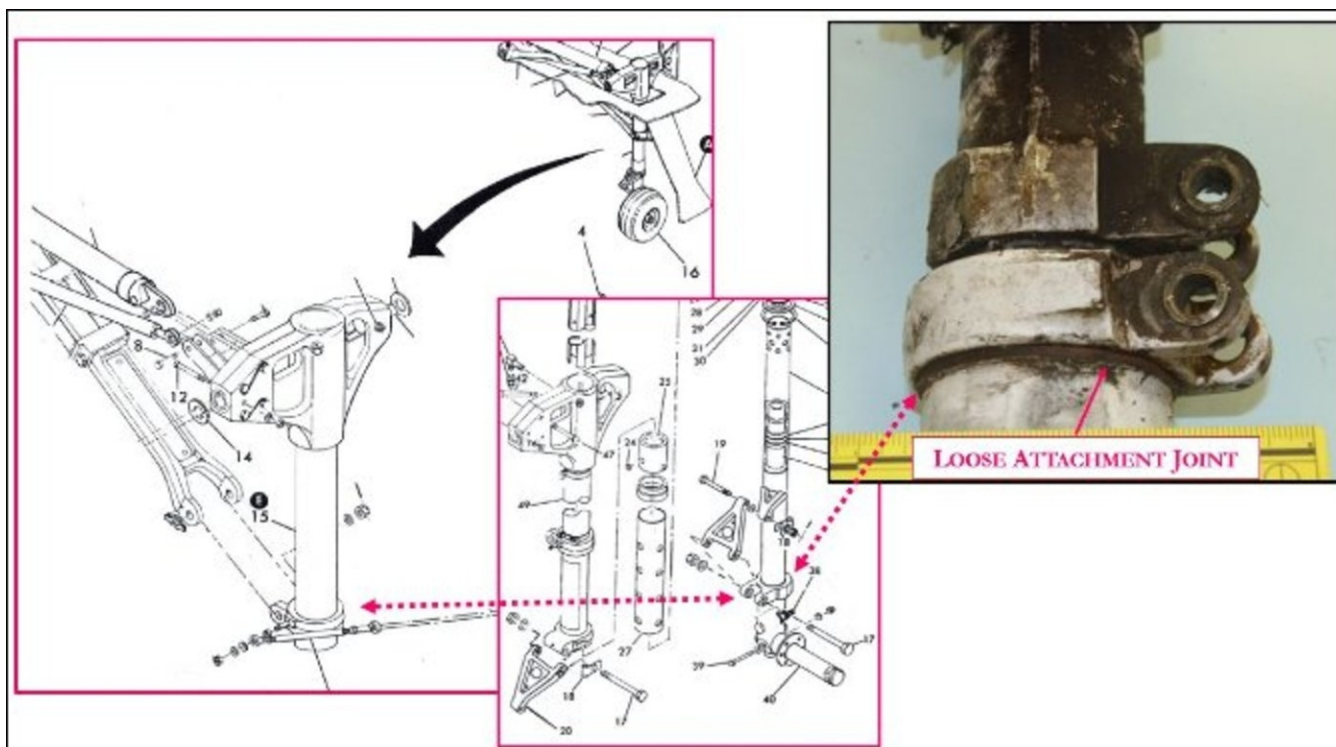
Postaccident examination of the landing gear assembly revealed that the weld had failed on the joint attached to the main landing gear cylinder and upper scissor assembly. Most of the fracture surface of the failure surface had been obliterated by smearing and grinding, consistent with post-fracture damage. The degree of the fracture surface damage was consistent with the fracture and separation happening before the accident. Landing gear components are under cyclic loads at every landing and during landing actions (such as braking or taxiing). There was no evidence of fatigue, corrosion, or other progressive mechanisms would have led to the fracture of this joint from the strut cylinder.

A recent hard landing resulted in a fracture of a joint from a cylinder to a main landing gear.

Postaccident examination of a portion of the left main landing gear assembly by the National Transportation Safety Board Materials Laboratory revealed that the weld had failed on the joint attached to the landing gear cylinder and upper scissor assembly. The inboard fitting of the joint remained affixed to the scissor assembly by an attachment bolt. The joint was loose where it attached to the cylinder, and it could be rotated against the cylinder exterior. The adjacent hexagonal cap below the loose joint was still tight against the cylinder assembly (see figure).

Figure: Diagram and forward aft view picture of the left main landing gear

The attachment joint had fractured and separated about the entire circumference of the cylinder exterior. This separation allowed the joint (and linkage) to rotate approximately 30° about the cylinder. The fracture surface of the attachment joint faced upward on the strut cylinder where the joint had been welded to the cylinder. Examination of the joint portions of the fracture surface, particularly along the fractured weld protrusions, did not reveal any fracture features. Portions of the external weld on the joint exhibited features of localized deformation, all of which were consistent with overstress fracture. Most of the fracture surface features had been obliterated by smearing and grinding, consistent with post fracture damage. The degree of the fracture surface damage was consistent with the fracture and separation existing prior to the accident. Landing gear components are under cyclic loads at every landing and during landing actions (such as braking or taxiing).
