Aviation Investigation Final Report

Location:	Grass Valley, California	Accident Number:	WPR19LA117
Date & Time:	April 19, 2019, 13:40 Local	Registration:	N621JM
Aircraft:	Nanchang CJ 6	Aircraft Damage:	Substantial
Defining Event:	Runway excursion	Injuries:	2 Minor
Flight Conducted Under:	Part 91: General aviation - Personal

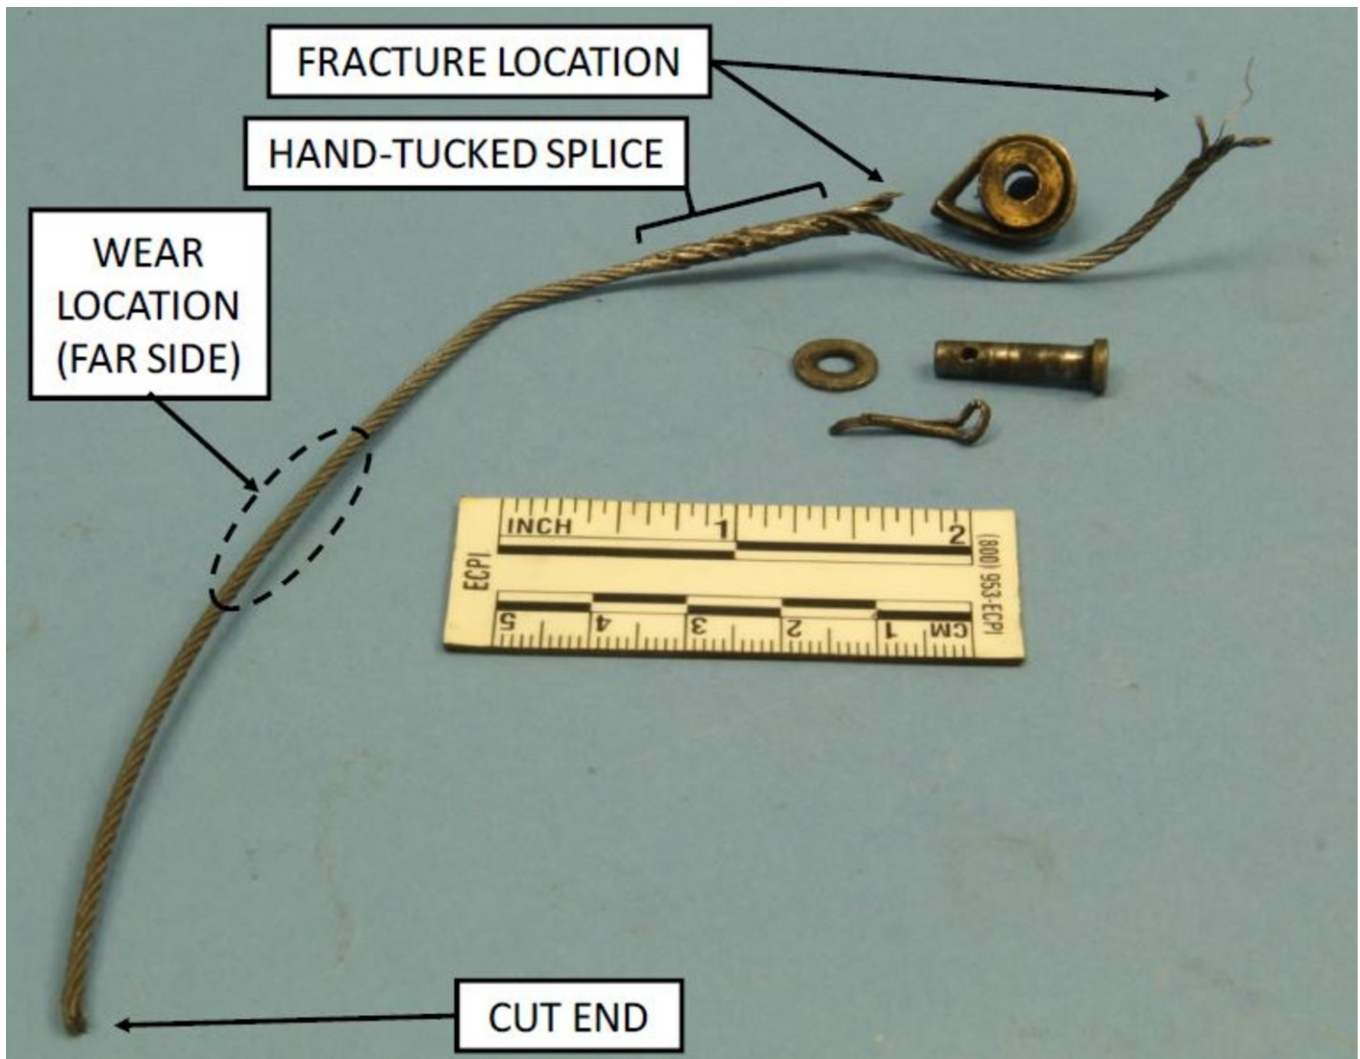
A loss of brake control due to fatigue fracture of the brake control cable, which resulted in the separation of the cable from the brake handle.

Examination of the brake cable revealed that it was constructed of seven strands of seven metal wires (7x7). When comparing the thimble with the cable contour between two fracture locations, the fit was consistent with a thimble-eye termination created by a hand-tucked splice joint, as seen in figure 1.

Figure 1: View of the brake cable components submitted to the NTSB Materials Laboratory.

The fracture surface of the cleaned cable was examined using a scanning electron microscope. Six of the seven strands of wires exhibited relatively flat fracture surfaces normally oriented to the wire axis, consistent with a progressive fracture mechanism, such as a fatigue fracture. Only one strand and a few of the remaining individual wires showed evidence of minor elongation at the fracture location. For further information, see the Materials Laboratory Factual Report within the public docket for this accident.
