# Aviation Investigation Final Report

<b>Location:</b>	Julian, California	<b>Accident Number:</b>	WPR18FA139
<b>Date &amp; Time:</b>	May 10, 2018, 20:31 Local	<b>Registration:</b>	N803FC
<b>Aircraft:</b>	Beech 76	<b>Aircraft Damage:</b>	Destroyed
<b>Defining Event:</b>	Controlled flight into terr/obj (CFIT)	<b>Injuries:</b>	3 Fatal
<b>Flight Conducted Under:</b>	Part 91: General aviation - Instructional

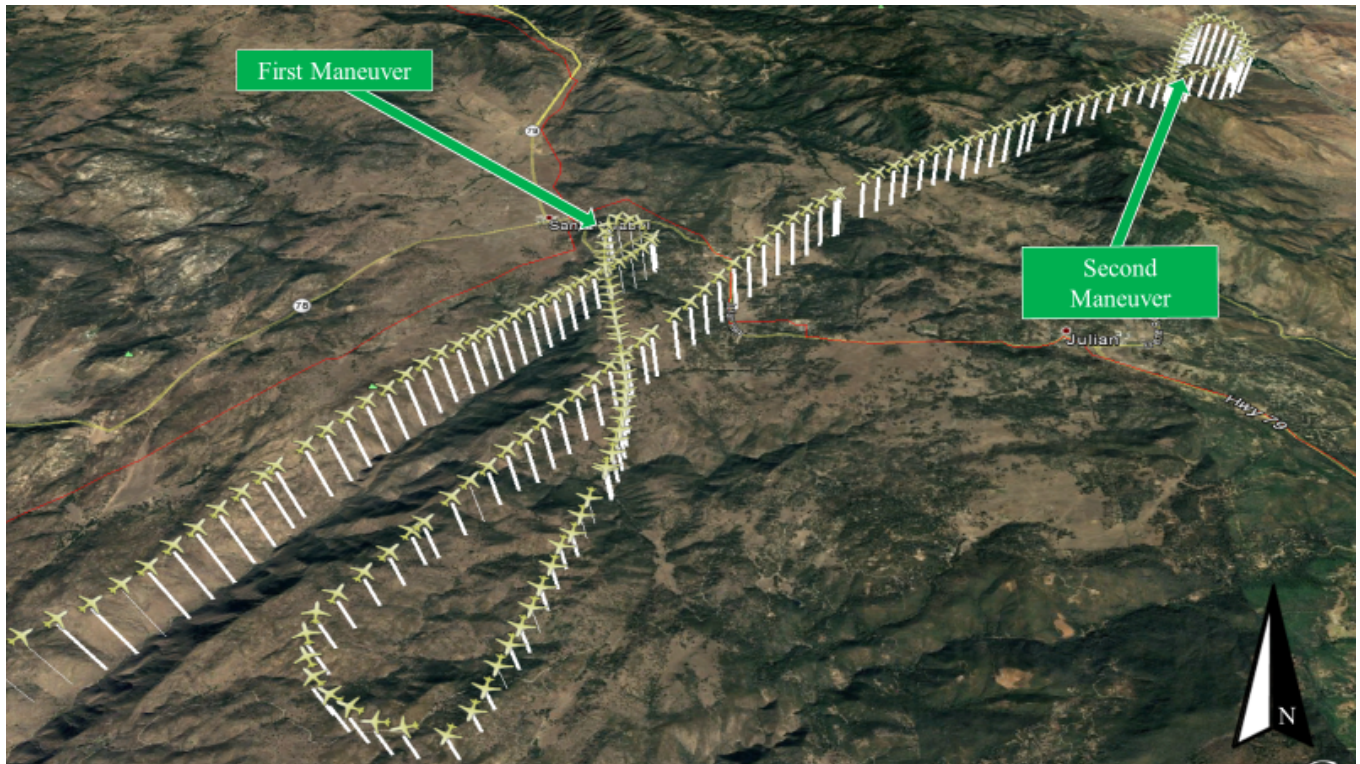
Figure 1. First and second maneuver.

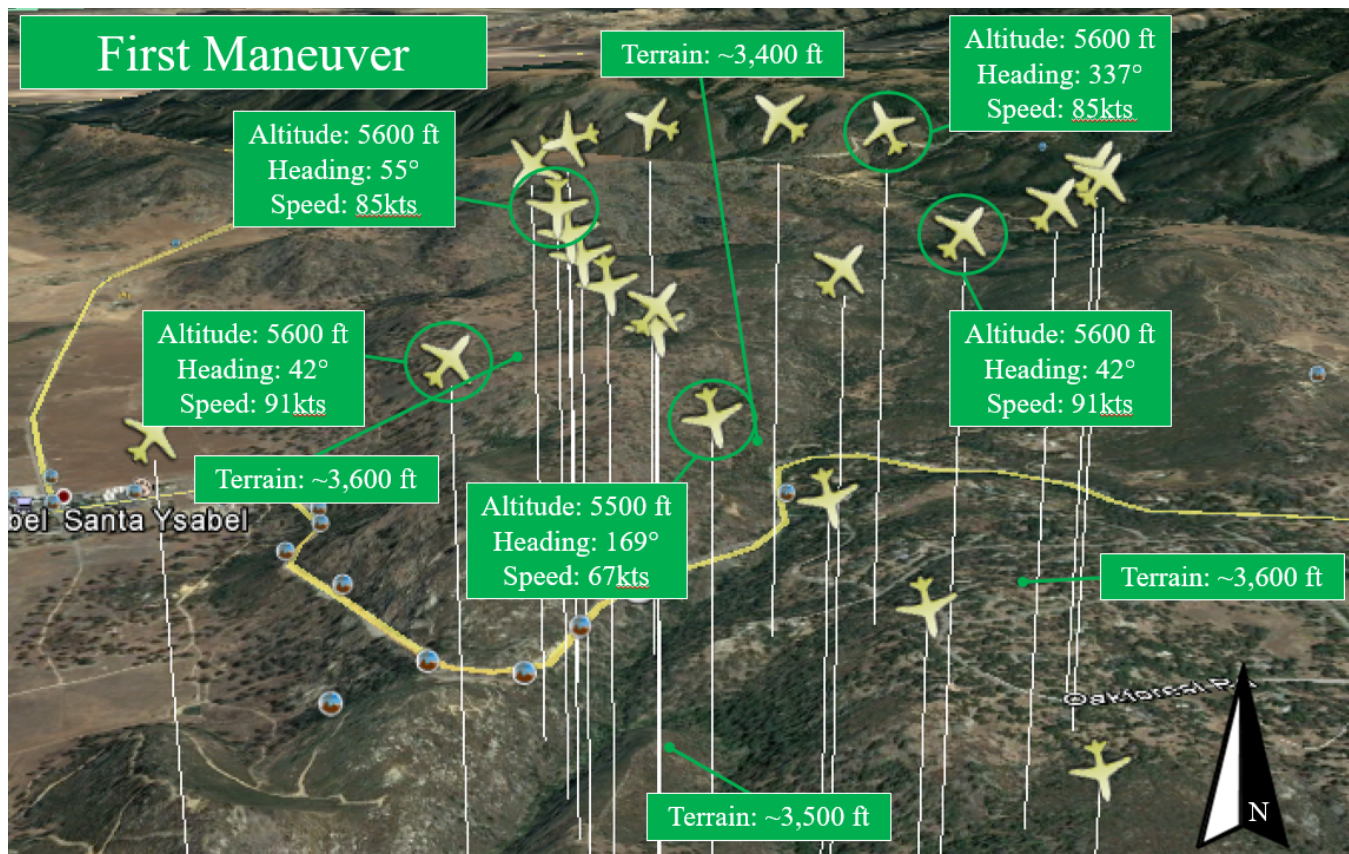
Review of Federal Aviation Administration (FAA) radar data identified the airplane near Ramona Airport (RMN), Ramona, California, about 2009. The radar track showed that the airplane traveled east and climbed to an altitude of about 5,600 ft mean sea level (msl) with the groundspeed varying from 116 to 133 knots for about 14 miles. The airplane then began to slow, and it made a left turn maneuver from about a 48° course heading to about a 176° course heading. Throughout the turn, the airplane's altitude remained about 5,600 ft msl, and the groundspeed decreased to 55 knots. At the completion of the turn, the groundspeed increased to about 67 knots, and the airplane began to climb to 6,600 ft msl while continuing to the southwest on a course heading of about 195°. The airplane then made a right turn course reversal to an easterly heading and proceeded in that direction for about 10 miles.

Figure 2. Radar track for the first maneuver along with relevant airplane and terrain information.

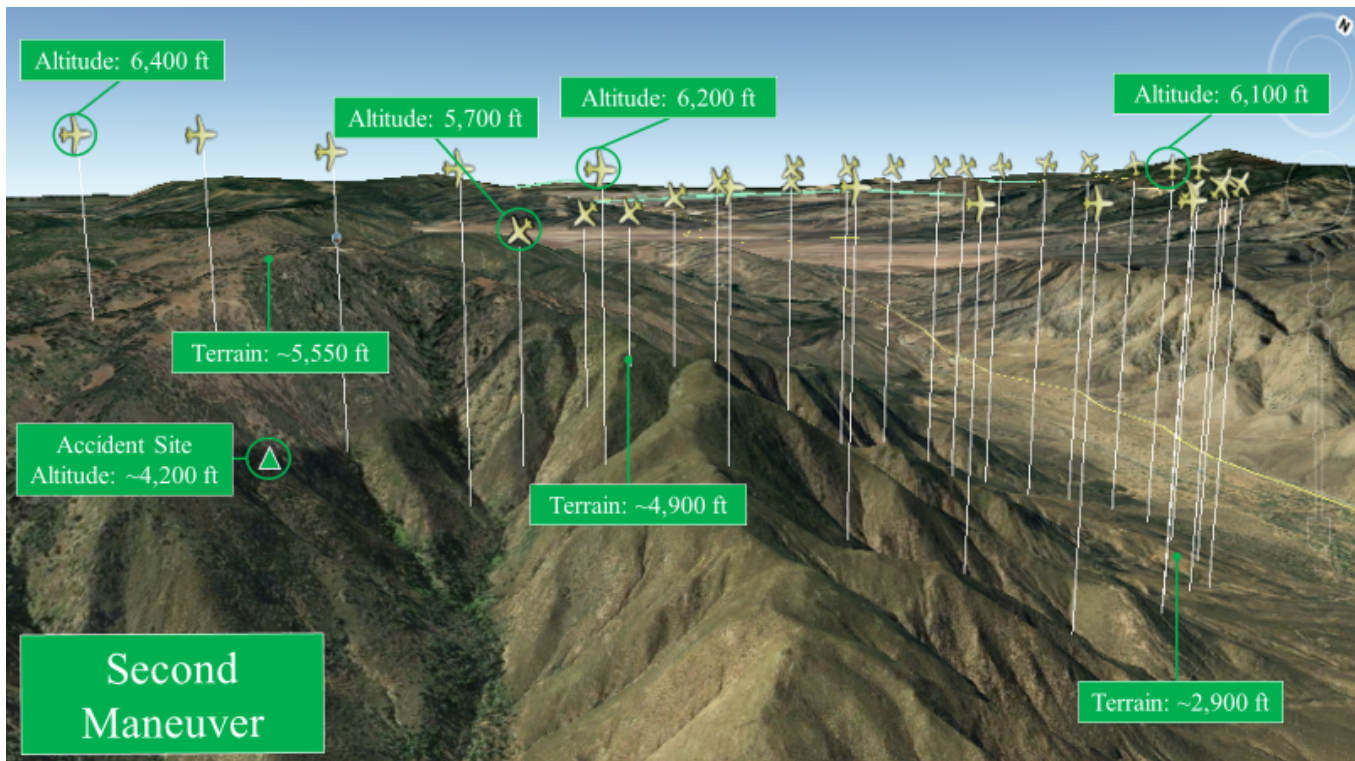
Weather reporting in the area of the accident site indicated extreme turbulence and severe up and downdrafts during high wind conditions. Although there is evidence of strong wind in the area at the time of the second maneuver, there is no consensus among the available wind data. However, the upset occurred immediately downwind of relatively high terrain and inside of a temperature inversion, which can promote wave action and turbulence. Thus, the airplane likely encountered a downdraft and the pilot was unable to recover, resulting in the airplane's subsequent impact with terrain.

The radar data then depicted the airplane initiated a second left 180° turn maneuver at an altitude of 6,200 ft msl and a groundspeed of about 121 knots. At the apparent apex of the turn, the airplane was at 6,100 ft msl and a groundspeed of 50 knots. The airplane then began to descend, and the groundspeed increased to 74 knots and then decreased to 50 knots. The last radar return, which was recorded about 2031, showed the airplane at an altitude of 5,700 ft msl and a groundspeed of 67 knots near the accident site. Figure 1 shows the flight tracks for both maneuvers, and figures 2 and 3 show the flight track for the first and second maneuvers, respectively, along with relevant airplane and terrain information.

Figure 3. Radar track for the second maneuver along with relevant airplane and terrain information.
