Aviation Investigation Final Report

Location:	La Verne, California	Accident Number:	WPR19FA001
Date & Time:	October 1, 2018, 11:50 Local	Registration:	N7997M
Aircraft:	Beech V35	Aircraft Damage:	Destroyed
Defining Event:	Collision during takeoff/land	Injuries:	1 Fatal
Flight Conducted Under:	Part 91: General aviation - Personal

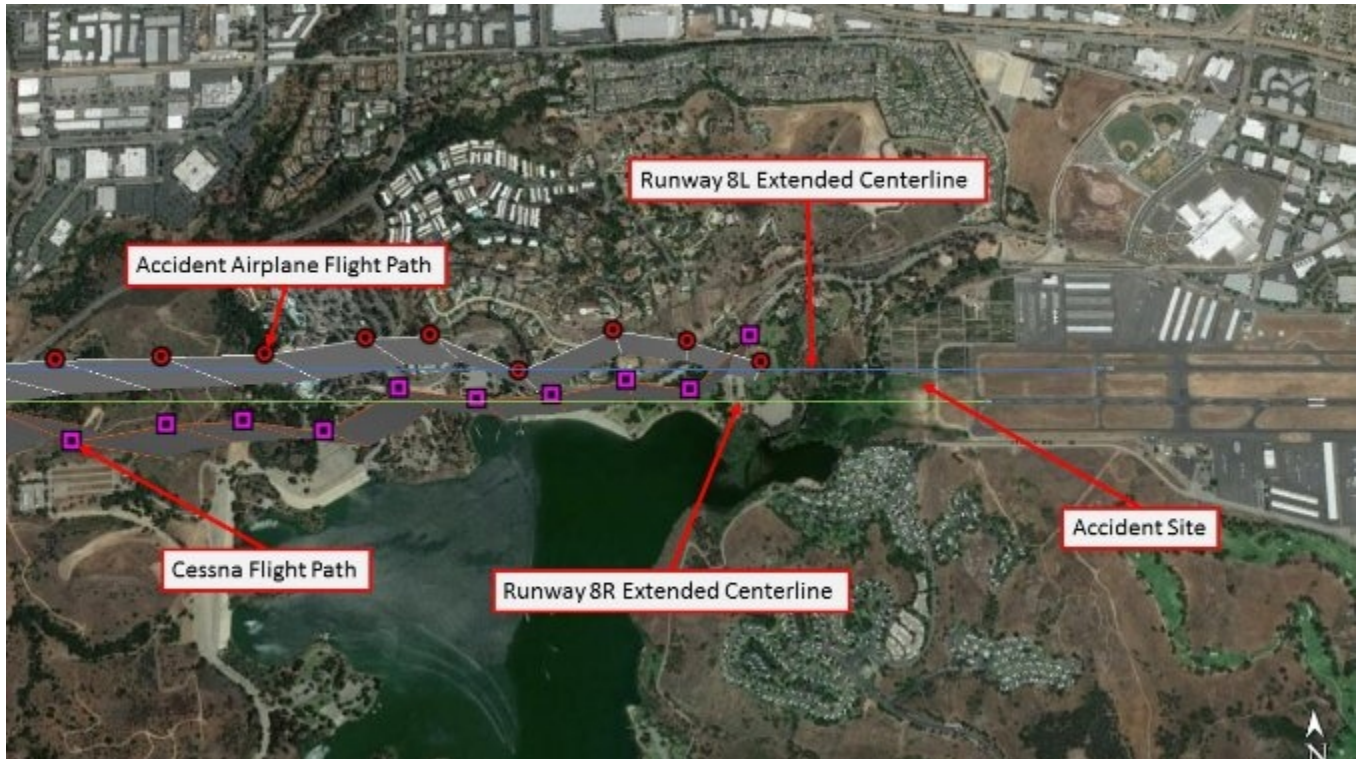
Recorded radar data (Figure 1) showed that both the accident airplane and the Cessna were approaching the airport from the west. The accident airplane was behind the Cessna, with the horizontal spacing between the two airplanes decreasing throughout the approach to landing. The Cessna's radar track indicated that it was south of the runway 8L centerline until 1147:31, when it turned left/north to align with runway 8L. The accident airplane's radar track showed that it was mostly north of the runway 8R centerline until 1147:54, when it made a right/south turn toward the runway 8R centerline. The data showed that, at 1147:59, the accident airplane was aligned with runway 8L, then turned right toward runway 8R. The last radar return was about 2,150 ft west of the runway 8R threshold and about 1,648 ft west of the accident site at 1,000 ft mean sea level (msl).

Figure 1: Radar data plots for the accident airplane and Cessna with extended runway centerlines.

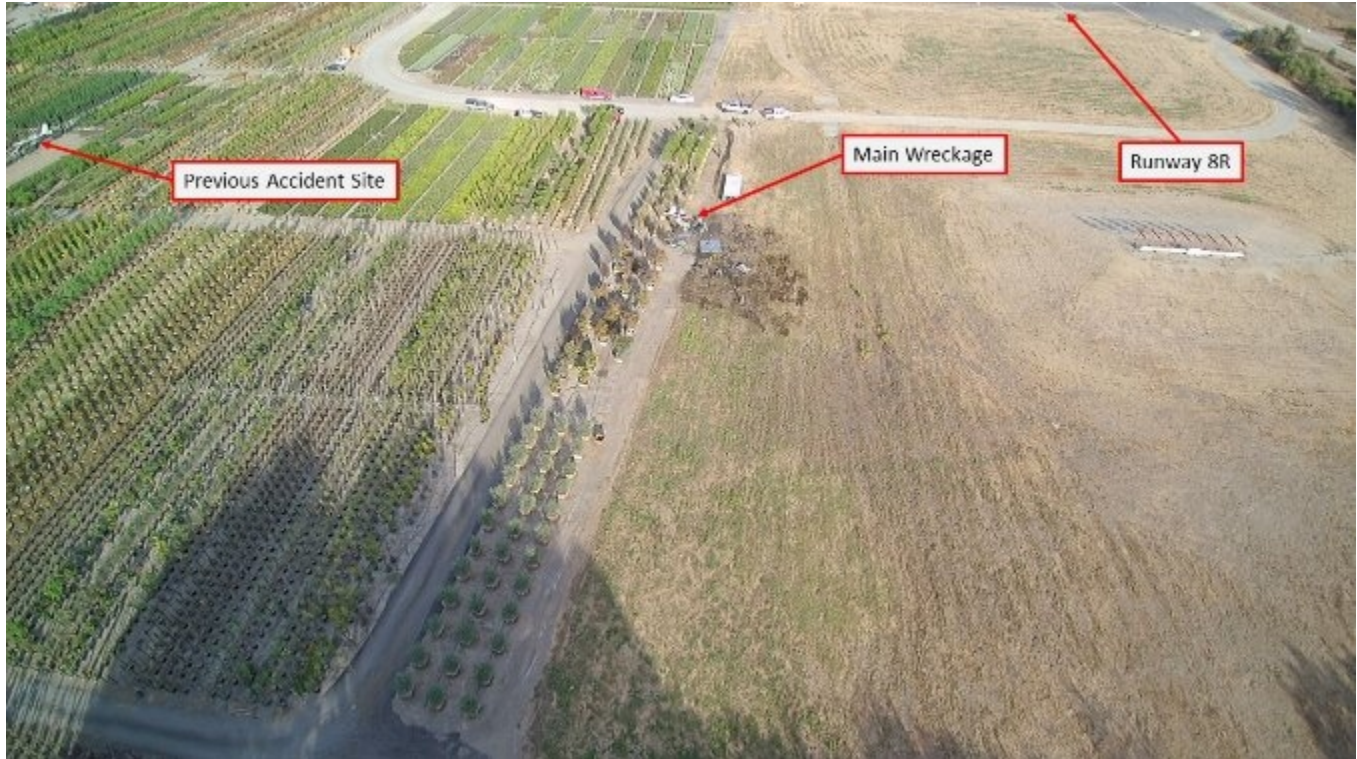
Two witnesses, who were conducting an investigation of an aircraft accident that occurred the day before, were located adjacent to the accident site as depicted in Figure 2. Both witnesses heard the sound of the airplane impacting trees before they turned to see it in a left banking, nose-low attitude that progressively steepened before the airplane impacted the ground. A post-impact fire ensued.

Figure 2: Accident site locations in relationship to runway 8R. Photo courtesy of the La Verne Fire Department.

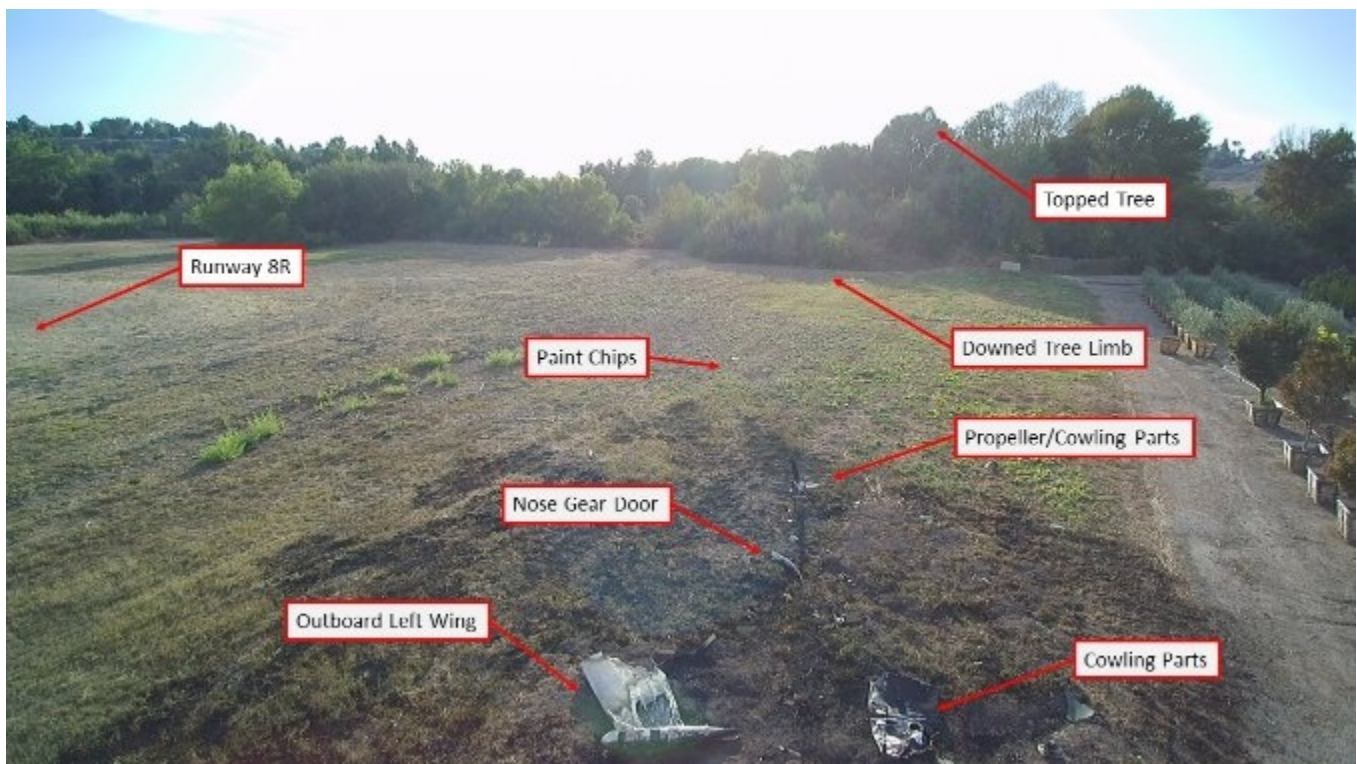
The first identified point of contact (FIPC) was a 50-ft-tall tree about 900 ft from the approach end of runway 8R and about 185 ft north of the runway centerline. The wreckage debris path (Figure 3) was about 400 ft long and oriented on a heading of about 070° magnetic.

A freshly cut tree limb was located about 146 ft beyond the FIPC. Paint chips consistent with the color of the airplane were located about 319 ft from the FIPC. About 30 ft beyond the paint chips was the propeller assembly and an impact crater that was about 2 ft wide and 4 ft in length. Portions of the nose wheel landing gear door, engine cowling, and green right-wing navigation lens fragments were located about 364 ft from the FIPC. The outboard 5 ft of the left wing was located about 370 ft from the FIPC (Figure 4). The main wreckage was located about 394 ft from the FIPC. The airplane came to rest upright on a heading of about 198°. The left aileron was located about 6 ft beyond the main wreckage.

Figure 3: Wreckage debris path, looking west from main wreckage. Photo courtesy of the La Verne Fire Department.

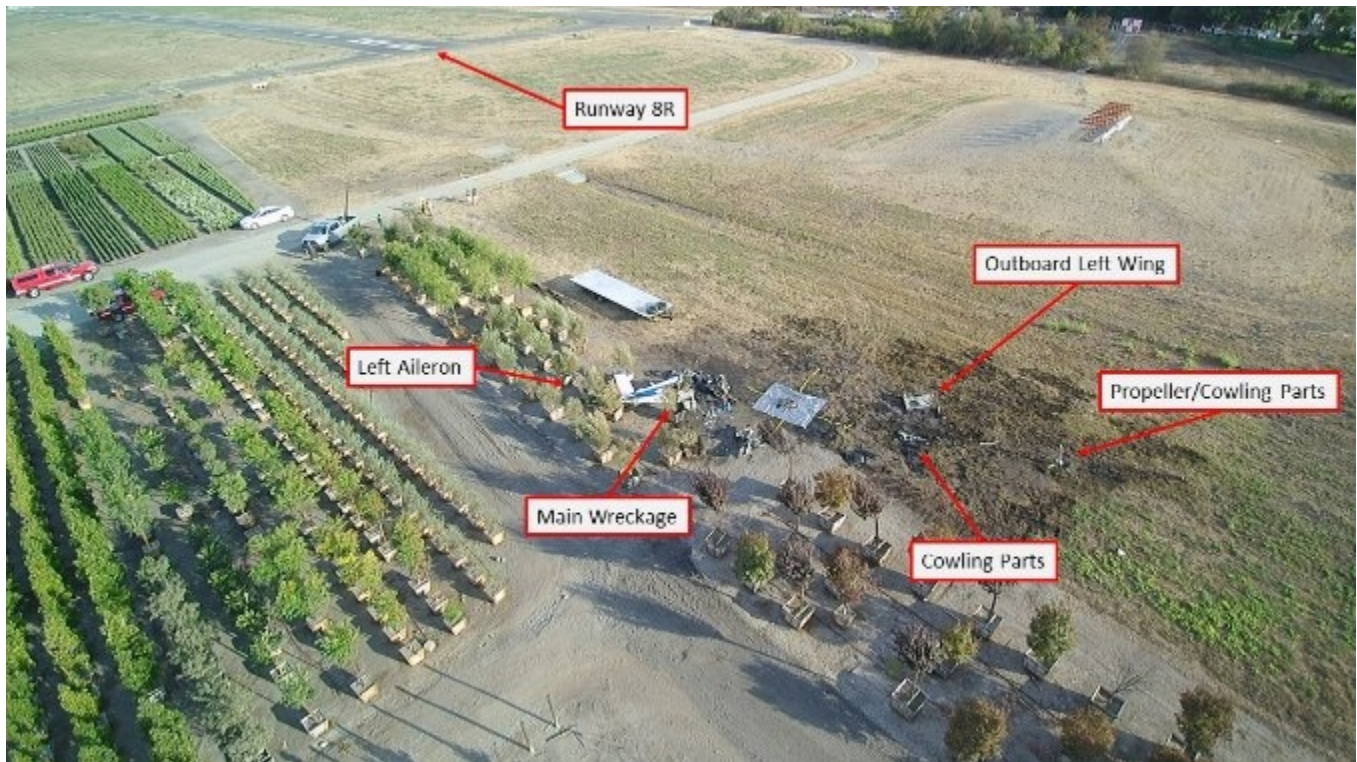
Figure 4: Aerial view of the accident site in relation to runway 8R. Photo courtesy of the La Verne Fire Department.
