# Aviation Investigation Final Report

<b>Location:</b>	Maxwell, California	<b>Accident Number:</b>	WPR18LA128
<b>Date &amp; Time:</b>	April 29, 2018, 15:30 Local	<b>Registration:</b>	N6674K
<b>Aircraft:</b>	GRUMMAN ACFT ENG COR-SCHWEIZER G 164C	<b>Aircraft Damage:</b>	Substantial
<b>Defining Event:</b>	Loss of engine power (total)	<b>Injuries:</b>	1 None
<b>Flight Conducted Under:</b>	Part 91: General aviation - Other work use

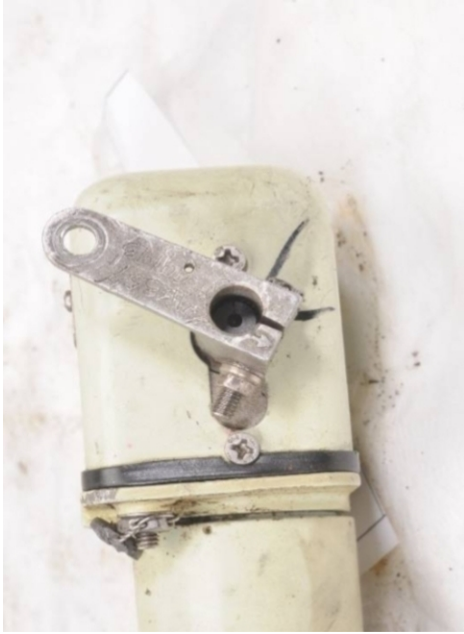
speed lever is moved to the EMERGENCY STOP position, the valve is moved to MANUAL, which closes the valve and terminates fuel to the engine. Postaccident examination of the arm on the FSOV showed a mark on the shaft to which the valve's arm is connected was positioned vertically relative to the body of the valve, which indicated the valve was in the AUTO position when removed from the airplane. (See Figures 1 and 2)

Computerized tomography scans of the fuel shutoff valve, which were conducted prior to a functional test, revealed that the Belleville washer was in the position that holds the ball against the seat in the valve, which would prevent the flow of fuel through the valve. When the washer was scanned for cracks, none were identified. These results are consistent with a normally operating valve found in the electrically CLOSED position.

Functional tests on the FSOV verified the functionality of the valve, but the valve failed to meet the acceptance criteria of a new part. The valve required a higher voltage to open than specified and had a higher leakage through the output port than was specified but passed all other tests.

*Figure 1. Fuel shutoff valve after removal from engine.*

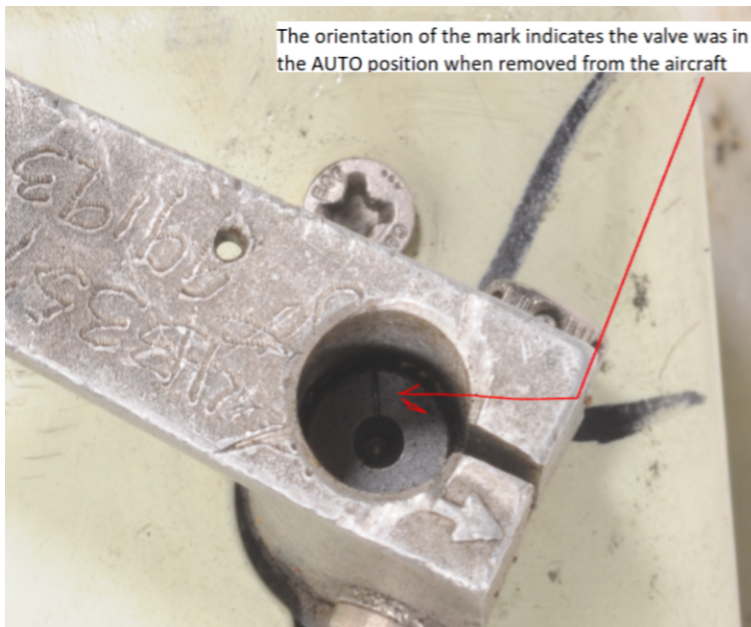
*Figure 2 – Close-up of the fuel shutoff valve in AUTO position*
