Aviation Investigation Final Report

Location:	Mill Creek, California	Accident Number:	WPR19FA126
Date & Time:	May 1, 2019, 11:00 Local	Registration:	N7302S
Aircraft:	Cessna 182	Aircraft Damage:	Substantial
Defining Event:	Loss of engine power (total)	Injuries:	1 Fatal, 2 Serious
Flight Conducted Under:	Part 91: General aviation - Personal

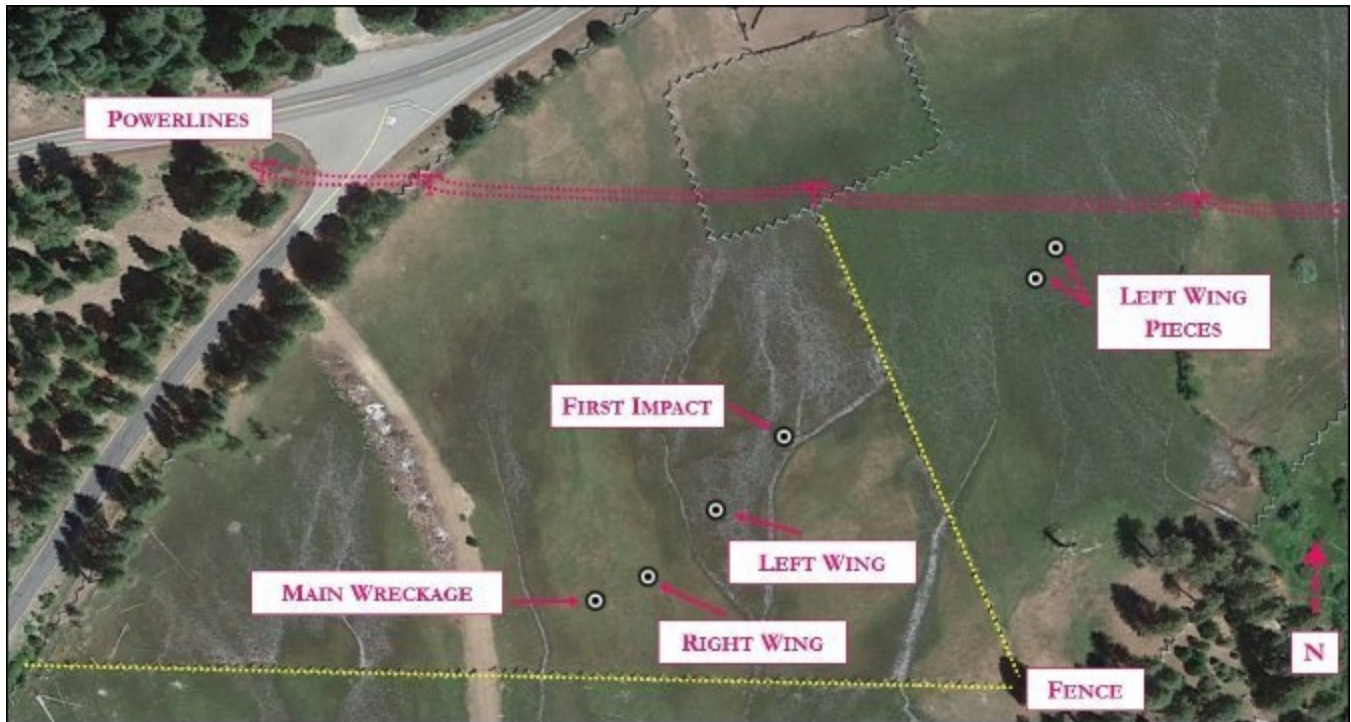
Figure 1. Accident Site

After rejecting his first selected field, the pilot turned the airplane toward a grassy meadow that was beyond trees. He planned to flare the airplane immediately after clearing the 4-ft fence that stretched northwest-southeast across the field. After the airplane passed over the treetops, he extended the flaps and continued toward the fence. The pilot suddenly saw powerlines immediately ahead and attempted to maneuver the airplane underneath them. The airplane contacted the wires and spun from the impact, coming to rest inverted (see Figure 1).

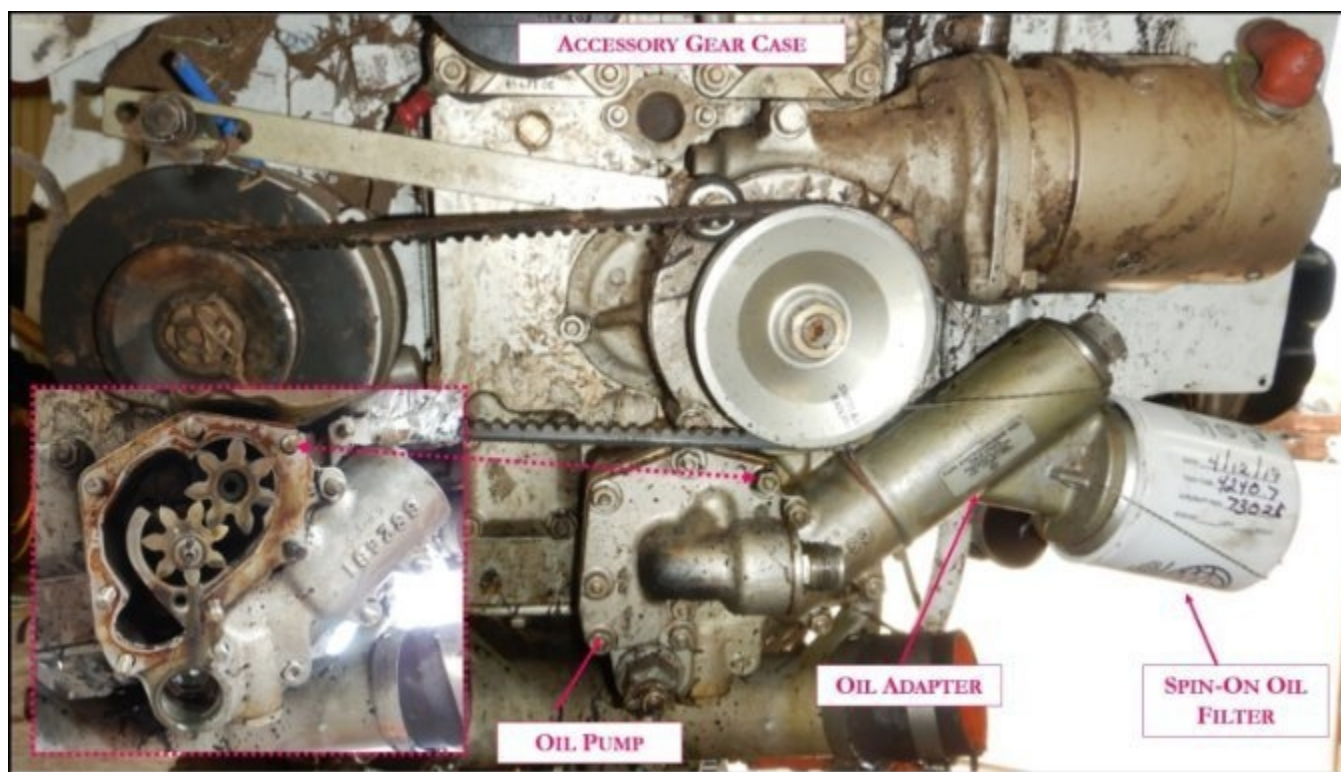
Figure 2. Accessory Gear Case Showing Location of Oil Filter Adapter

The purpose of the adapter was to enable the engine to use a conventional, spin-on oil filter. As manufactured, the oil pump was equipped with a brass oil screen mounted to the casing; the filter adapter used the oil screen bore to attach to the engine. The adapter included a tee casting (housing) and a hub (shaft), which was threaded into the oil screen hole on the engine's oil pump casting. The tee casting had a sleeve with a through-bore and a mounting base that accepted a spin-on oil filter. When installed, the shaft was journaled into the bore of the sleeve and screwed into the oil screen hole, which had two oil passage openings. A crown (1-inch bolt head) at the outboard end of the shaft secured the tee casting against the oil pump casing; a gasket was placed between the crown and the outboard surface of the sleeve's bore. Another gasket was placed between the oil pump casting and the inboard surface of the sleeve's bore. Oil inlet and oil outlet passages are provided through the hub and the tee casting to circulate oil from the oil screen hole into the spin-on filter, and back into the oil screen hole from the spin-on filter (see Figure 2).

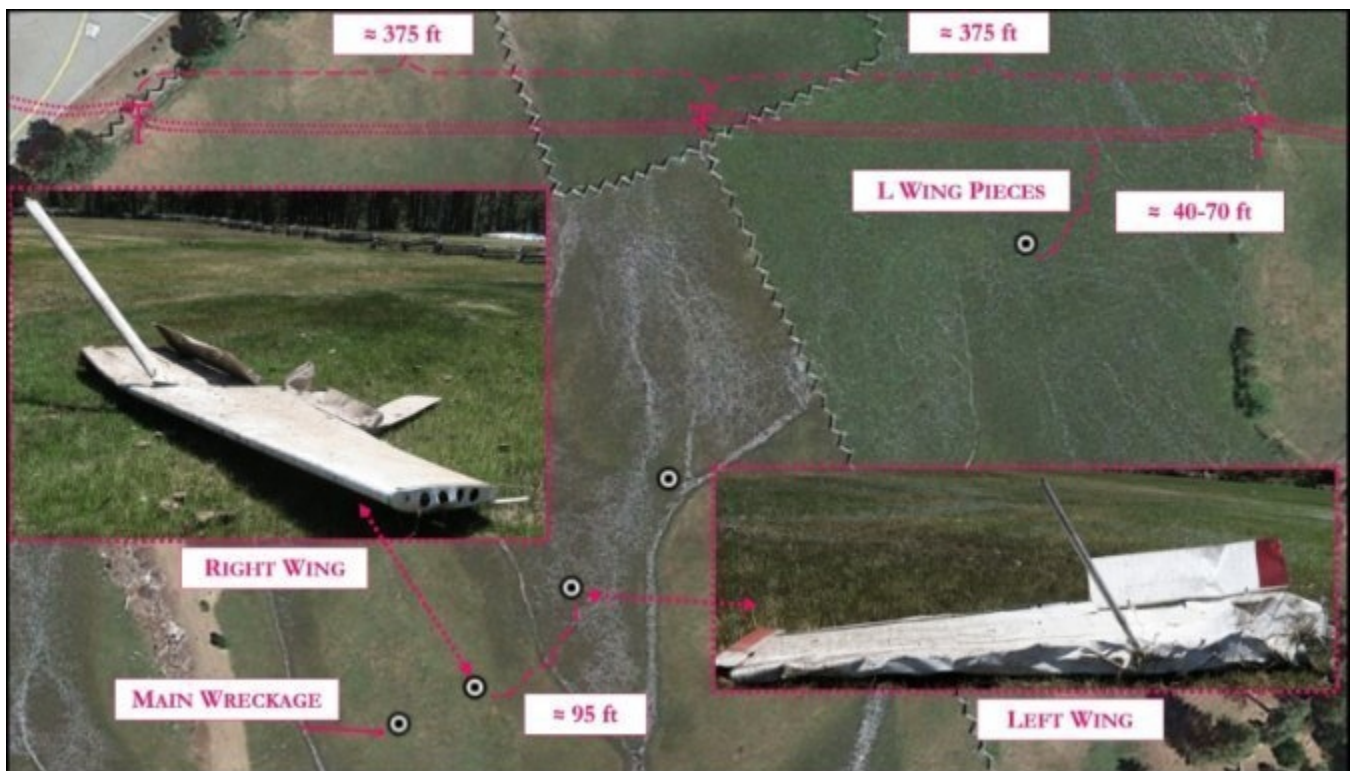
Figure 3. Accident Location Showing Debris Field

The first identified pieces of debris were pieces of the fairing from the left-wing strut located about 40 and 70 ft from the power lines. The towers supporting the lines were about 375 ft apart (see Figure 3). The first identified points of ground contact were two nearly parallel indentations in the vegetation and dirt spaced about 6 ft apart on the far northeastern end of the debris field. There were deep craters after the indentations and disrupted grass that continued southwest toward the main wreckage. The craters corresponded in size and orientation to that of the vertical stabilizer and rudder, consistent with the airplane impacting terrain inverted.

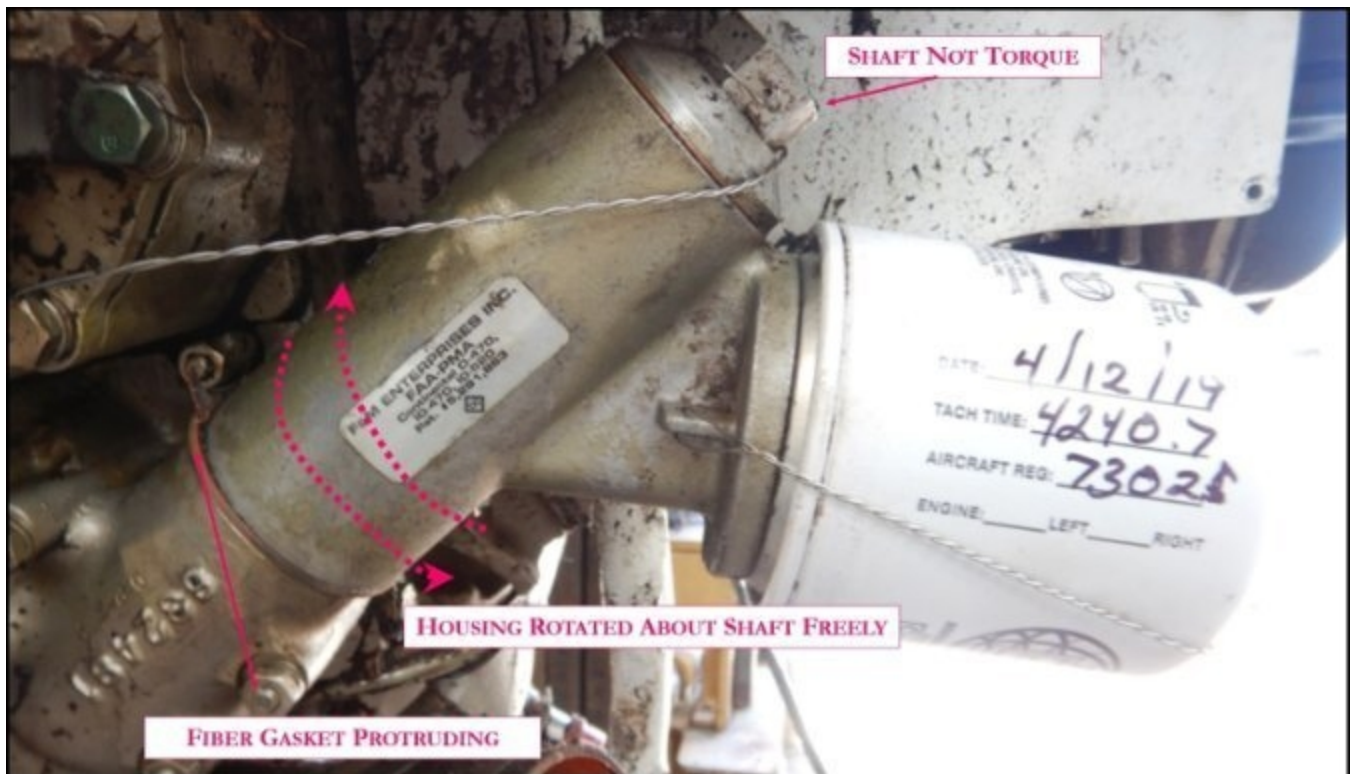
Postaccident examination revealed several holes in the engine crankcase. The oil filter adapter was found loose and the fiber gasket was protruding beyond the castings. Removal of the oil filter adapter revealed that the fiber gasket was split. The failure of the gasket allowed oil to exit the engine, resulting in oil starvation and the subsequent catastrophic failure.

Additional examination revealed that the oil filter adapter was loose, and the adapter housing could be rotated about the shaft (see Figure 4). The safety wire was removed and the breakaway torque of the adapter, which was required to be 65 foot-pounds (ft/lbs), was less than 20 ft/lbs and the housing could be rotated by hand with minimal effort.

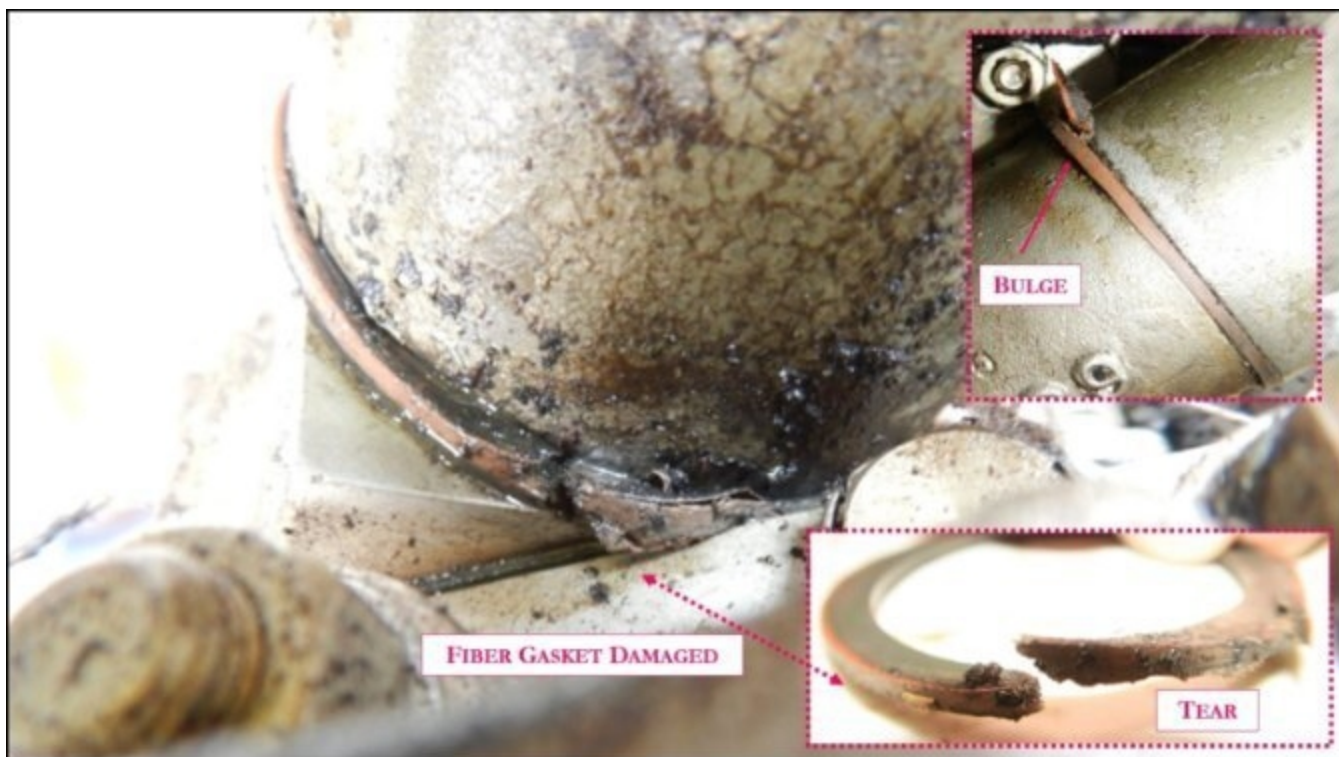
Figure 5. Fiber Gasket

A total loss of engine power due to oil starvation as a result of the failure of a gasket on the oil filter adapter and the pilot's inability to clear power lines during the emergency landing.

In response to this accident and related testing, Stratus Tool Technologies issued a Service Bulletin (SB), SB-001, dated October 25, 2019, that stated that the oil filter adapter should be inspected for oil leakage and gasket damage. If no discrepancies were found, the SB provided detailed instructions of how to install the adapter properly (eliminating rotation of the housing by use of a wood block) and how to mark the adapter to provide a visual indication of rotation after it is installed.
