Aviation Investigation Final Report

| Location: | Maple Lake, Minnesota | Accident Number: | CEN18LA237 |
| Date & Time: | June 22, 2018, 18:30 Local | Registration: | N736MM |
| Aircraft: | Zenith STOL CH701 | Aircraft Damage: | Substantial |

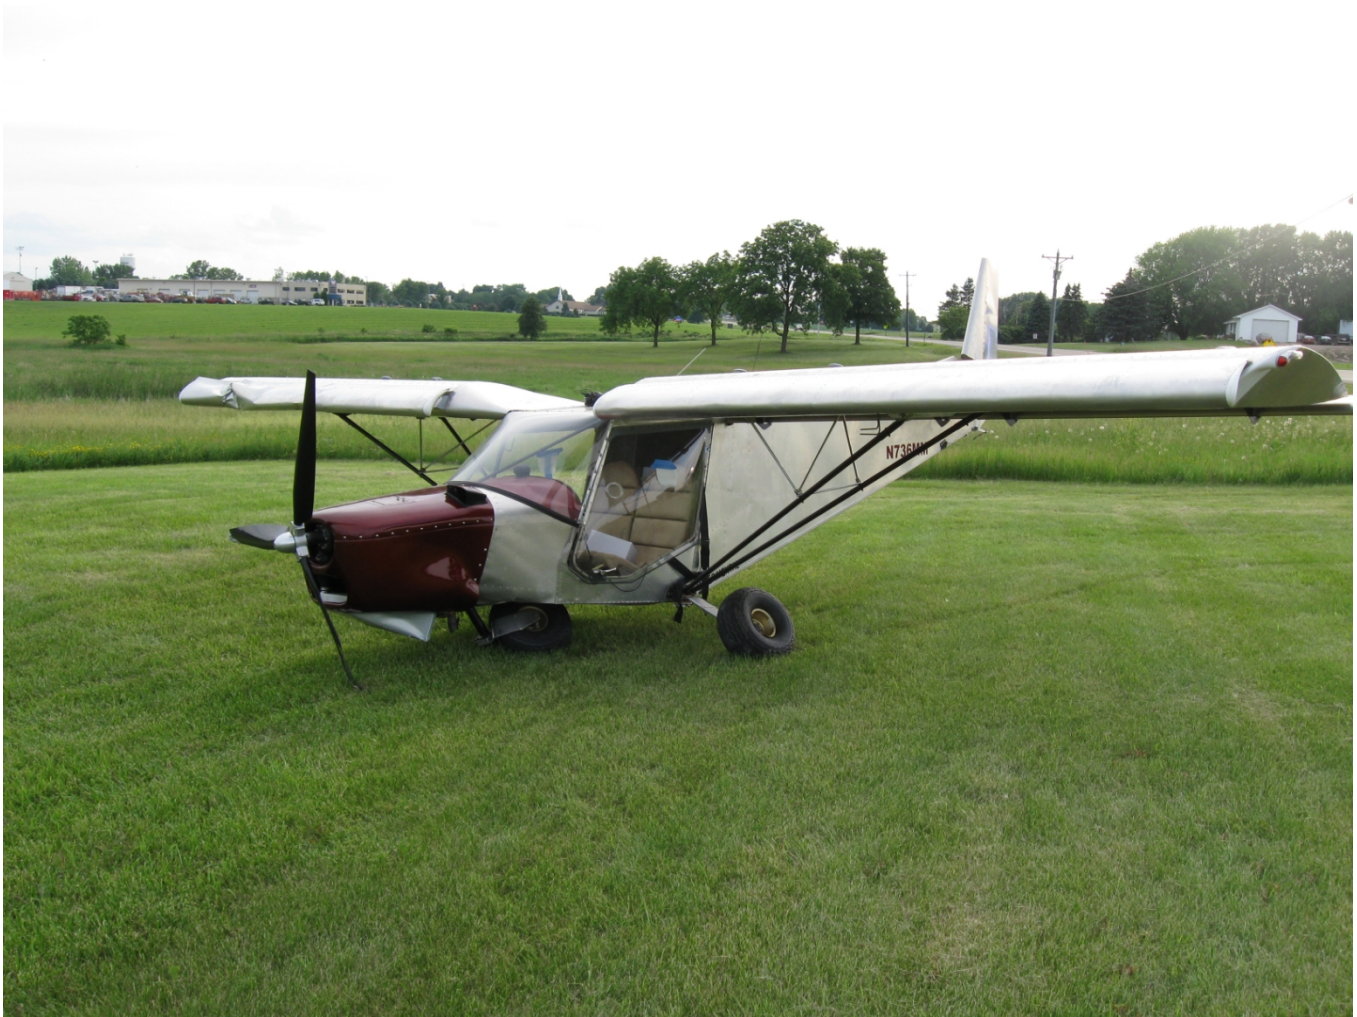
The pilot attempted to troubleshoot the engine failure by switching fuel tanks, turning the fuel boost pump on, and attempting a restart of the engine with no success. The pilot reported he decided to attempt a forced landing to runway 10. However, due to the presence of power lines that he would be unable to maintain clearance over, the pilot attempted a forced landing onto a road. The airplane landed about 20 ft short of the road and impacted a ditch. The airplane came to rest in a grass-covered field about 400 ft to the northwest of the runway threshold for runway 10, as shown below in figure 1. During the forced landing, the nosewheel collapsed resulting in substantial damage to the fuselage and the engine mount. The right wing sustained substantial damage from impacting a street sign.

Figure 1 – View of the front of the airplane (courtesy of the Wright County Sheriff's Office).
