Aviation Investigation Final Report

Location:	Amagansett, New York	Accident Number:	ERA18LA157
Date & Time:	June 2, 2018, 14:33 Local	Registration:	N41173
Aircraft:	Piper PA 31	Aircraft Damage:	Destroyed
Defining Event:	Loss of control in flight	Injuries:	4 Fatal
Flight Conducted Under:	Part 91: General aviation - Personal

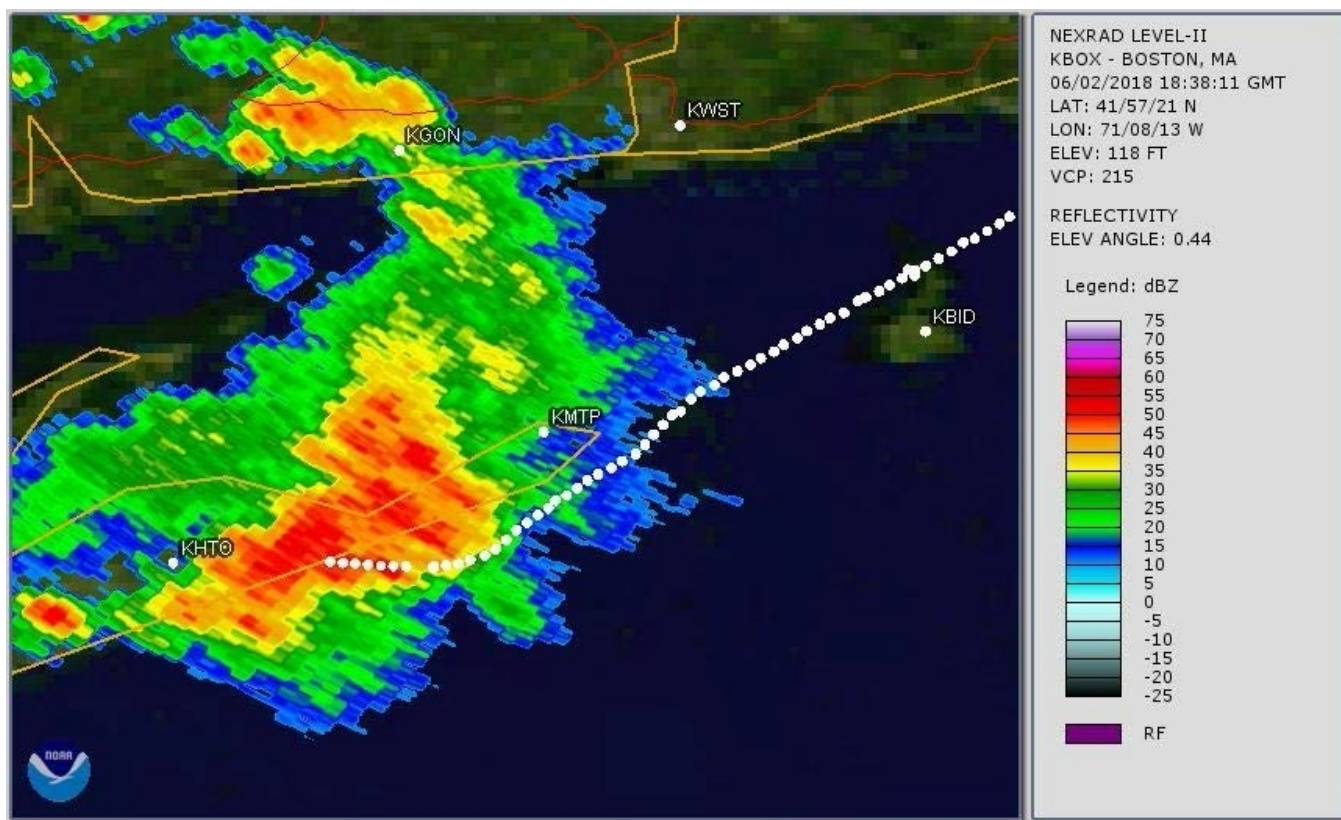
Figure 1: Boston WSR-88D Base Reflectivity Image at 1438 with flight track

Figure 1 depicts the accident airplane's flight track overlaid on the Boston WSR-88D base reflectivity image for 1438 (Echoes less than 10 dBZ have been removed from the image). The airplane's flight track entered the leading of the echoes with a maximum of 53 dBZ "extreme" intensity echoes with tops near 48,000 ft. Extreme intensity echoes over 50 dBZ extended between the accident site and HTO.
