# Aviation Investigation Final Report

<b>Location:</b>	Eagle Mountain, Utah	<b>Accident Number:</b>	WPR18FA186
<b>Date &amp; Time:</b>	June 28, 2018, 10:54 Local	<b>Registration:</b>	N320MF
<b>Aircraft:</b>	Cessna 320	<b>Aircraft Damage:</b>	Destroyed
<b>Defining Event:</b>	Aerodynamic stall/spin	<b>Injuries:</b>	1 Fatal
<b>Flight Conducted Under:</b>	Part 91: General aviation - Aerial observation

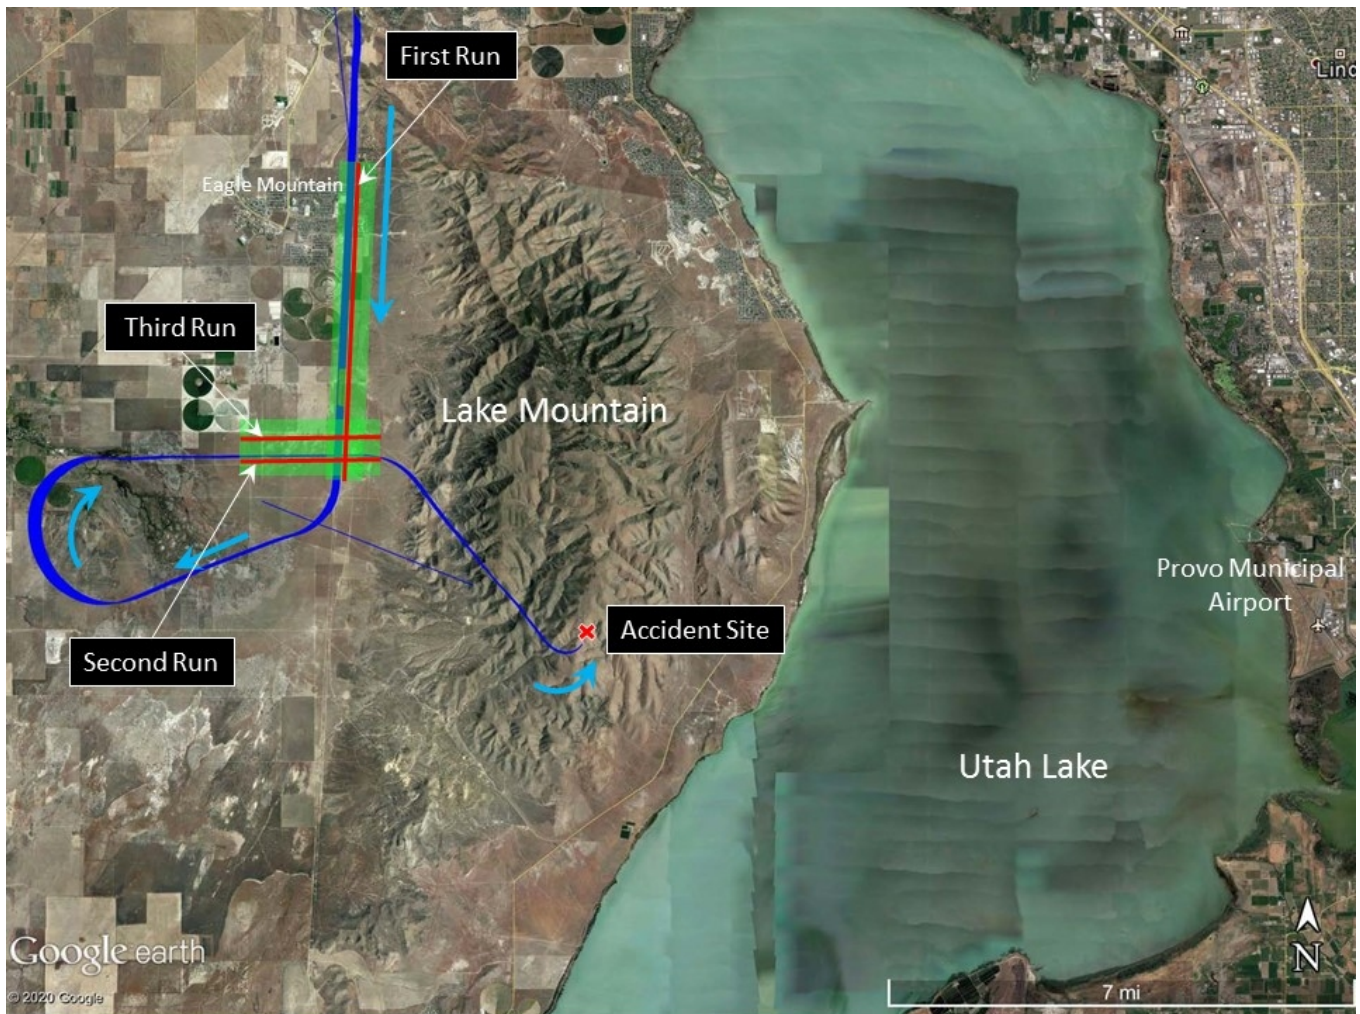
Figure 1-Flight data and highlighted photograph area.

The pilot was scheduled to perform aerial photography over level terrain located west of Lake Mountain. (See figure 1.) The elevation of the survey area was about 4,840 ft mean sea level (msl); Lake Mountain rises in elevation to about 7,600 ft. The pilot was to complete three photo runs before landing at Provo Municipal Airport (PVU), Provo, Utah for fuel. The planned altitude of the flight while conducting the photography was 7,255 ft msl. The route the photo runs are flown was determined by the pilot.

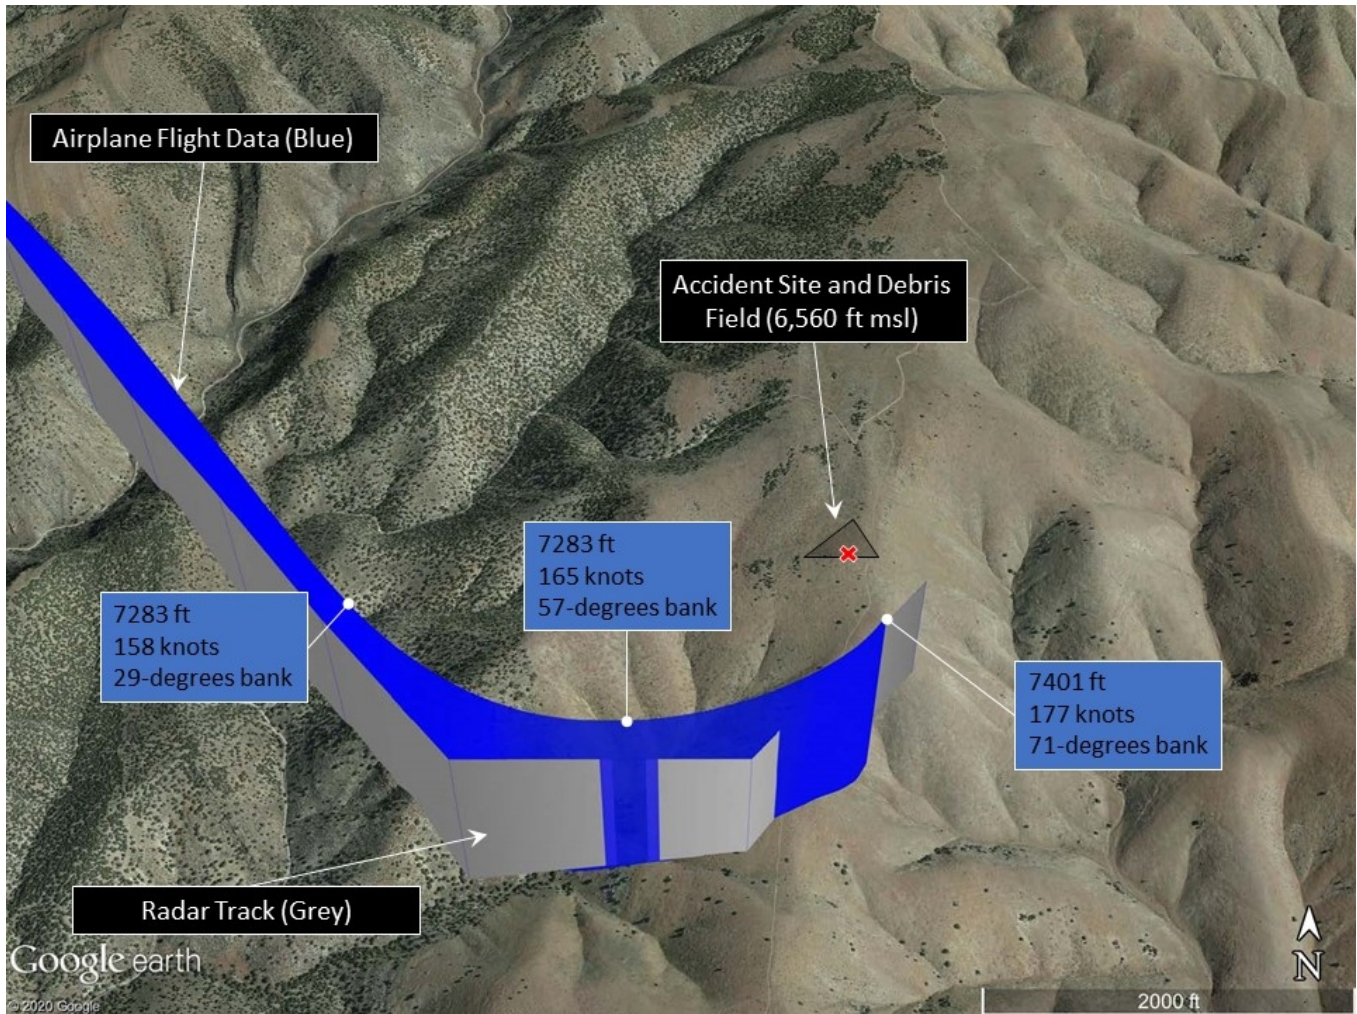
Figure 2-Radar track and airplane flight data.

The flight data showed the airplane at an altitude of 7,325 ft msl as it traveled east, then south along the west side of Lake Mountain, entering the first of three planned photo runs. The first run was about 5 miles long. After exiting the first run, the airplane departed the area to the southwest, then continued the right turn until reaching an easterly heading. The second run was entered from the west and was about 2 miles long, ending near the foothills of Lake Mountain. The pilot conducted the second run with a groundspeed between 169 and 194 knots at an altitude of 7,325 ft msl. Following the second run, the airplane reached the foothills of Lake Mountain and turned right to a southeasterly heading. The third run was similar to the second run and was not flown. As the airplane headed southeast, the groundspeed decreased to about 152 knots while its altitude remained constant, about 7,300 ft msl. About 1/2 nautical mile west of the accident site, the airplane entered a left turn. During the turn, the airplane's bank angle increased, its groundspeed increased from 158 kts to 177 kts, and its altitude increased from 7,283 ft to 7,401 ft msl. The last data point was located 840 ft above and about 1/4 mile south of the accident site and depicted the airplane in a 71° bank. (see figure 2)

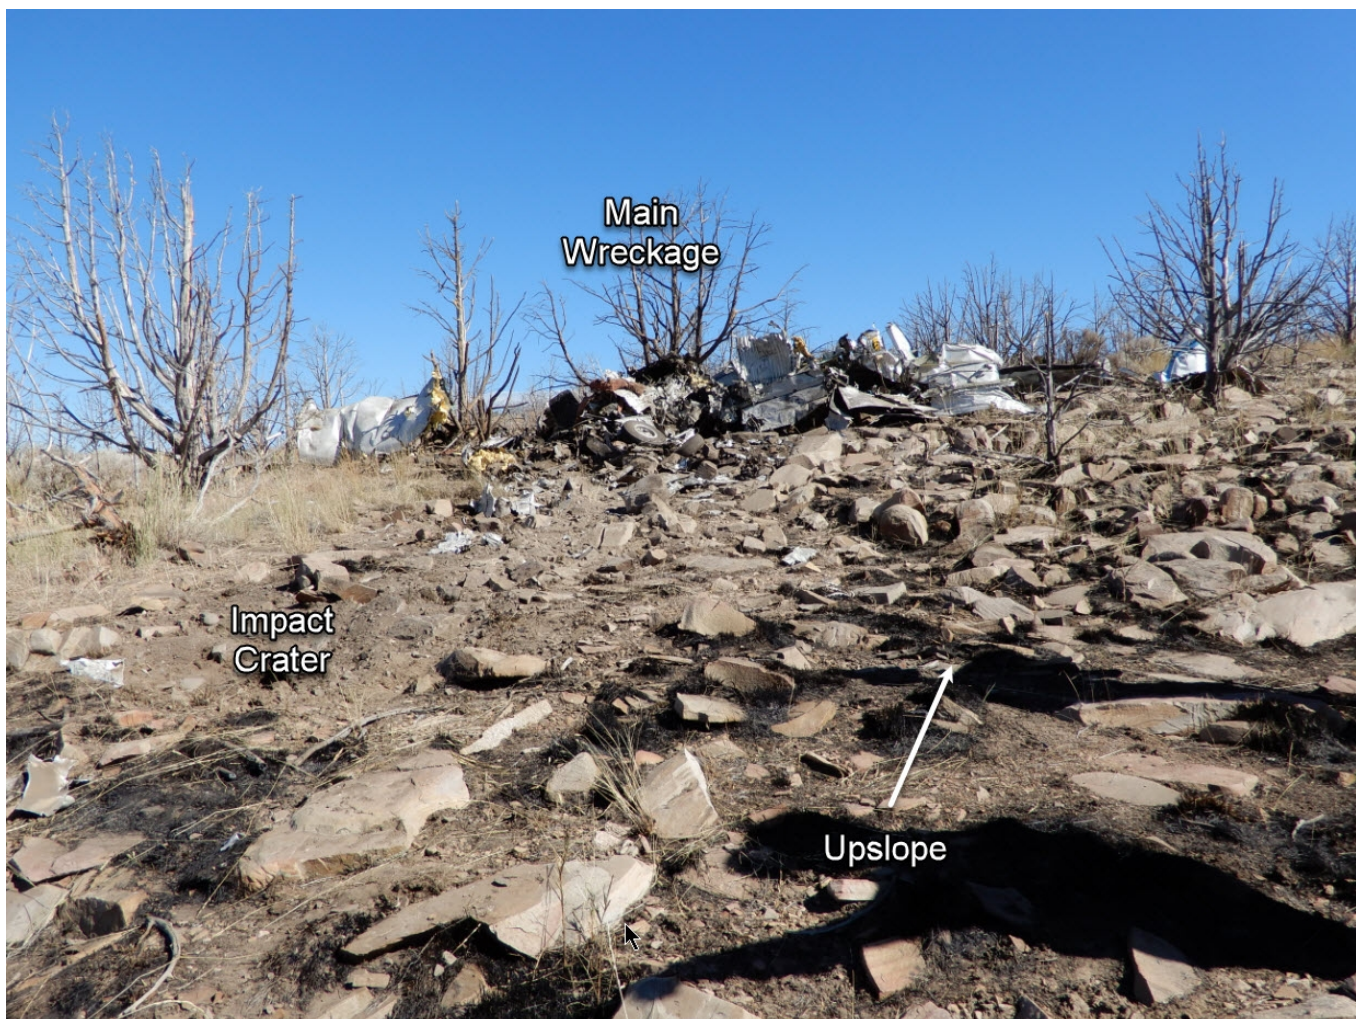
Figure 3-Accident site.

Examination of the accident site revealed that the airplane impacted mountainous terrain at an elevation of 6,560 ft msl, in a near-vertical nose down attitude. The debris field was about 470 ft wide and about 240 ft long and was oriented on a heading of about 350° magnetic. The main wreckage comprised of both wings, the cabin area, and empennage. The engines separated from the main wreckage and were found further up the debris field. The engines sustained substantial damage and parts from the engine were scattered throughout the debris field. (See figure 3.)

The first identified point of contact (FIPC) was a small crater measuring about 4 ft wide and about 6 inches deep. Upslope from the FIPC was an area of disturbed rock and dirt about 4 ft wide, extending about 37 ft to the main wreckage. Contained within the area of disturbed rock and dirt was another shallow crater, about 5 ft from the FIPC, that was saturated with oil and contained a separated propeller blade. Propeller blades from both engines were separated from the propeller hubs and located throughout the debris field. The propeller blades had separated tips and heavy gouging.
