Aviation Investigation Final Report

Location:	Burnet, Texas	Accident Number:	WPR18FA201
Date & Time:	July 21, 2018, 09:15 Local	Registration:	N47HL
Aircraft:	Douglas DC3	Aircraft Damage:	Destroyed
Defining Event:	Loss of control in flight	Injuries:	6 Serious, 1 Minor, 6 None
Flight Conducted Under:	Part 91: General aviation

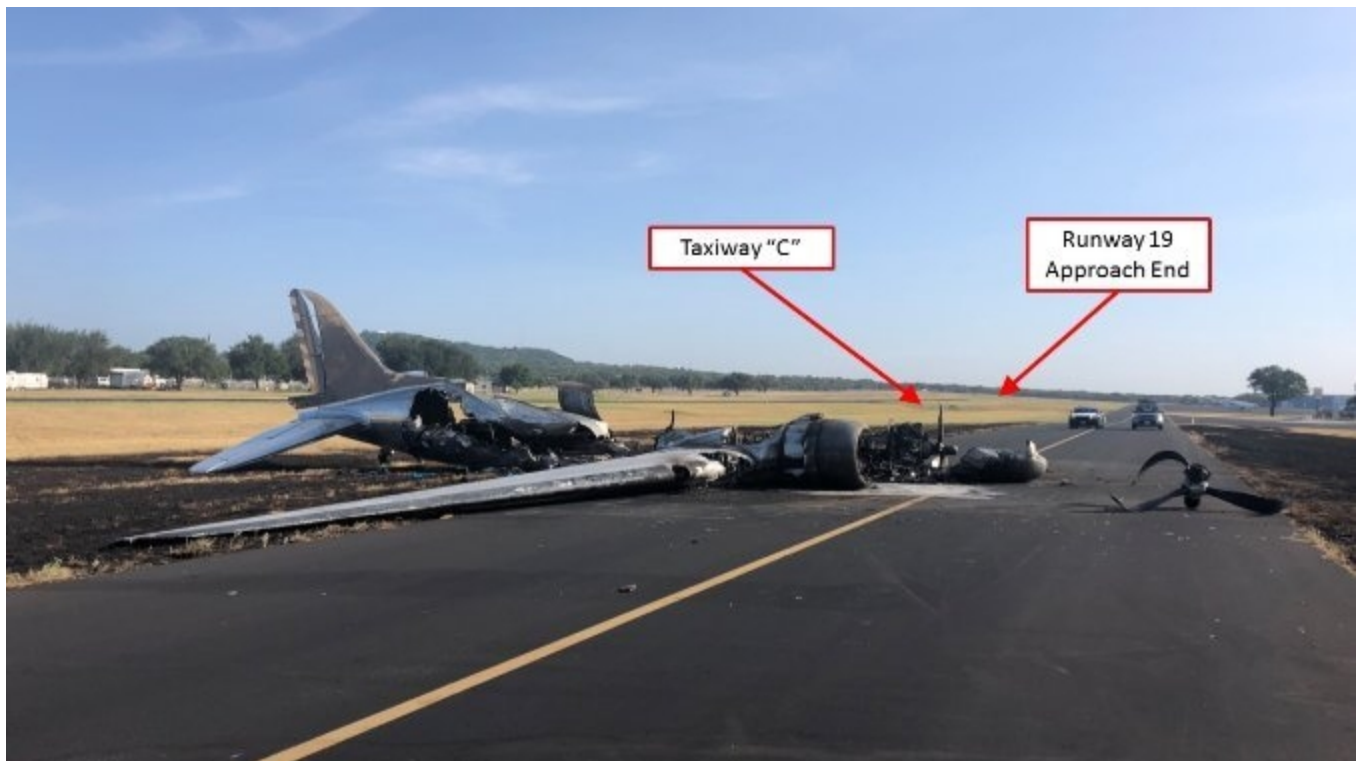
Examination of the accident site revealed that the airplane came to rest upright on a heading about 113° magnetic, about 145 ft east of the left side of runway 19, partially on the taxiway. (Figure 1)

Figure 1. A photograph showing the main wreckage in relation to runway 19 and taxiway C.
