Aviation Investigation Final Report

Location:	West Columbia, South Carolina	Accident Number:	ERA18LA213
Date & Time:	July 25, 2018, 13:41 Local	Registration:	C-GRFF
Aircraft:	Piper PA46	Aircraft Damage:	Substantial
Defining Event:	Course deviation	Injuries:	2 None
Flight Conducted Under:	Part 91: General aviation - Personal

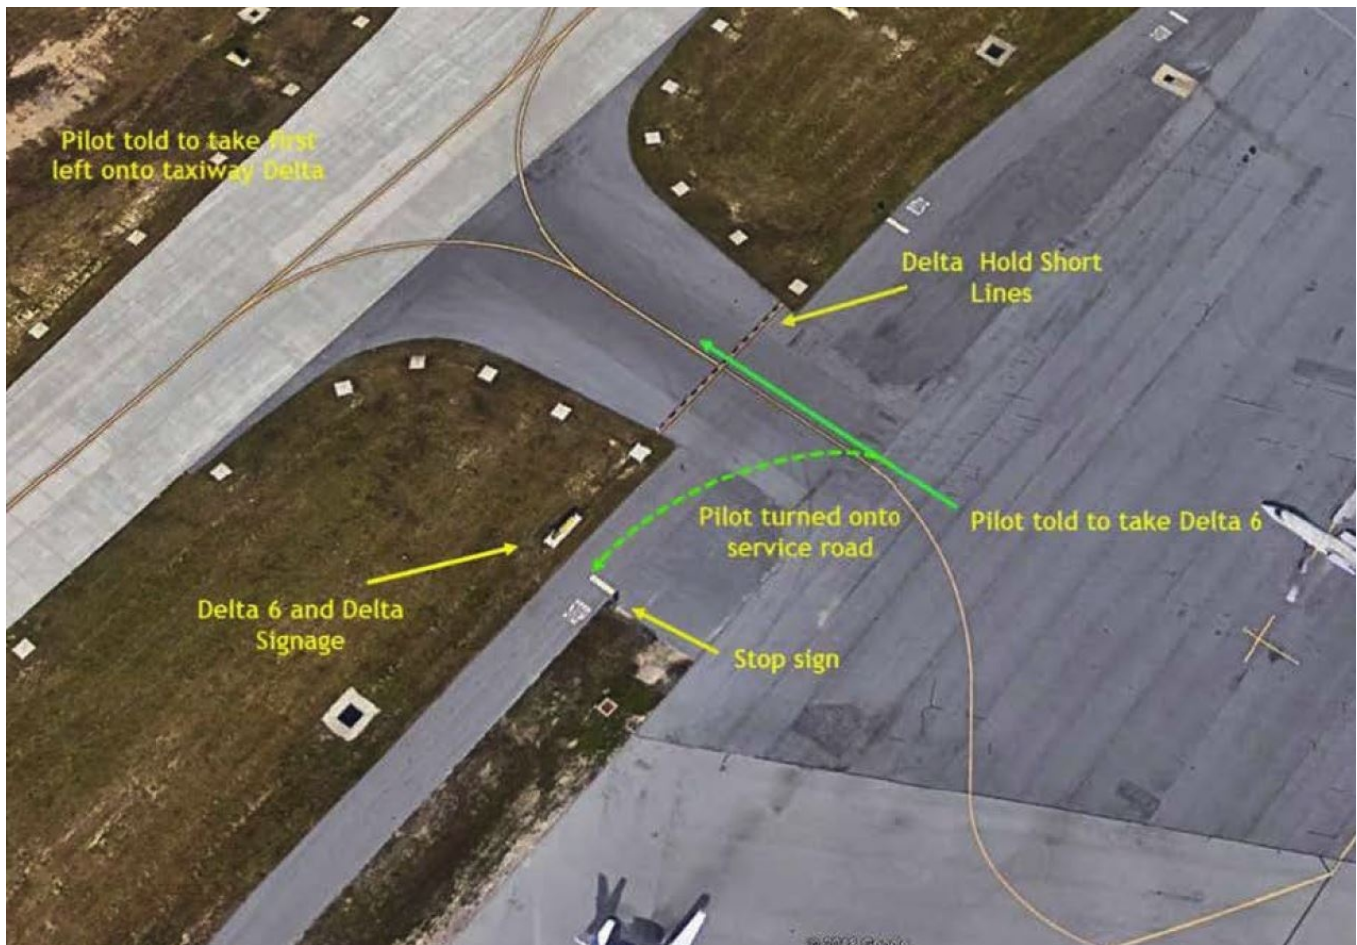
The pilot's inadvertent navigation onto a service road instead of a taxiway, which resulted in a collision with a stop sign.

Examination of an aerial images and photos of the area where the airplane struck the stop sign revealed that the airplane was taxiing from an aircraft parking ramp area toward a perpendicular taxiway (Delta). A vehicle service road ran parallel to taxiway Delta, and both were intersected by taxiway Delta 6 (see Figure 1). A centerline was painted on the ramp area that transitioned through taxiway Delta 6 and onto taxiway Delta. There was no taxiway centerline painted on the service road. The stop sign was located in a grassy area adjacent to the service road.

Figure 1 – Annotated aerial photograph of the area where the airplane was taxiing.
