# Aviation Investigation Final Report

<b>Location:</b>	Sioux Falls, South Dakota	<b>Accident Number:</b>	CEN19LA049
<b>Date &amp; Time:</b>	December 25, 2018, 17:03 Local	<b>Registration:</b>	N6745V
<b>Aircraft:</b>	Beech 58	<b>Aircraft Damage:</b>	Destroyed
<b>Defining Event:</b>	Aerodynamic stall/spin	<b>Injuries:</b>	2 Fatal
<b>Flight Conducted Under:</b>	Part 91: General aviation - Personal

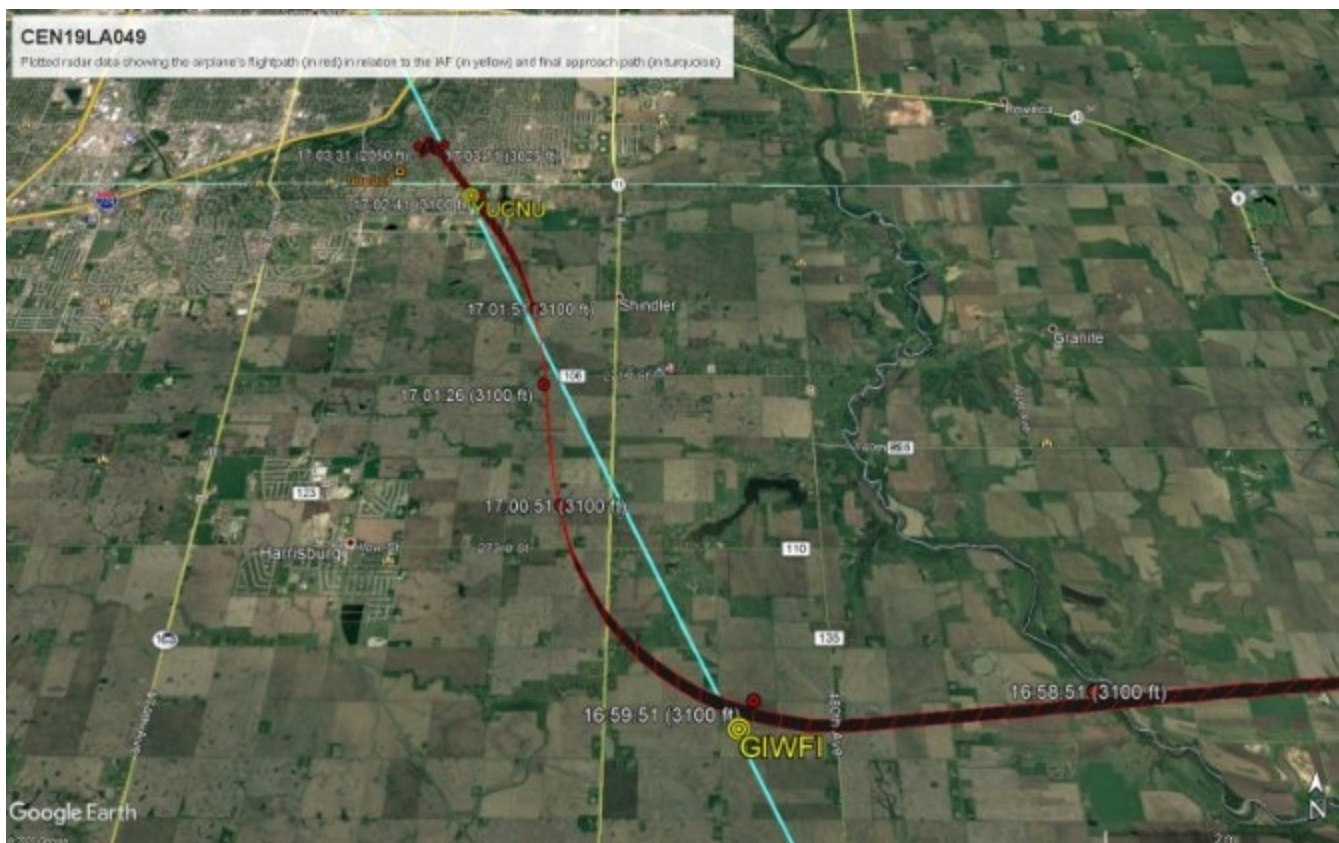
A review of the airplane’s flight track showed the pilot making S-turns across the approach course, which is consistent with the pilot hand-flying the approach, not a coupled autopilot approach. Therefore, it is unlikely that the pilot was flying the instrument approach using the autopilot system. Further, although the autopilot system could not be functionally tested due to impact and fire damage, it is unlikely that the autopilot system played a role in the accident if it was not in use.

Therefore, based on the radar data, it is likely that the pilot failed to maintain adequate airspeed during the final approach, which resulted in the exceedance of the airplane’s critical angle of attack and a subsequent aerodynamic stall. Given the witness account and surveillance video, it is likely the pilot was attempting to recover from the stall but did not have adequate altitude to do so.

At 1659:41, the airplane was at 3,100 ft msl and 156 KCAS as it turned toward the final approach path just inside the GIWFI IAF. The airplane then began to slow in airspeed and proceeded west of the final approach centerline, turned back through the extended centerline to the east, and then made a left turn back through the centerline to the west. (See figure 1 for plotted radar data showing the airplane's flightpath in relation to the IAF and final approach path.) At 1701:26, as the airplane crossed the approach path back to the east, the controller cleared the airplane to land on runway 33; the airplane began to descend at 1703:10. At 1703:16, the airplane was at 3,000 ft msl about 78 KCAS. Shortly thereafter, the airplane began to rapidly descend, turning sharply left until the data ended at 1703:31. At 1703:33, the controller issued a low-altitude alert and advised the pilot to check the airplane's altitude immediately. No other recorded communications were received from the pilot.

**Figure 1.** Plotted radar data showing the airplane's flightpath (in red) in relation to the IAF (in yellow) and final approach path (in turquoise).
