Aviation Investigation Final Report

Location:	Gainesville, Texas	Accident Number:	CEN17LA105
Date & Time:	February 21, 2017, 00:20 Local	Registration:	N6343L
Aircraft:	American Aviation AA 1A	Aircraft Damage:	Substantial
Defining Event:	Fuel exhaustion	Injuries:	1 Serious, 1 Minor
Flight Conducted Under:	Part 91: General aviation - Personal

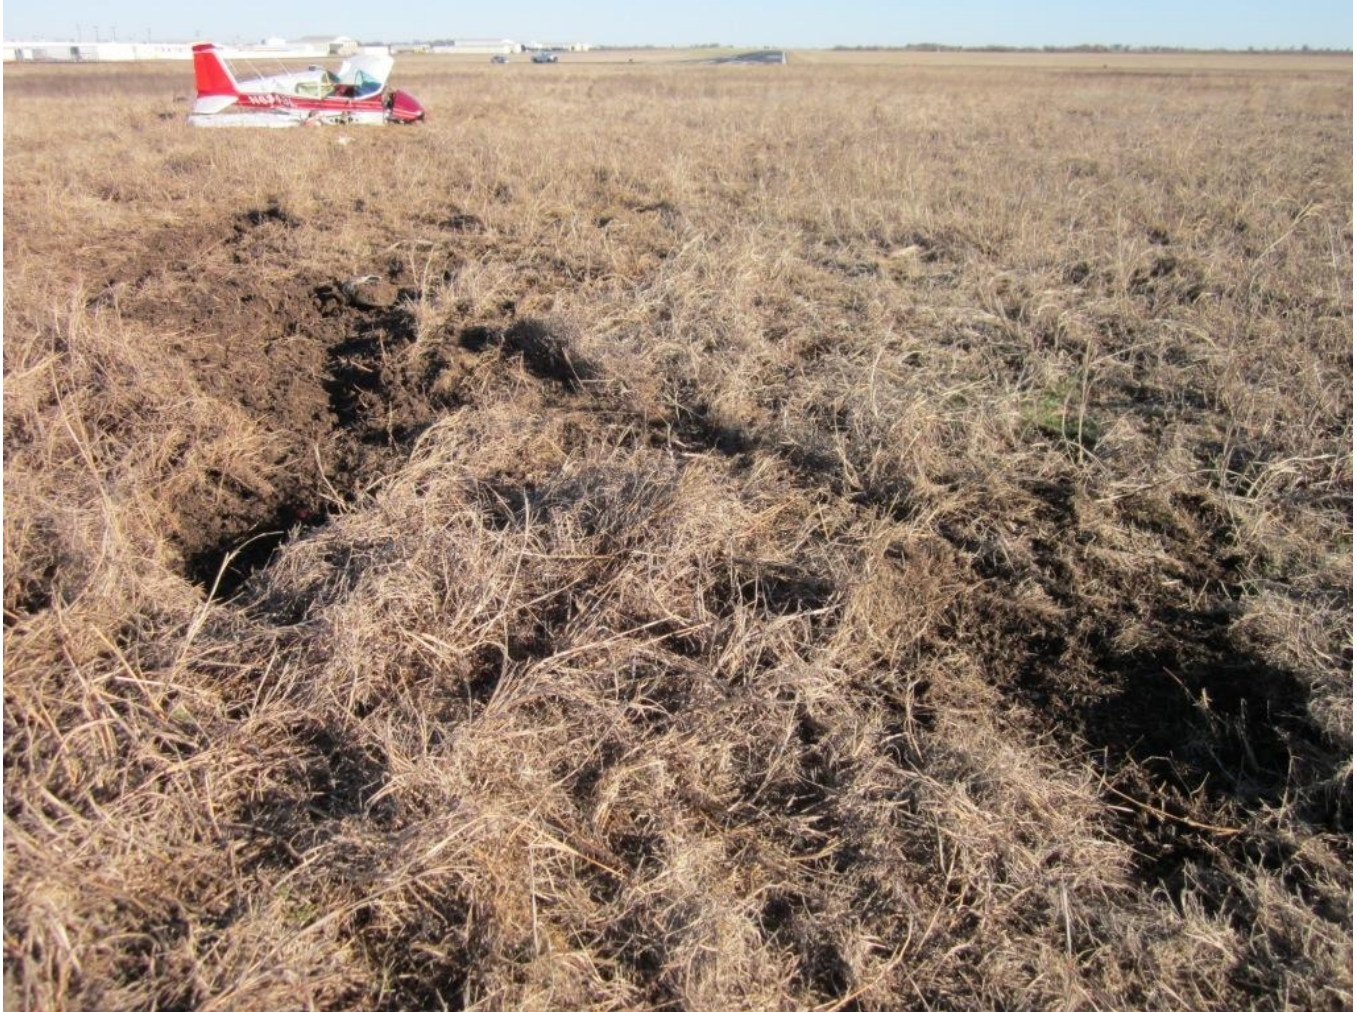
Figure 1 – Accident site

The Federal Aviation Administration (FAA) inspector spoke with the pilot on the phone, who stated that the passenger had recently purchased the airplane. The passenger, who was not a certificated pilot, asked the pilot to fly with him on a familiarization flight. They departed DTO and reportedly completed about 15 touch-and-go landings at North Texas Regional Airport (GYI), Sherman/Denison, Texas. They then departed GYI for GLE to get additional fuel for the airplane. They approached GLE from the north and intended to land on runway 18. During the final descent, the pilot, who claimed to be flying the airplane, observed a coyote on the runway, so he executed a go-around. During the go-around, the pilot stated that the engine lost power and he made a 180° turn back toward the runway because he did not want to land on the highway. The pilot did not remember in which direction the turn was made. The airplane was not able to make the runway, so the pilot made a forced landing to a field (figure 1).

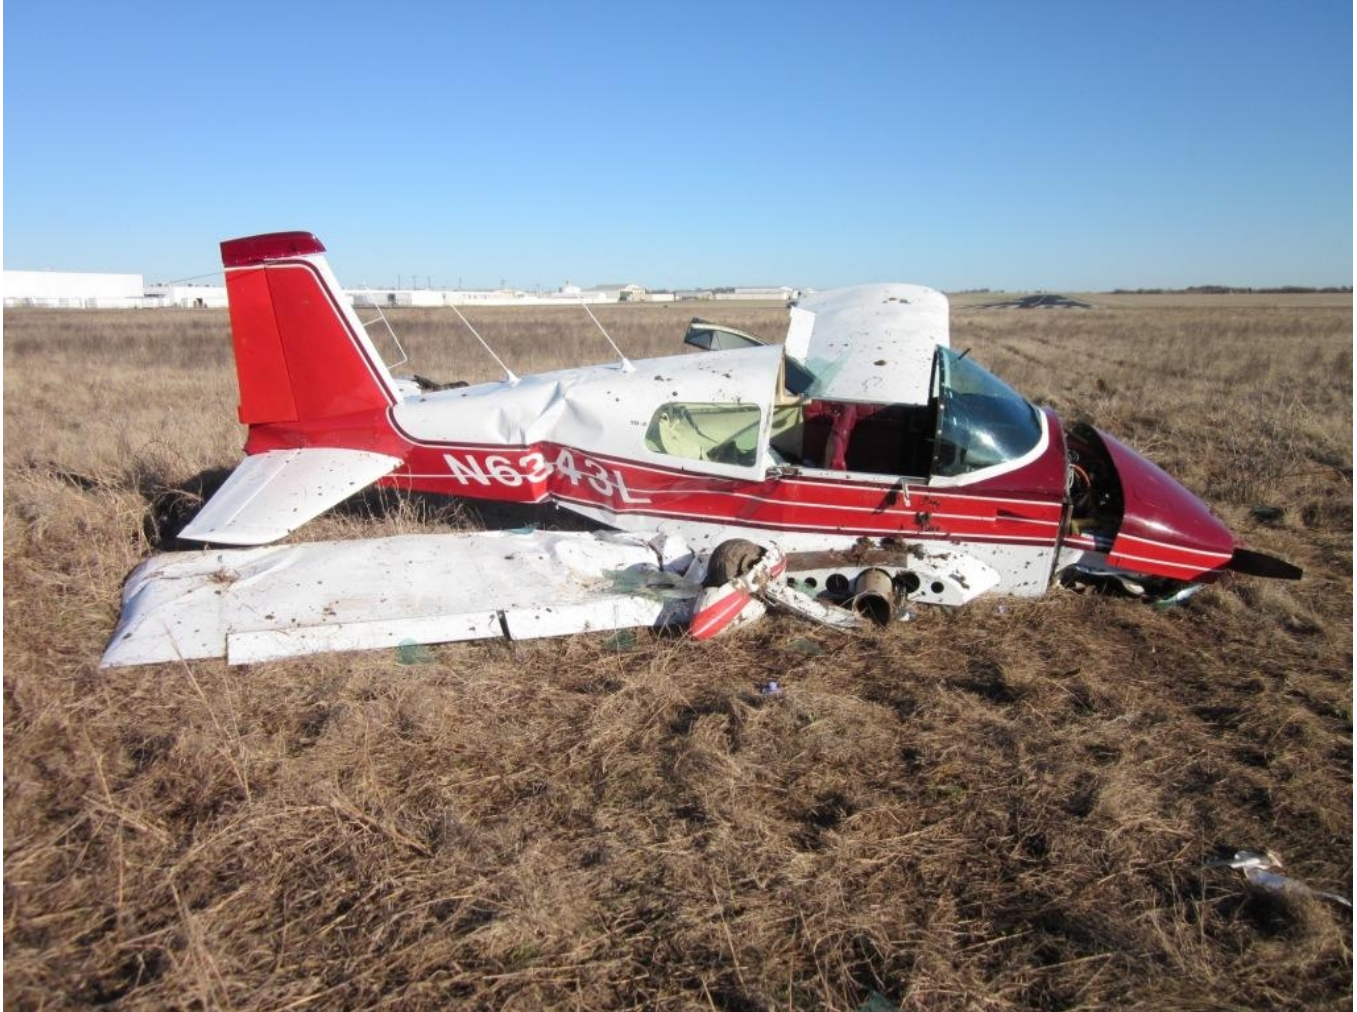
Figure 2 – Accident airplane right side

The airplane came to rest upright facing east in a field about 150 yards south of runway 36 at GLE and was slightly right of the runway's extended centerline (figure 2). The initial impact point and subsequent debris path was oriented toward the northwest. One propeller blade was bent aft near mid span and the other blade was straight and unremarkable. The right wing had separated from the fuselage, folded upside down, and twisted aft toward the empennage. The right-side fuel lines to the wing were separated and no fuel was observed in the right wing fuel tank. The left wing remained attached to the fuselage. The FAA inspector drained the left fuel tank sump drain, which contained a few tablespoons of dirty liquid.

The airplane was recovered by a wreckage retrieval company. When the left wing was removed for transport, there was less than one cup of fuel recovered from the left fuel tank. The ring wing tank was completely empty.
