# Aviation Investigation Final Report

<b>Location:</b>	Paramus, New Jersey	<b>Accident Number:</b>	ERA19LA062
<b>Date &amp; Time:</b>	December 9, 2018, 12:15 Local	<b>Registration:</b>	N5756W
<b>Aircraft:</b>	Mooney M20K	<b>Aircraft Damage:</b>	Substantial
<b>Defining Event:</b>	Loss of engine power (total)	<b>Injuries:</b>	2 Minor, 2 None
<b>Flight Conducted Under:</b>	Part 91: General aviation - Personal

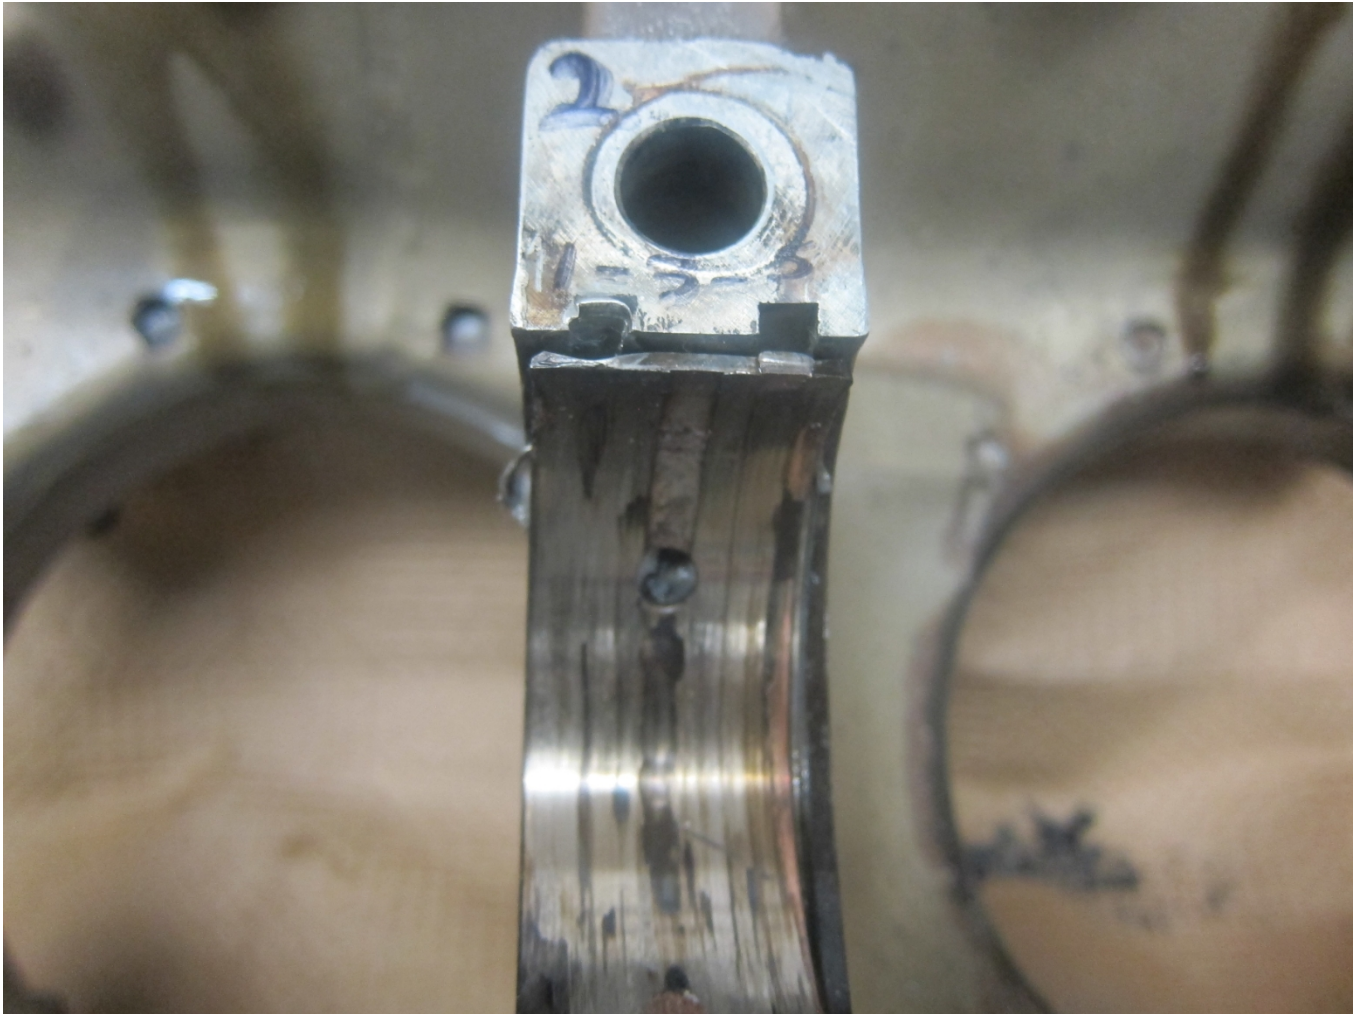
Postaccident examination of the engine revealed that the Nos. 1 and 2 connecting rods exhibited thermal discoloration consistent with a loss of lubrication. Additionally, the breakaway torques measured at 8 of the 12 through-bolts showed that they were below the manufacturer's specifications. The No. 2 main bearing saddles exhibited impingement damage, and the No. 2 bearing was partially rotated clockwise, which blocked the oil passages leading to the connecting rod bearings. The mating surfaces of the main bearing saddles had remnants of silk thread around the through-bolt holes, which was contrary to manufacturer guidance that prohibited placing silk thread in these areas. Given this information, it is likely that maintenance personnel applied silk thread to a prohibited area during an engine overhaul that occurred about 255.8 flight hours before the accident. This resulted in a loss of torque on the crankcase through-bolts, which allowed the No. 2 main bearings to shift, resulting in restriction of lubrication to that area and subsequent engine failure.

The engine was examined at the manufacturer's facility under NTSB supervision. The examination revealed that the engine case was breached over the No. 2 cylinder. The oil sump was removed and metallic debris was noted. The oil filter was removed and disassembled, and metal was noted in the filter. The oil pump was examined and scoring was noted inside the pump housing. The crankcase was split and the No. 1 connecting rod was separated from the crankshaft, and the Nos. 1 and 2 connecting rods exhibited thermal discoloration. Further examination of the mating surfaces of the main bearing saddles had remnants of silk thread around the through-bolt holes (see figure 1).

Figure 1. View of No. 2 main bearing saddle and No. 2 main bearing. Note remnants of silk thread.

The break-away torque was measured for the through-bolts on the engine. Eight out of the 12 through bolt torque values were below the manufacturer's recommended torque values as can be seen in the engine teardown report in the public docket associated with this case. The through bolts associated with the Nos. 2 and 3 main bearings and measured between 172 in-lbs and 395 in-lbs, which was below the manufacturer specification of 590-610 in-lbs of torque. The No. 2 main bearing saddles exhibited impingement damage and the No. 2 bearing was partially rotated clockwise, which blocked the oil passage to the connecting rod bearings.

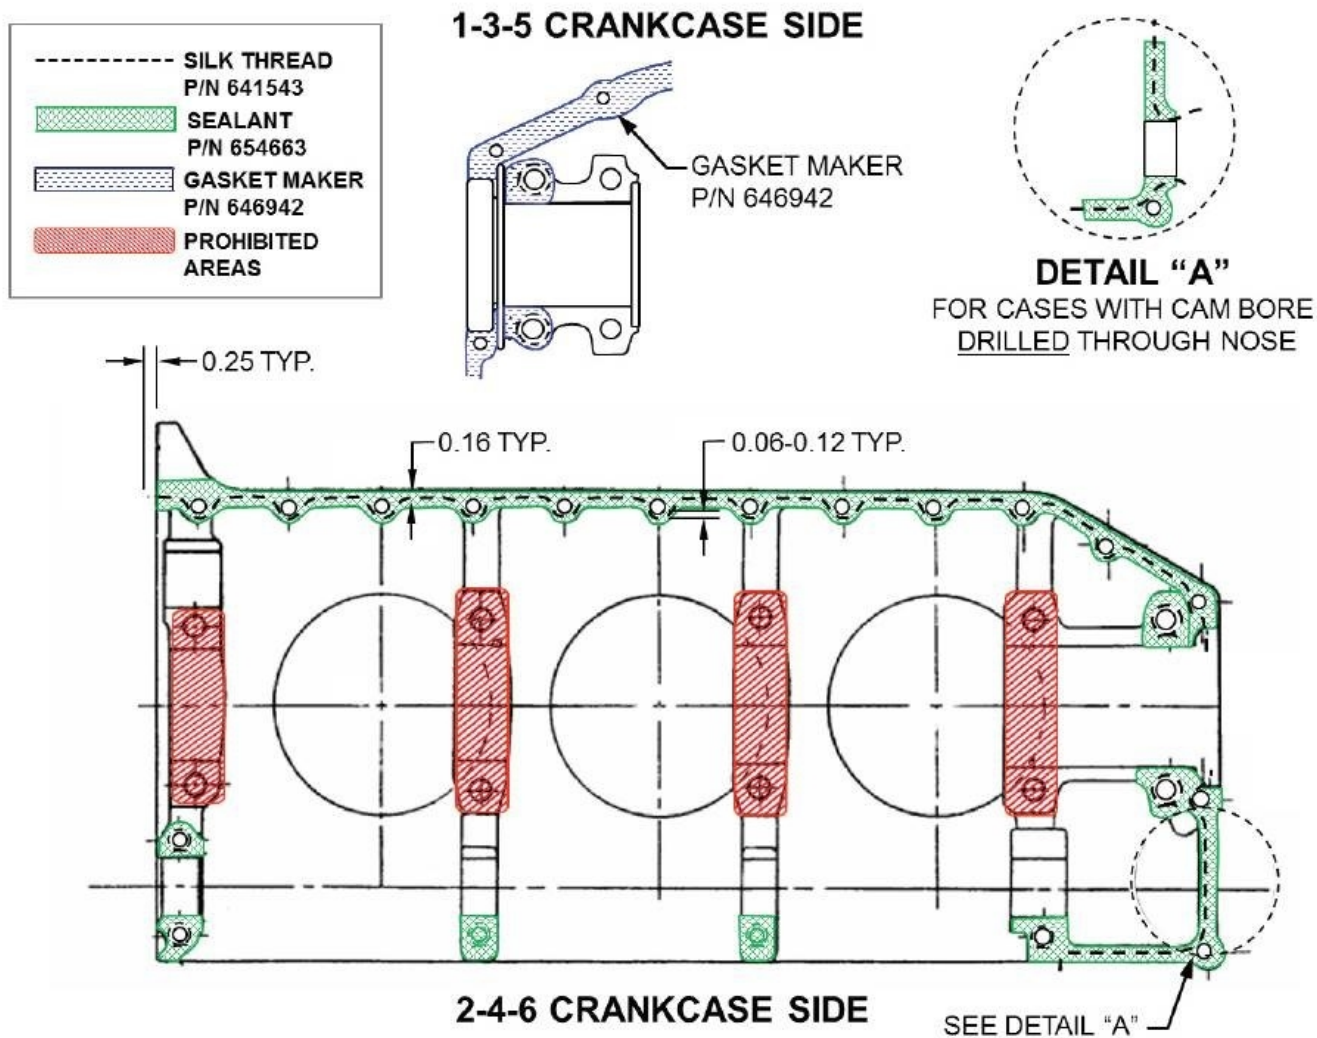
The engine manufacturer published a Service Information Letter (SIL) titled "Sealants, Lubricants, and Adhesives Authorized by CMI" in 1999 (revised September 16, 2014). This guidance, which was applicable at the time of the accident engine's overhaul stated that the when reassembling the crankcase halves, maintenance personnel should *"...apply and position P/N 641543 (a continuous, single piece of grade 'D' silk thread on the 2-4-6 case half as specified (see Figures 5 through 8...)). Ensure the free ends of your thread are covered by gaskets (except the nose oil seal)." Figure 2 below is from the SIL, and shows that the #2 main bearing saddle was one of four "prohibited" areas where silk thread should not be placed.*

Figure 2 – Areas where silk thread application is prohibited noted in red, which include the No. 2 main bearing saddle.
