# Aviation Investigation Final Report

<b>Location:</b>	Hollywood, Florida	<b>Accident Number:</b>	ERA16FA309
<b>Date &amp; Time:</b>	September 3, 2016, 09:50 Local	<b>Registration:</b>	N6091E
<b>Aircraft:</b>	Cessna 172	<b>Aircraft Damage:</b>	Destroyed
<b>Defining Event:</b>	Windshear or thunderstorm	<b>Injuries:</b>	2 Fatal
<b>Flight Conducted Under:</b>	Part 91: General aviation - Personal

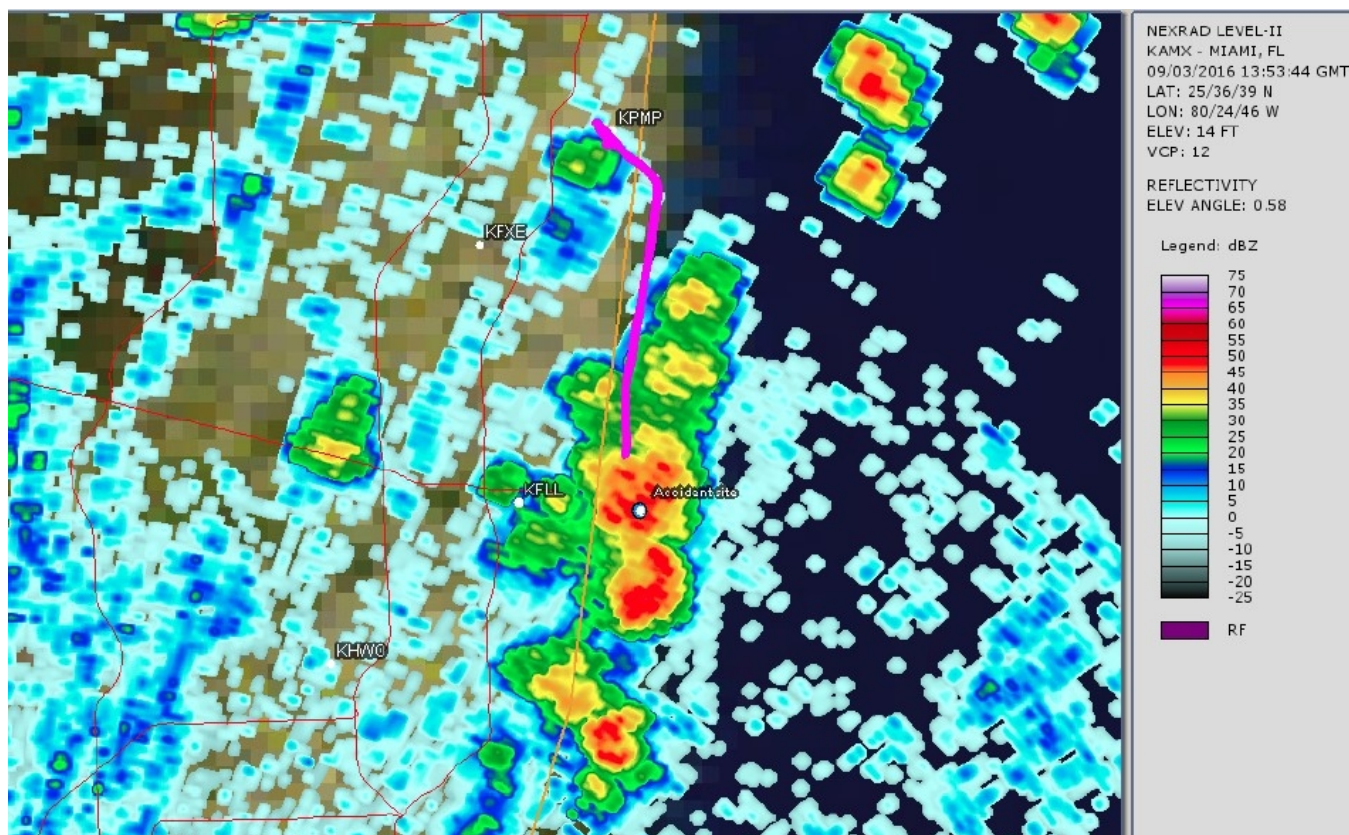
The National Weather Service Miami (KAMX) Weather Surveillance Radar – 1988, Doppler (WSR-88D) was operating in the severe storm precipitation mode surrounding the time of the accident. KAMX WSR-88D composite reflectivity images at 0938, 0943, 0948, and 0953 depicted a band of heavy-to-extreme intensity echoes along the southeast Florida coast and immediately east of FLL during the period, with the echoes in the immediate vicinity of the accident site reaching maximum intensity and then decreasing in intensity with time and moving north-northeastward. The lowest 0.5°-elevation scan depicted the conditions immediately above the airplane between 870 to 3,220 ft and depicted echoes between 40 to 52 dBZ (heavy-to-extreme intensity). Overlaying the airplane's GPS track on the 0953 0.5°-base reflectivity image (see figure 1) indicated that the airplane traveled into a small but intense reflectivity core of 51dBZ (extreme intensity) precipitation.

Figure 1 - KAMX WSR-88D Composite Reflectivity Image at 0953 with the airplane's 0950 GPS-derived position superimposed in magenta.
