Aviation Investigation Final Report

Location:	La Porte, Texas	Accident Number:	CEN18FA267
Date & Time:	July 15, 2018, 09:00 Local	Registration:	N3135J
Aircraft:	Kolb Twinstar	Aircraft Damage:	Substantial
Defining Event:	Aerodynamic stall/spin	Injuries:	2 Fatal
Flight Conducted Under:	Part 91: General aviation - Personal

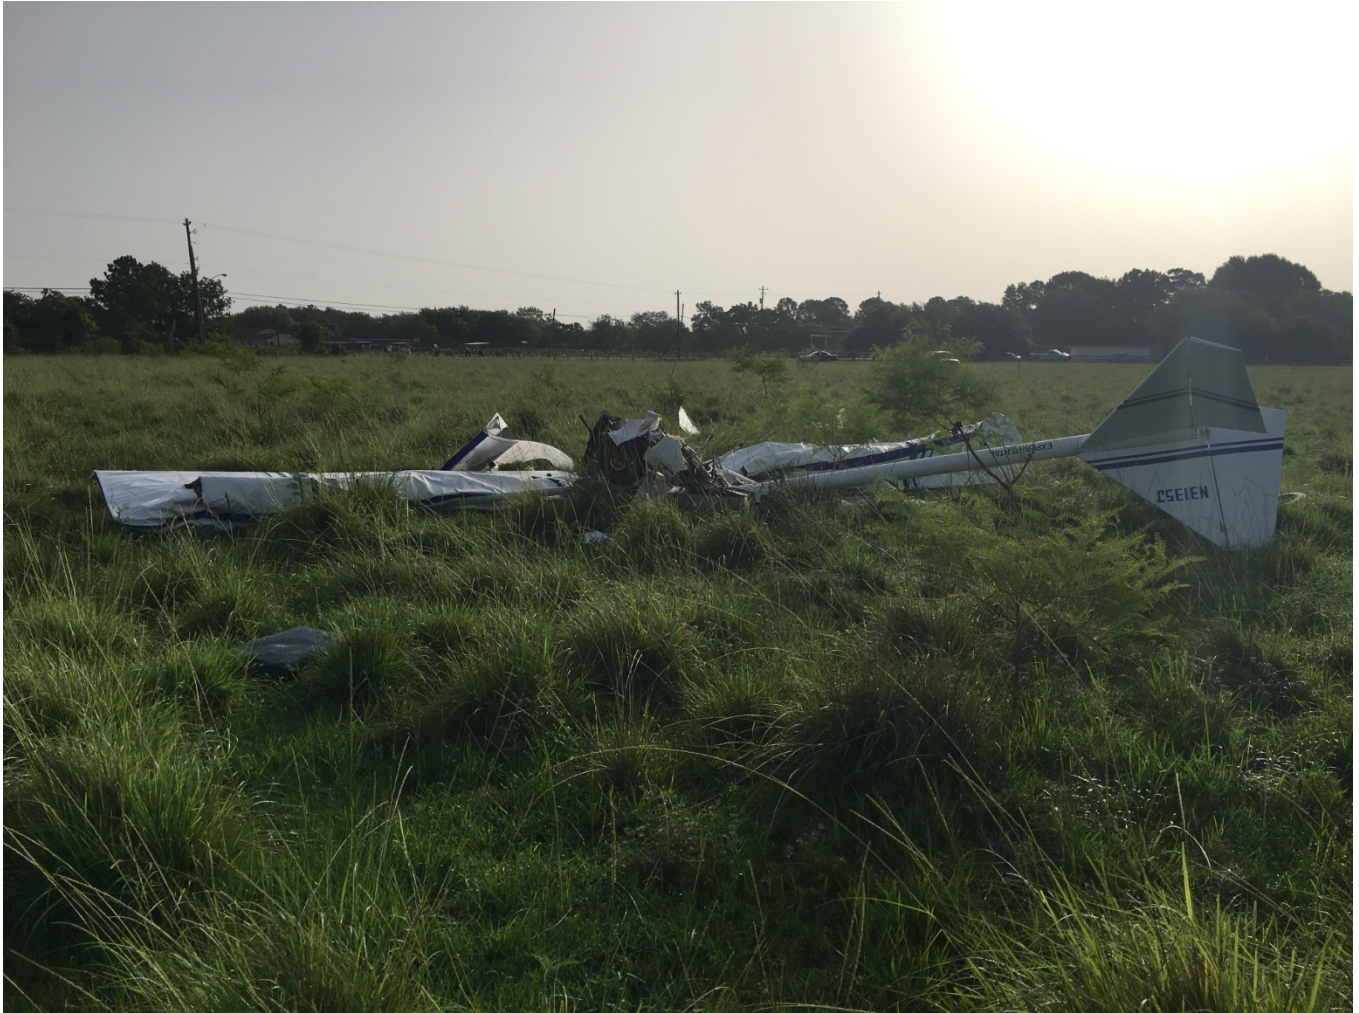
Figure 1. Main wreckage

The initial ground impact scar contained portions of the forward fuselage and instrument panel. The main wreckage came to rest inverted about 20 ft from the initial impact point. The main wreckage consisted of the fuselage, both wings, empennage, and engine. Both wings exhibited forward-to-aft accordion-type crush damage, and the flap and aileron control surfaces remained attached to each wing. The three-blade composite propeller assembly remained attached to the engine and fragmented blade sections were located in the debris field. The engine remained partially attached to the fuselage structure (see figure 1.).

Postaccident examination of the airplane revealed no evidence of mechanical malfunctions or failures that would have precluded normal operations.
