# Aviation Investigation Final Report

<b>Location:</b>	Vinton, Iowa	<b>Accident Number:</b>	CEN18LA278
<b>Date &amp; Time:</b>	July 17, 2018, 13:45 Local	<b>Registration:</b>	N5553X
<b>Aircraft:</b>	Aero Commander S2R	<b>Aircraft Damage:</b>	Substantial
<b>Defining Event:</b>	Loss of engine power (partial)	<b>Injuries:</b>	1 None
<b>Flight Conducted Under:</b>	Part 137: Agricultural

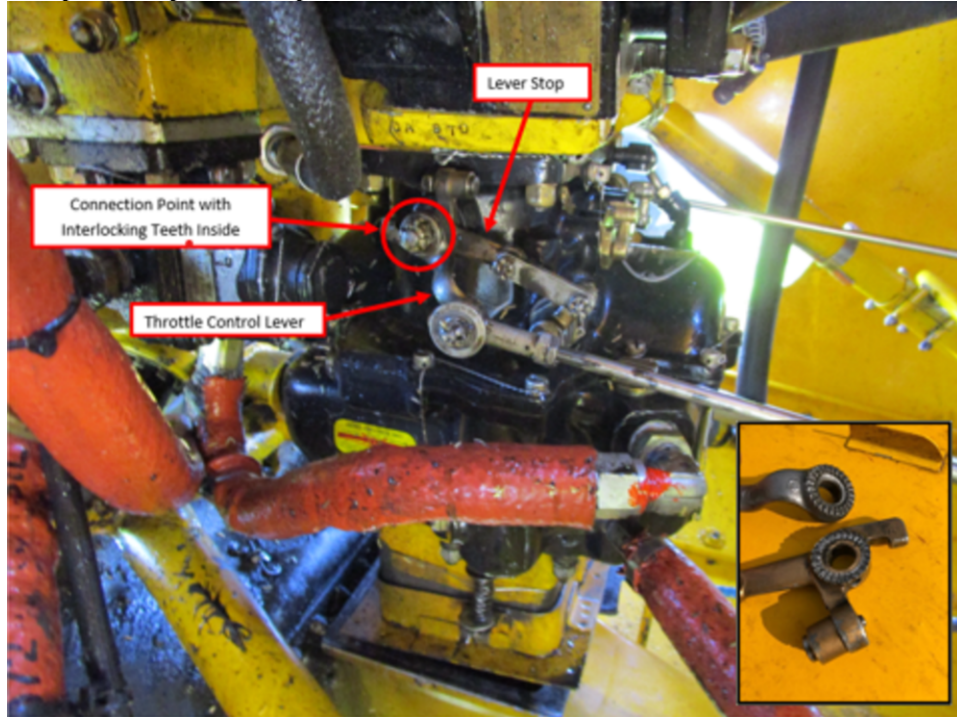
Examination of the throttle control system revealed that the interlocking teeth mechanisms between the carburetor lever stop assembly and the throttle control lever were worn and lost integrity to interconnect. The teeth on the lever stop assembly were severely worn. Thus, it is likely that during the accident flight, when the pilot actuated the throttle control lever, the throttle control system failed when the worn-down teeth on the lever stop would not engage the teeth on the mating throttle control lever. This caused a loss of the throttle lever input, which allowed the engine to enter a low rpm condition. The material examination also noted a mismatch in hardness of the associated parts; although the hardness values were typical for the respective part compositions and microstructures, the mismatch in hardness lent itself to higher wear rates. A review of the airplane's maintenance records revealed that the carburetor had been removed for overhaul and reinstalled 135 hours before the accident. It is likely that maintenance personnel reinstalled the worn parts without thoroughly inspecting them.

Loss of throttle control input due to a failure in the throttle control system. Contributing to the accident was the inadequate inspection and reinstallation of worn parts by maintenance personnel.

Examination of the throttle control system revealed that teeth on the carburetor lever stop assembly and throttle control lever were worn out and no longer interconnected (see Figure 1); the lever stop assembly teeth were noted to be severely worn. When the throttle control lever was actuated, the worn-down teeth of the mating parts would glide over each other with no respective response from the carburetor lever stop assembly. The castellated hex retaining nut was found properly cotter pinned. Upon removal of the cotter pin, the nut could not be tightened to the next accessible castellation. The lever stop assembly roll pin was tight and had to be removed with a drift punch. Both levers fit tight on the throttle shaft. A logbook review indicated that a carburetor overhaul and installation was completed 135 hours before the accident. The associated parts were removed and sent to the National Transportation Safety Board Materials Laboratory for further examination, which revealed that the lever stop assembly had a composition consistent with aluminum alloy, while the composition of the throttle control lever was carbon steel. The hardness of the steel throttle control lever averaged

52 HRA and the hardness of the aluminum lever stop averaged 34 HRA; these data were typical for the respective part compositions and microstructures.

Figure 1: Diagram of Throttle Control Lever and Lever Stop from Accident Airplane with Inset Photo of Worn Teeth
