Aviation Investigation Final Report

| Location: | Covington, Tennessee | Accident Number: | ERA18FA240 |
| Date & Time: | September 1, 2018, 17:20 Local | Registration: | N815EY |
| Aircraft: | LANCE M HOOLEY JETEZ | Aircraft Damage: | Destroyed |

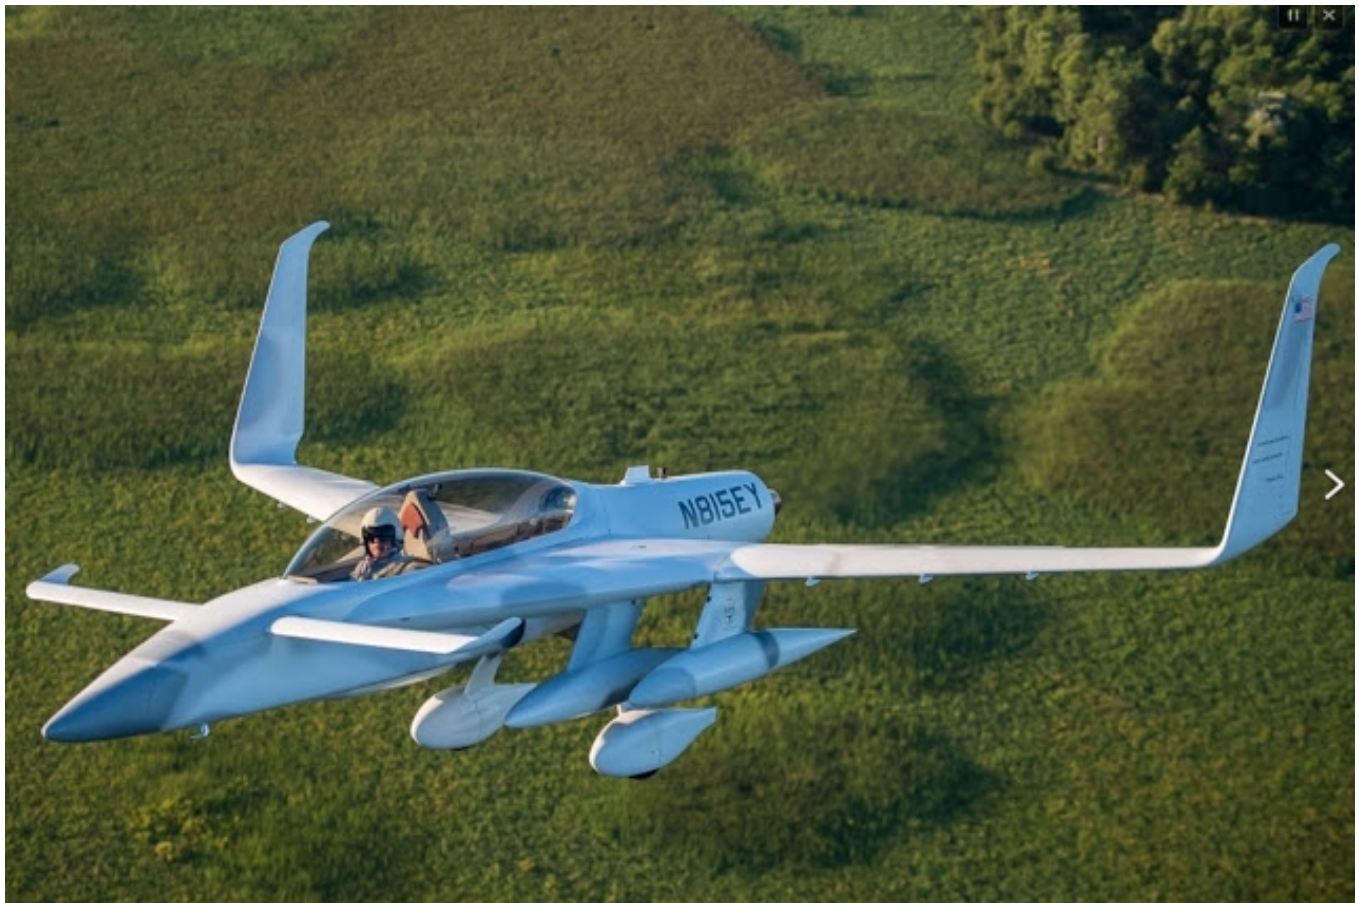
Figure 1. Accident airplane. (Source: *KITPLANES* magazine, May 2018.)

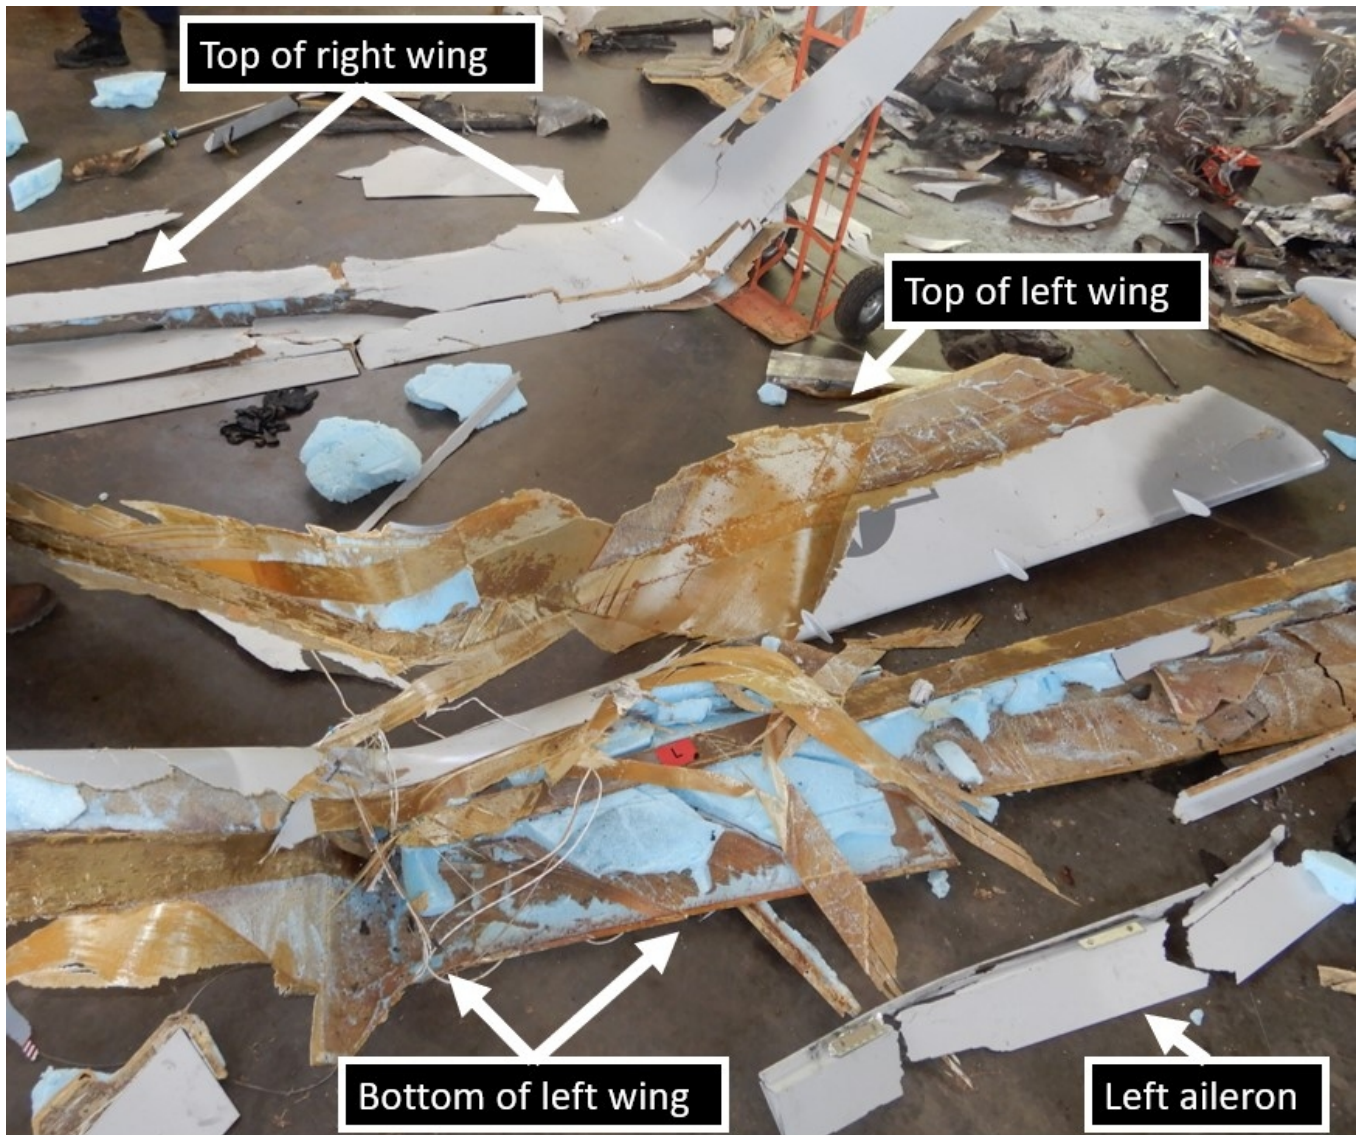
Portions of the left wing upper skin plies displayed evidence of fiber material transfer from the lower wing skin. Portions of the left wing upper spar cap and upper skin had a glossy appearance with no apparent evidence of fiber material transfer. The left winglet skin panels showed evidence of fiber material transfer between the winglet skin and the winglet spar caps. After examination, the left and right wing components were laid out. Figure 2 shows the top and bottom portions of the left wing and left aileron.

Figure 2. Left and right wing fragments.

Further examination of portions from the internal left wing structure was performed by the NTSB Materials Laboratory in Washington, DC. This examination showed that the upper wing surfaces and the upper spar cap sections had areas that were consistent with a resin-starved or dry laminate. These areas were also consistent with an adhesive disbond between the respective faying surfaces. This adhesive disbond was consistent with a lack of impregnation and interfacial interaction of the resin into and with the glass fiber fabric, resulting in a lack of strong adhesion between the wing skin and the spar cap. These issues were consistent with a fabrication problem during manufacturing of the layup rather than wear over time or an environmental degradation failure. Reference the Materials Laboratory Factual Report in the public docket for additional details and photographs.
