Aviation Investigation Final Report

Location:	Daytona Beach, Florida	Accident Number:	ERA18LA164
Date & Time:	June 9, 2018, 15:00 Local	Registration:	N21161
Aircraft:	Piper PA 44	Aircraft Damage:	Substantial
Defining Event:	Loss of control in flight	Injuries:	2 Minor
Flight Conducted Under:	Part 91: General aviation - Instructional

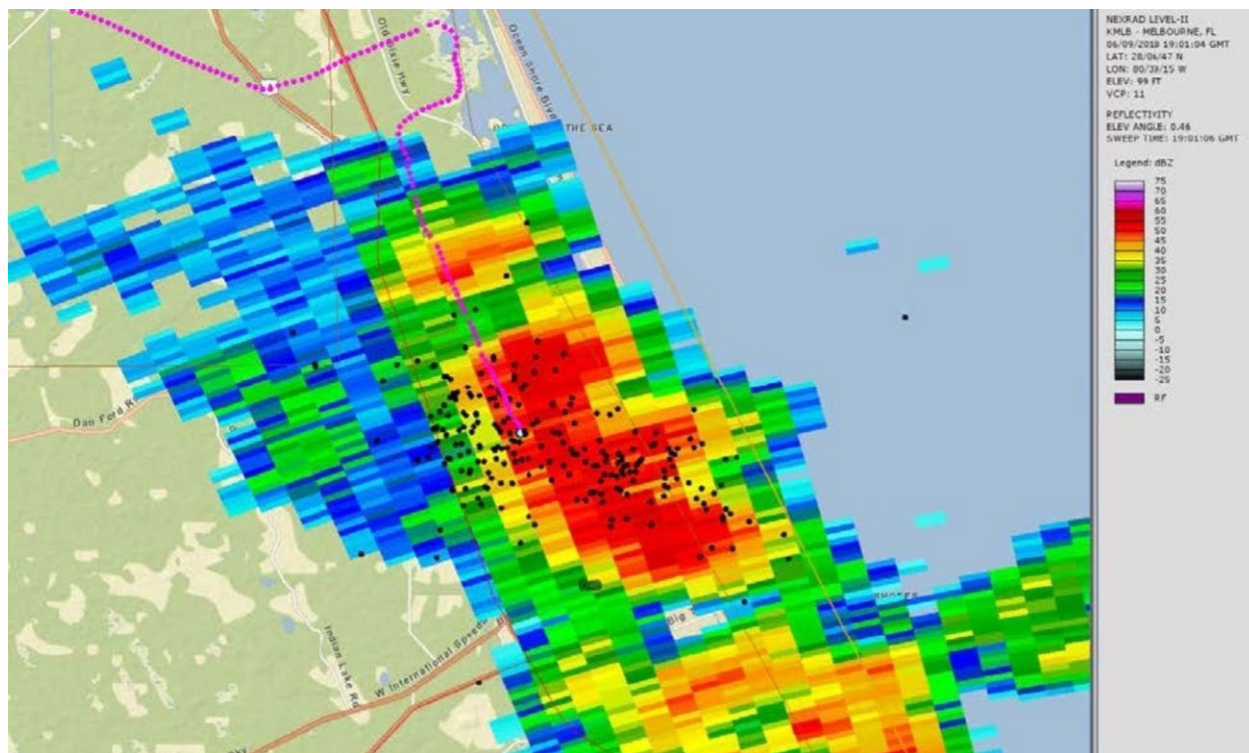
Base reflectivity scans from around the time of the accident indicated very heavy rainfall and possible hail. Two hundred fifty-five lightning flashes occurred around the accident site between 1445 and 1505;

the closest lightning occurred within 1,000 ft of the accident flight. See figure 1 for the base reflectivity scan from 1501.

Figure 1. Reflectivity scan at 1501 with the air traffic control flight track data points in pink and the lightning flashes as black dots.
