Aviation Investigation Final Report

Location:	Deer Park, Washington	Accident Number:	WPR18FA195
Date & Time:	July 13, 2018, 10:21 Local	Registration:	N24442
Aircraft:	Cessna 172	Aircraft Damage:	Substantial
Defining Event:	Birdstrike	Injuries:	3 Fatal
Flight Conducted Under:	Part 91: General aviation - Instructional

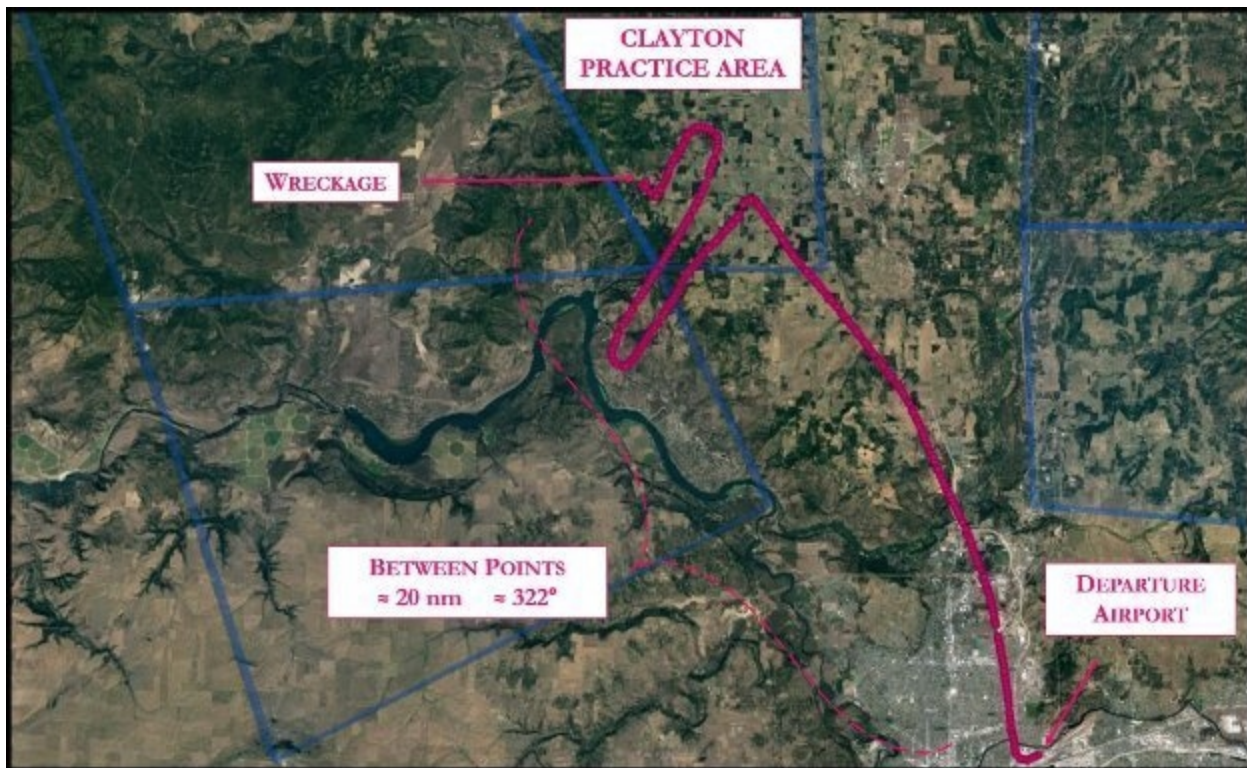
Figure 1: Radar Data from Departure Airport to Accident Site.

A review of the radar track data indicated that, after entering the practice area at 1010, (Figure 1) the airplane began a gradual 90° left turn and continued in a southwesterly direction, temporarily leaving the Clayton boundary. The airplane continued in a gradual climb to about 7,000 ft mean sea level (msl) and then made a 180° right turn. The flight track remained on a northeasterly heading until about 1018, at which point the airplane made another 180° left turn to a heading of 208°. The airplane proceeded about 2.5 miles at altitudes varying between about 7,000 to 7,450 ft msl. At 1020:53, the data indicated the airplane was at an altitude of 7,000 ft msl and an estimated ground speed of 77 knots. The airplane then made a sharp 90° right turn (Figure 2) and continued on a 305° heading for about 14 seconds. The airplane then made another sharp 90° right turn, and the last recorded track data, at 1021:18, indicated an estimated ground speed of 117 knots.

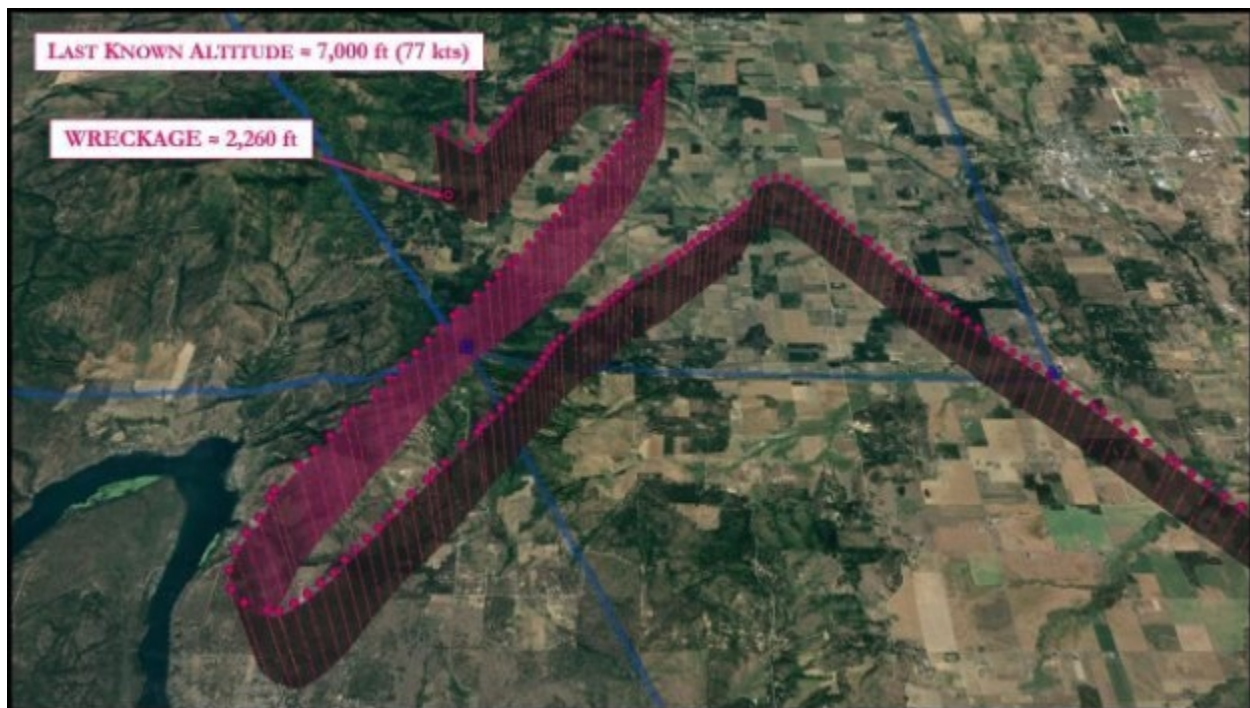
Figure 2: Radar Data Prior to Accident (showing altitude profile)

The accident site was located about 740 ft southwest of the last recorded track data (Figure 2). Witnesses reported that the airplane banked hard, then descended in a steep dive toward terrain. During the descent, the wings departed the airplane before ground impact.

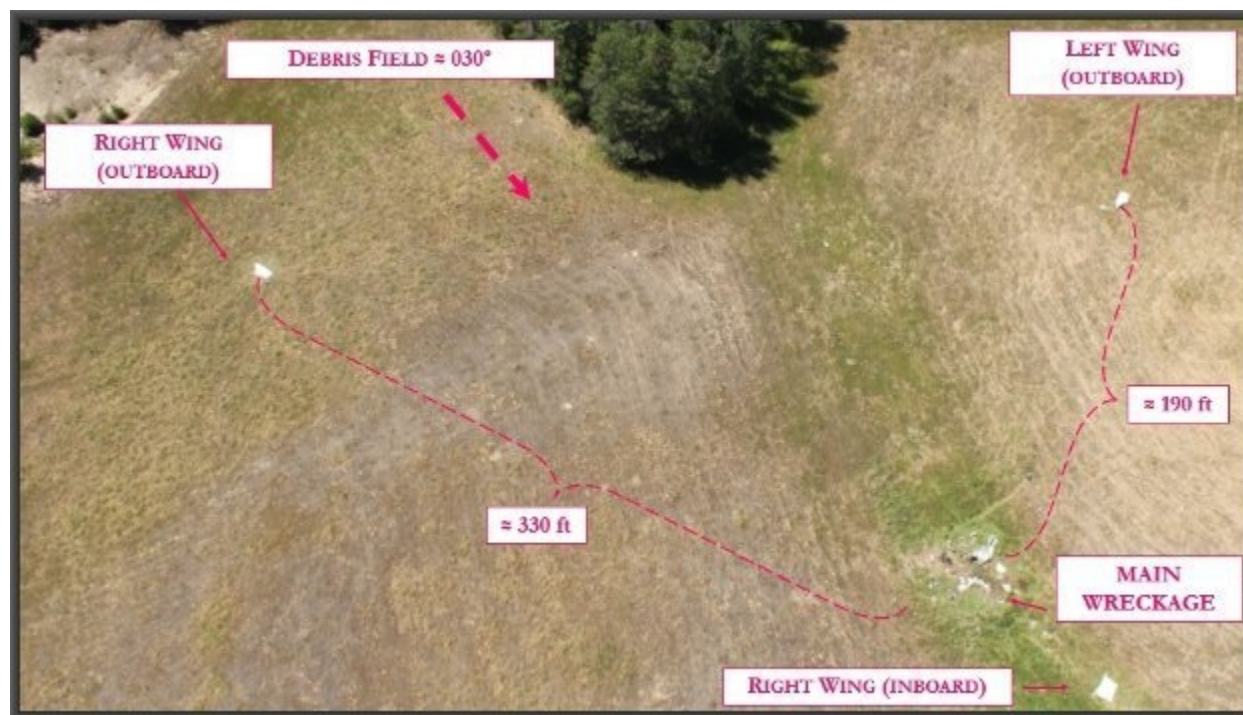
Figure 3: Accident Site

The wreckage was distributed over a 400 ft distance on a median magnetic bearing of about 030°. The outboard sections of both the right and left wings were located at the beginning of the debris field about 330 and 190 ft from the main wreckage, respectively (Figure 3). The debris between the outboard wing

sections and the main wreckage consisted of left-wing pieces. All control surfaces and their associated mass balance weights were accounted for in the debris field.
