Aviation Investigation Final Report

Location:	Boulder City, Nevada	Accident Number:	WPR19LA141
Date & Time:	May 7, 2019, 16:00 Local	Registration:	N423EB
Aircraft:	Flight Design CTLS	Aircraft Damage:	Substantial
Defining Event:	Aerodynamic stall/spin	Injuries:	1 Serious, 1 Minor
Flight Conducted Under:	Part 91: General aviation - Personal

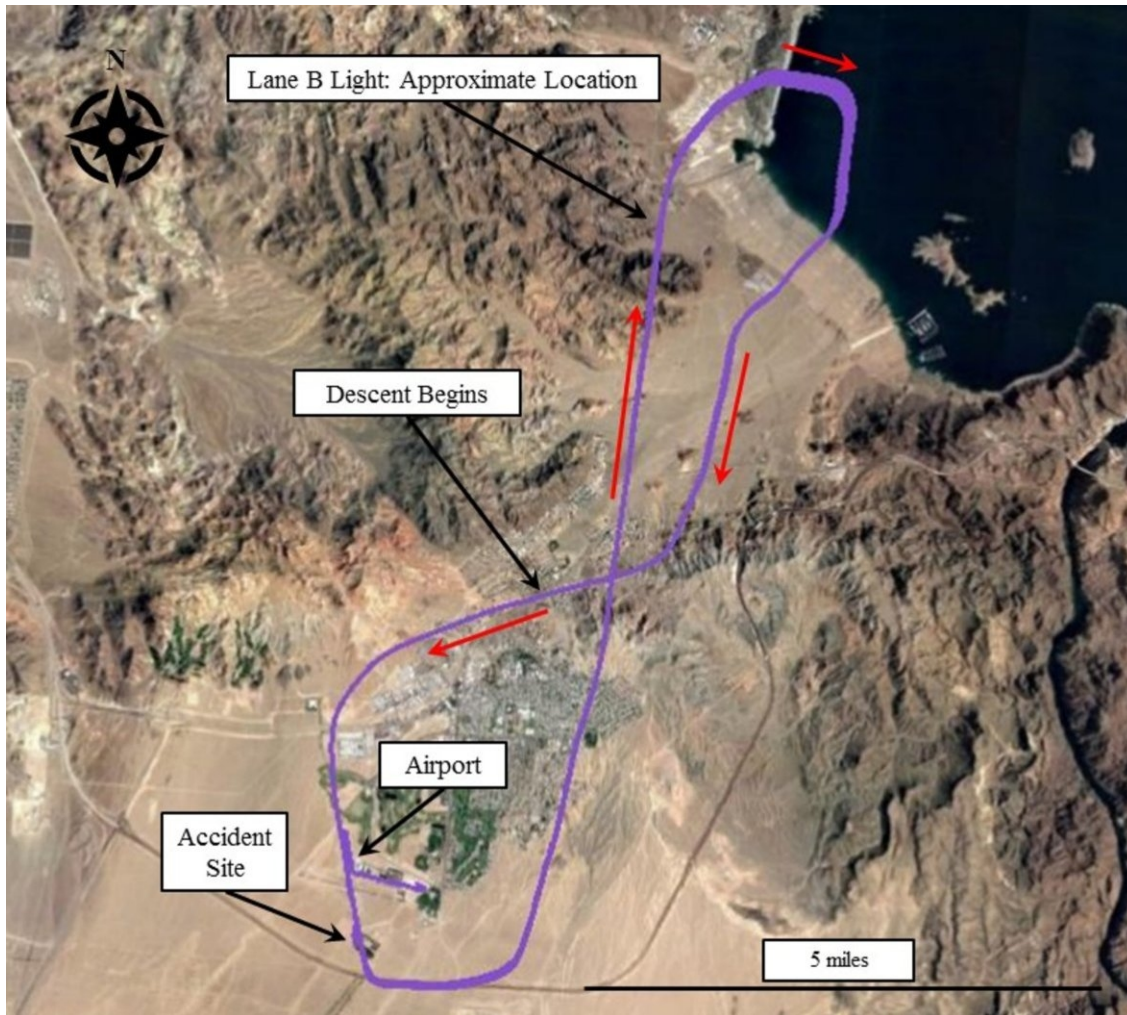
Figure 2: Flight Track Data from Dynon PFD

The pilot began a descent at 1555:06 about 2.5 nm northeast of the airport from 3,500 ft msl (1,300 ft above ground level). Seconds later, the Dynon recorded the airplane’s maximum airspeed during the accident flight, which was a true airspeed of 134 kts and 124 KIAS. At 1556:31, while on short final about 0.5 nm north of the airport and about 400 ft above the runway, the airplane’s vertical speed rapidly increased momentarily about 30 seconds before the airplane reached the runway. At 1556:54, the airplane reached the runway touchdown zone and while over the first half of the runway the pilot’s airspeed reduced from about 76 knots indicated airspeed to about 53 knots, and the engine power was reduced to about 1,600 rpm. In the last half of the runway the engine rpm advanced to 4,695 rpm with a corresponding throttle position of 95%, while the airspeed decreased further to about 47 knots. At the

end of the runway, the airplane's pitch attitude increased to about 14° nose up and the indicated airspeed decreased to about 35 knots. The airplane then descended into the ground.

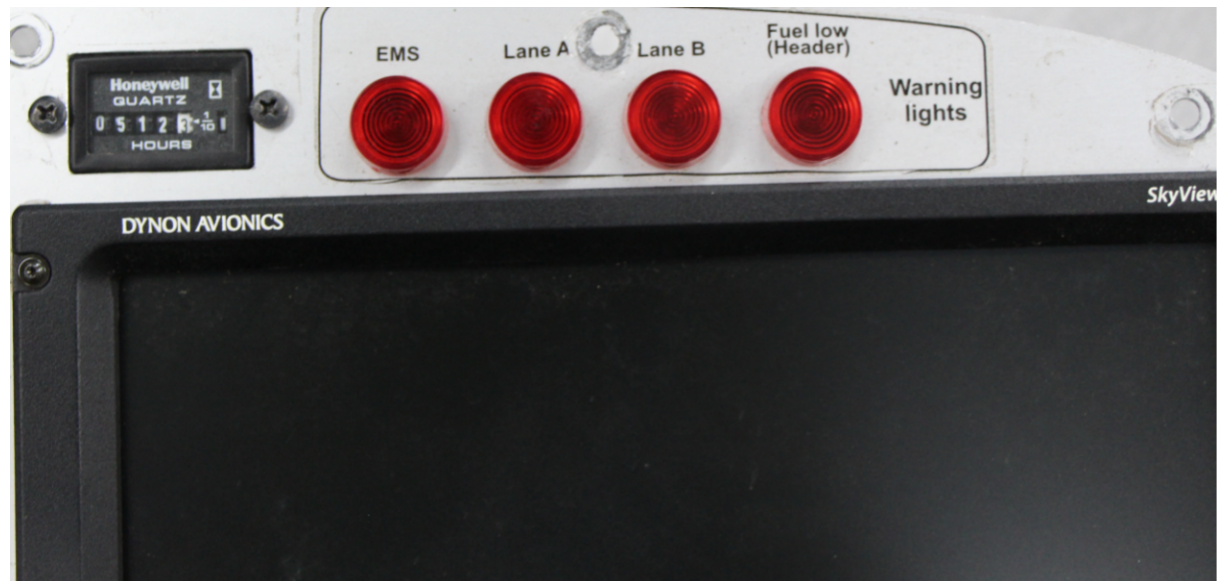
Figure 4: Annunciator Panel

In the event of a Lane failure, a warning light on the instrument panel annunciator display would appear. This panel was developed by the airframe manufacturer and located directly about the Dynon PFD. (see Photograph 1)

This information was based on SkyView software 15.1.0, which was released in March 2017, but was also valid for the version used by the accident pilot, 15.3.5. Dynon confirmed that a solid Lane B

warning lamp would have displayed the message “Rotax: Land Aircraft” after the pilot depressed the “Warning” button. The pilot did not recall depressing a button to see the message appear.
