Aviation Investigation Final Report

Location:	Farmington, New Mexico	Accident Number:	WPR19FA103
Date & Time:	March 31, 2019, 14:39 Local	Registration:	N173CT
Aircraft:	Cirrus SR22	Aircraft Damage:	Destroyed
Defining Event:	VFR encounter with IMC	Injuries:	1 Fatal
Flight Conducted Under:	Part 91: General aviation - Personal

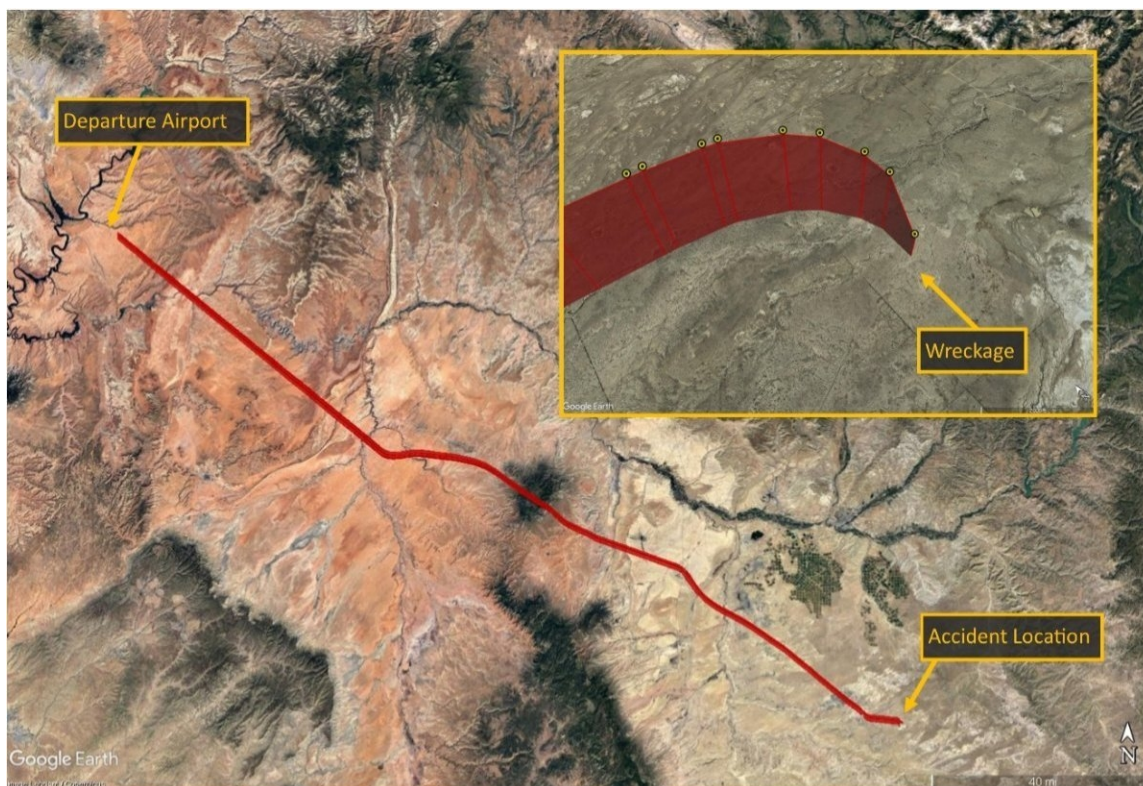
Figure 1. ADS-B-derived flight track. Final turn inset

Federal Aviation Administration (FAA) automatic dependent surveillance-broadcast (ADS-B) data (See Figure 1) revealed the accident airplane depart at 1351 and climb on an eastbound heading. While the target was climbing out of a transponder-reported altitude of 9,125 ft mean sea level (msl), the accident pilot contacted Cedar City Flight Service Station to activate a visual flight rules (VFR) flight plan. During that exchange, the briefer asked the pilot if he had the AIRMET advisory for icing and mountain obscuration for the planned route of flight, and the pilot reported that he did.

The controller then provided the pilot with a frequency change, which the pilot read back correctly. No other radio transmissions were received from the pilot, and at 1438:10, the airplane had descended to 8,575 ft msl (about 3,000 ft agl) and began a descending right turn. The radius of the turn was about 3,200 ft, during which the airplane was traveling at about 187 mph. The last recorded return from the airplane occurred 20 seconds later, with the airplane at 6,850 ft msl on a southbound track. The altitudes measured over the last 20 seconds corresponded to a descent rate of about 5,175 ft per minute.

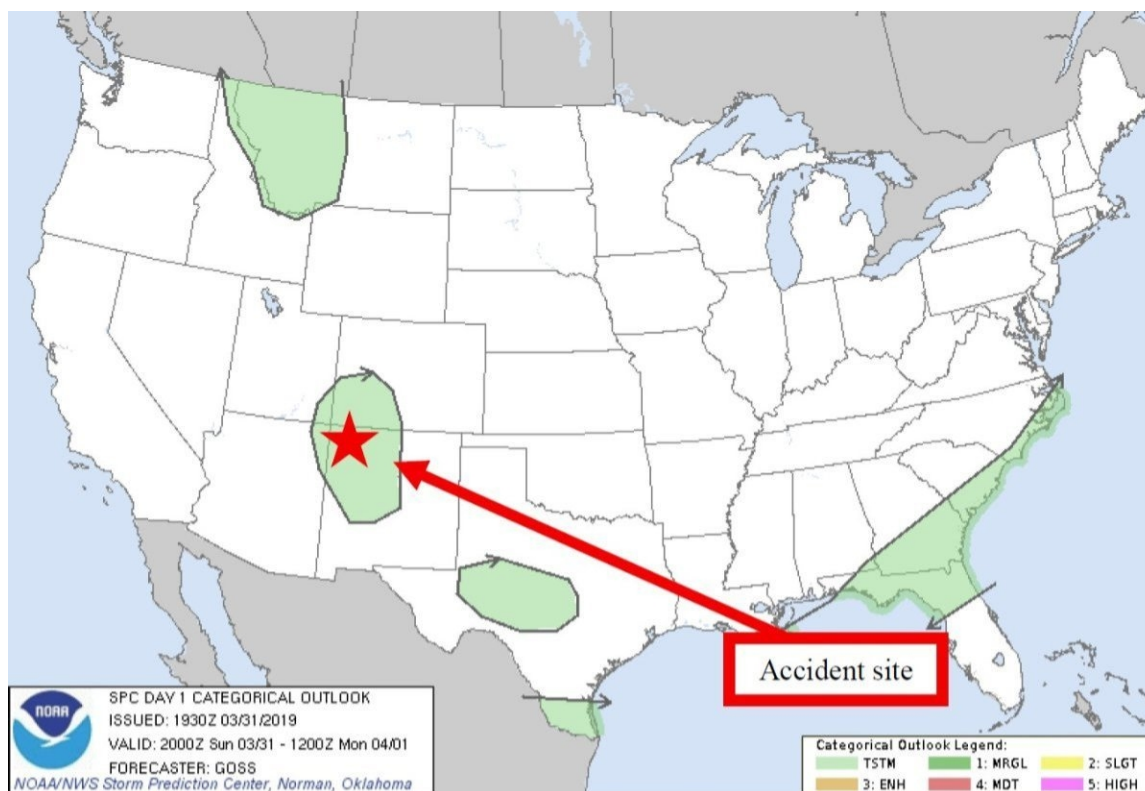
Figure 2. SPC day 1 Convective Outlook valid at the time of the accident

The National Weather Service (NWS) Storm Prediction Center (SPC) issued a Day 1 Convective Outlook at 1030 and 1330, indicating areas of general thunderstorms forecast for the accident site during the accident period. (See Figure 2.)

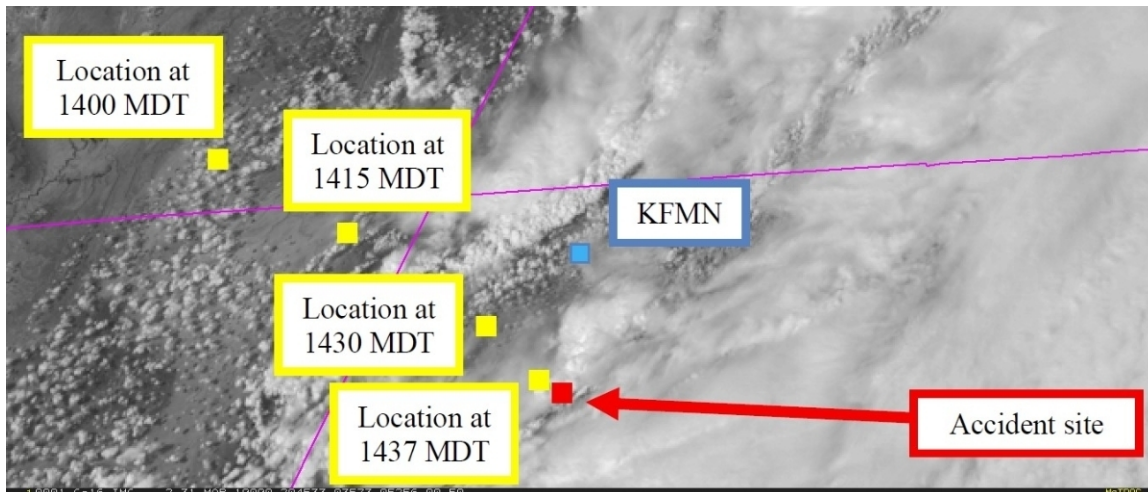
Figure 3. GOES-16 visible image at 1445

Visible satellite imagery at 1430 and 1445 indicated a band of cumuliform clouds above the accident site at the accident time. The cloud cover and cumuliform bands were moving from northwest to southeast with the cloud cover increasing in areal coverage with time. The airplanes track flew directly under the cumuliform band. (See Figure 3.)
