# Aviation Investigation Final Report

<b>Location:</b>	Summersville, Missouri	<b>Accident Number:</b>	CEN19FA093
<b>Date &amp; Time:</b>	March 5, 2019, 22:04 Local	<b>Registration:</b>	N7369W
<b>Aircraft:</b>	Piper PA28	<b>Aircraft Damage:</b>	Substantial
<b>Defining Event:</b>	Fuel exhaustion	<b>Injuries:</b>	1 Fatal
<b>Flight Conducted Under:</b>	Part 91: General aviation - Personal

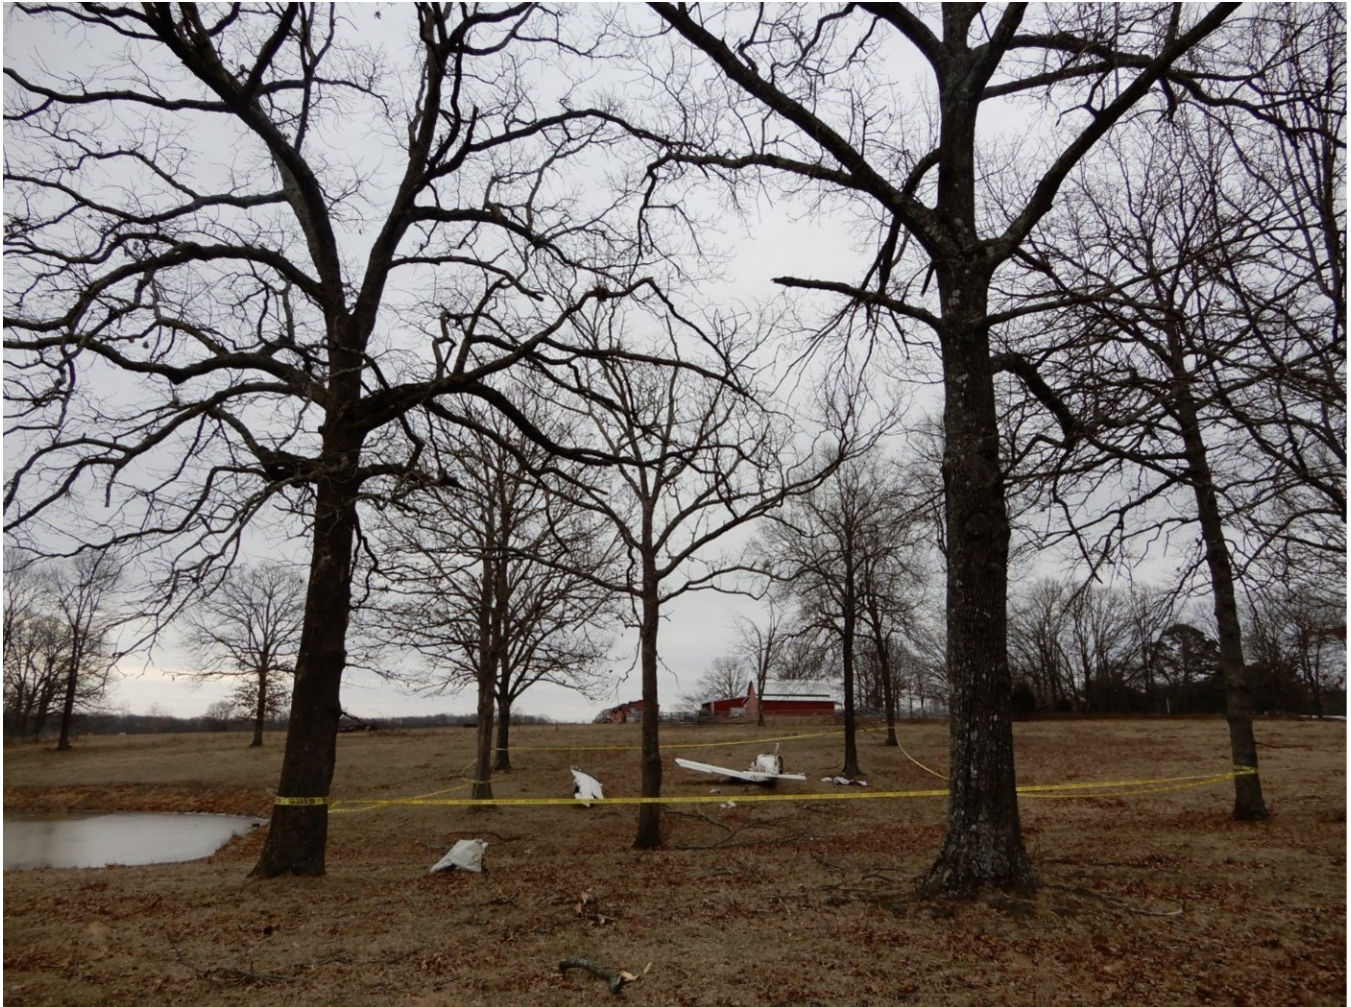
**Figure 1. Accident Site**

The accident site had deciduous walnut trees and hilly terrain covered in short grass (see figure 1). The airplane came to rest on a measured heading of 99° at an elevation of 1,310 ft.

The initial impact point was located at the top of a 45-ft-tall tree, characterized by broken branches. The main wreckage came to rest about 76 ft east of the initial impact point. A section of the right wing, broken branches, and paint chips were scattered on the ground between the initial impact point and a second tree. The second tree was about 45 ft tall and exhibited broken branches near the top and witness marks consistent with impact from the airplane. Additional branches, plexiglass, paint chips, torn metal from the wing, torn fiberglass, the baggage door, and a fragmented red lens cover were scattered over 45 ft between the second tree and the main wreckage.
