Aviation Investigation Final Report

Location:	Ramona, California	Accident Number:	WPR17FA063
Date & Time:	February 12, 2017, 14:10 Local	Registration:	N2179L
Aircraft:	Cessna 172	Aircraft Damage:	Substantial
Defining Event:	Controlled flight into terr/obj (CFIT)	Injuries:	1 Fatal, 2 Minor
Flight Conducted Under:	Part 91: General aviation - Instructional

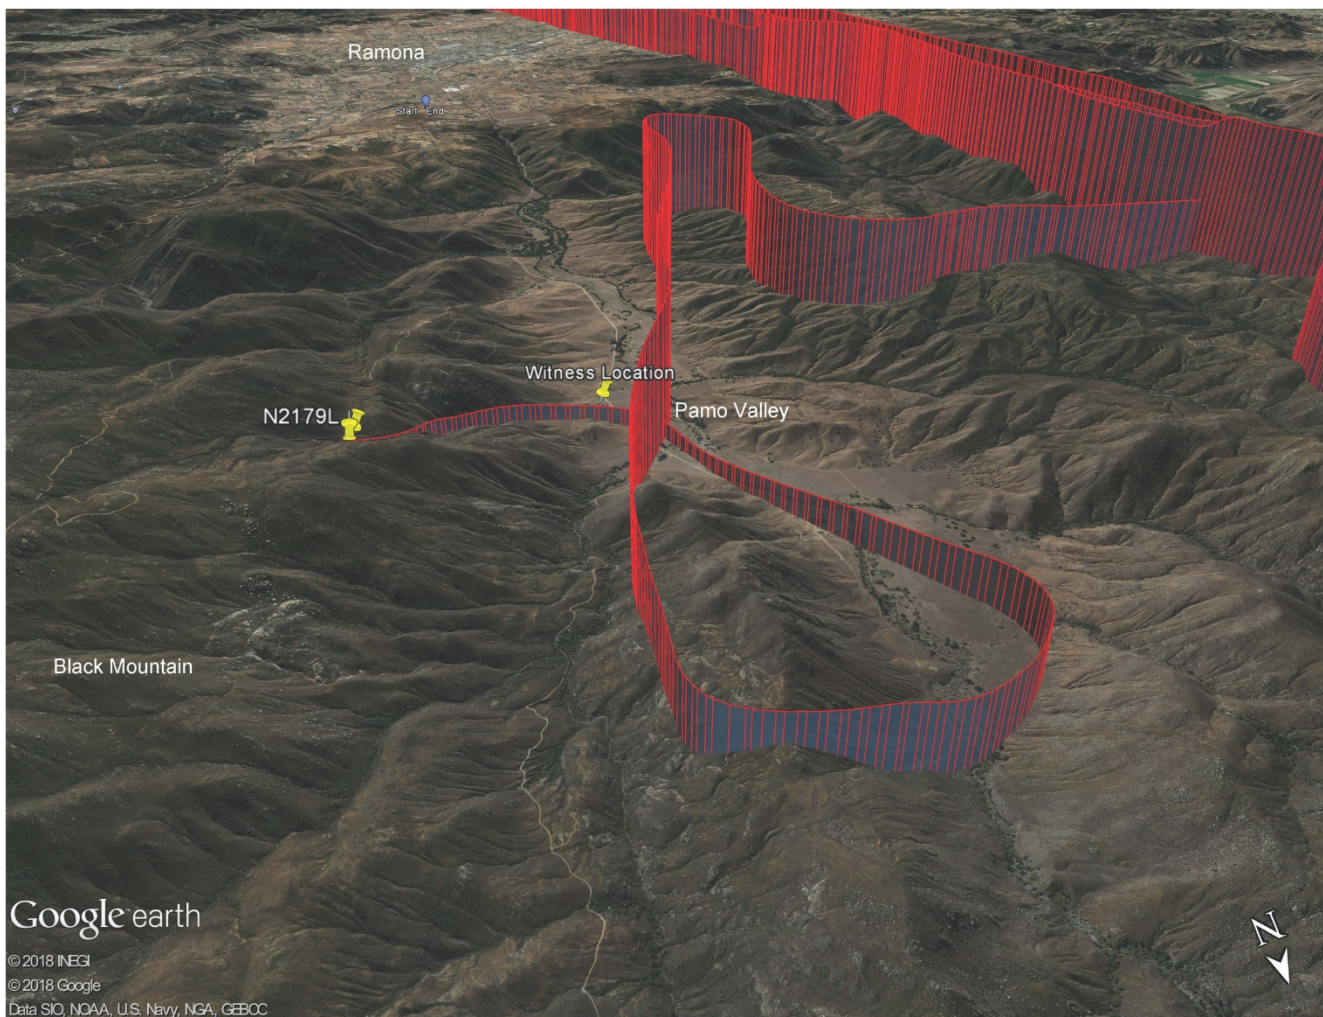
Figure 1-Aerial View of Accident Flight Track

Flight track data recovered from a personal electronic device onboard the airplane showed that, after the simulated engine failure maneuver, the airplane climbed and turned east entering terrain that rose in front and on both sides of the airplane. The track continued to climb for about 1 minute 5 seconds before reaching the accident site.

The flight track data for the final 1 minute 5 seconds of the flight indicated that the airplane climbed about 584 ft, corresponding to a rate of climb slightly less than the published maximum rate of climb. During the climb, the left turn towards the east would have decreased the rate-of-climb performance, which likely accounts for the rate of climb being less than the published maximum.

A personal electronic device was recovered from the airplane and revealed the accident flight track data was obtained from the ForeFlight application on the device. The track data depicted the airplane departing SEE and performing maneuvers between 2,000 and 5,100 ft agl in a practice area about 5 miles west of the accident site. The airplane departed the practice area to the east and made multiple turns over Pamo Valley, descending to about 285 ft agl. The airplane then climbed and turned east entering an area of terrain that rose in front and on both sides of the airplane. The track continued to climb for about 1 minute 5 seconds, about 584 ft, before reaching the accident site. Refer to Figure 1.
